YOUR INSPECTION REPORT

FOR THE PROPERTY AT:
28 Traymore Crescent
Toronto, ON M6S 4K5

INSPECTION DATE:
Monday, March 24, 2025

RE: Report No. 8214, v.2
28 Traymore Crescent
Toronto, ON
M6S 4K5

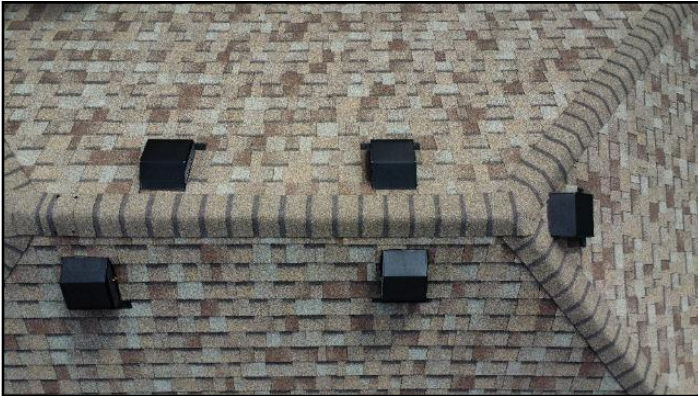
1. Asphalt shingles

- [Strip when reroofing](#)
- Newer, good condition

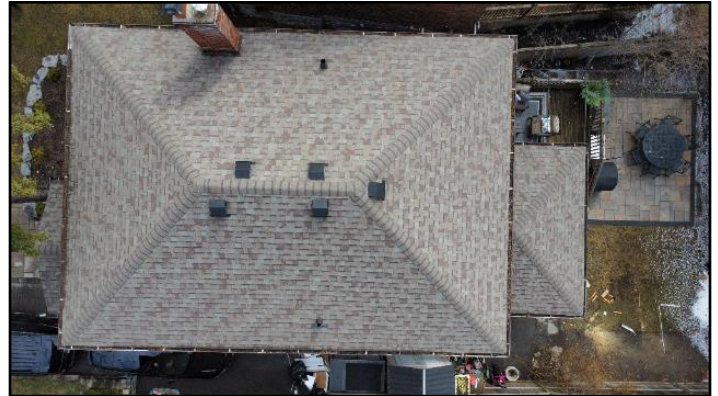
2. Asphalt shingles

Approximate age: • 3 years

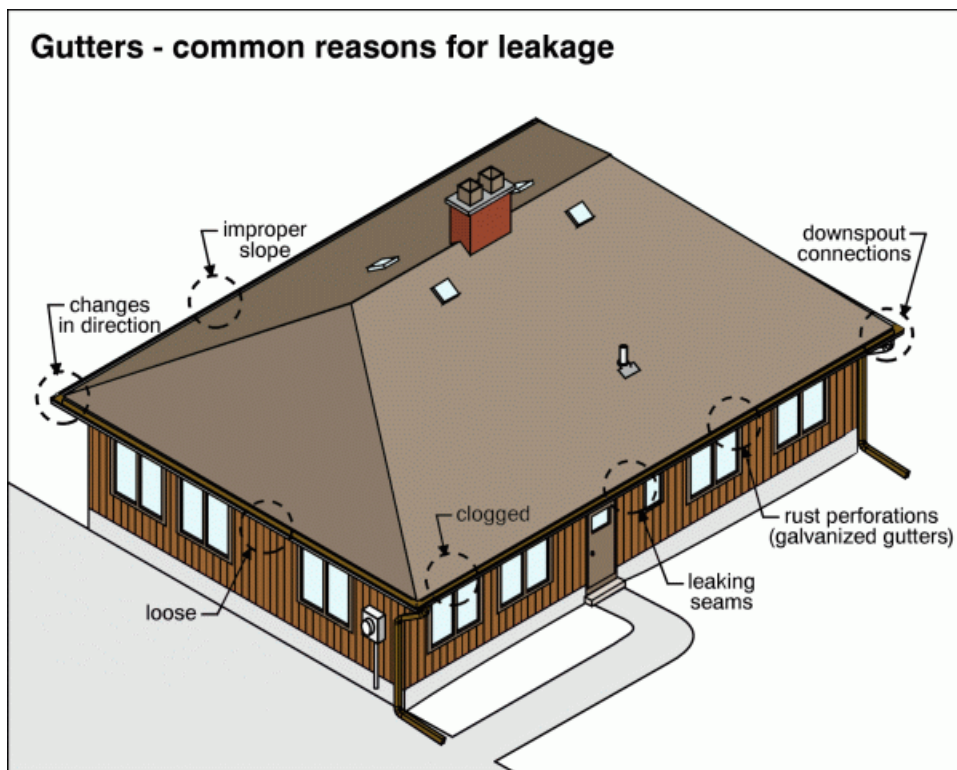
Condition: • [Clogged](#)

Time: Less than 1 year

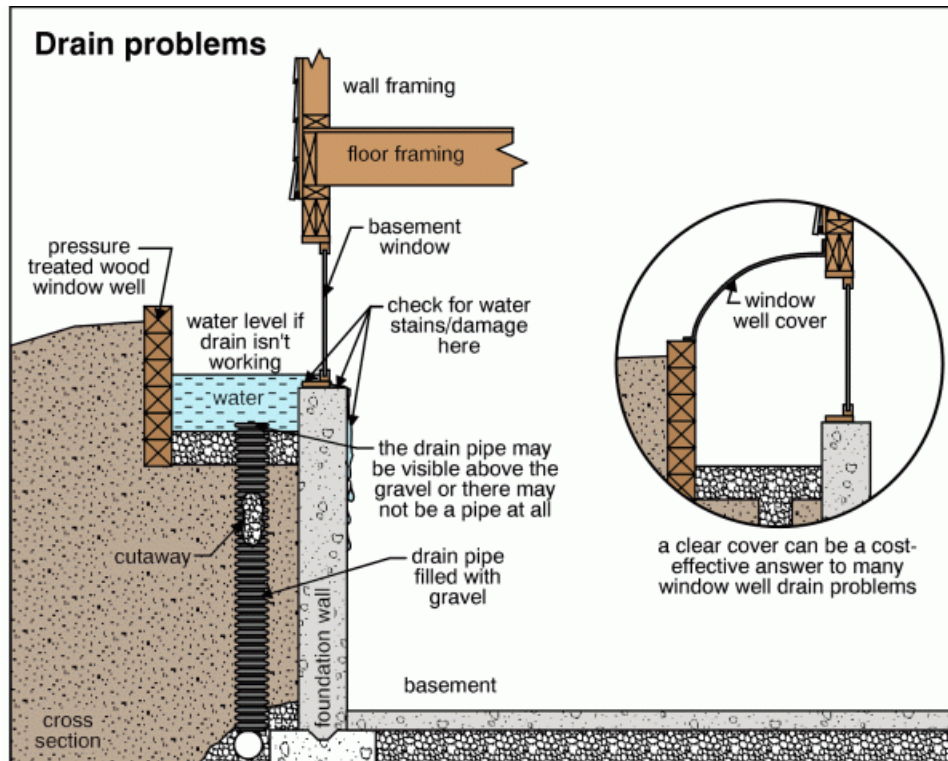
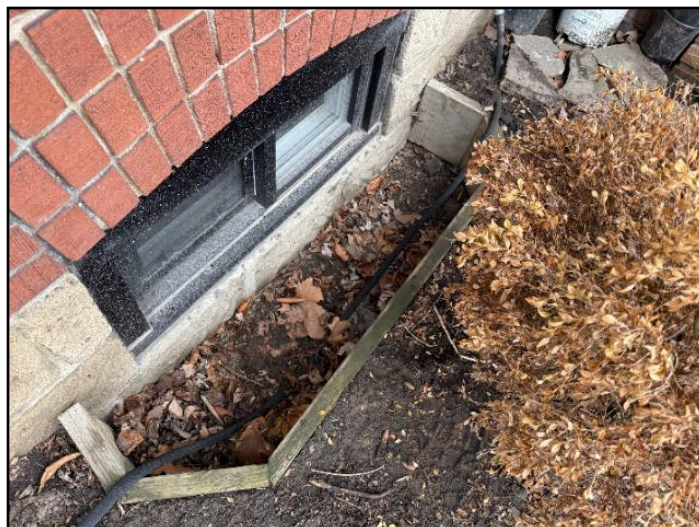
3. Missing

Condition: • [Missing](#)

Task: Monitor drainage at well and improve if necessary

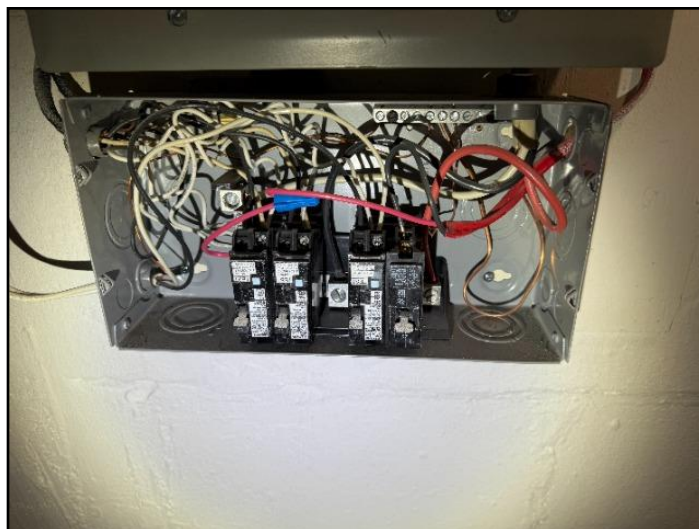
5. Breakers - basement

Condition: • Federal Pacific OR Pioneer Stab-Lok panel is installed

This type of panel has been associated with concerns regarding breaker failure, particularly in older models.

Implication(s): Fire Hazard

It is recommended to have the panel inspected by a licensed electrician familiar with Stab-Lok panels to verify proper operation. The electrician may advise breaker testing, breaker replacement, or panel replacement depending on their findings.

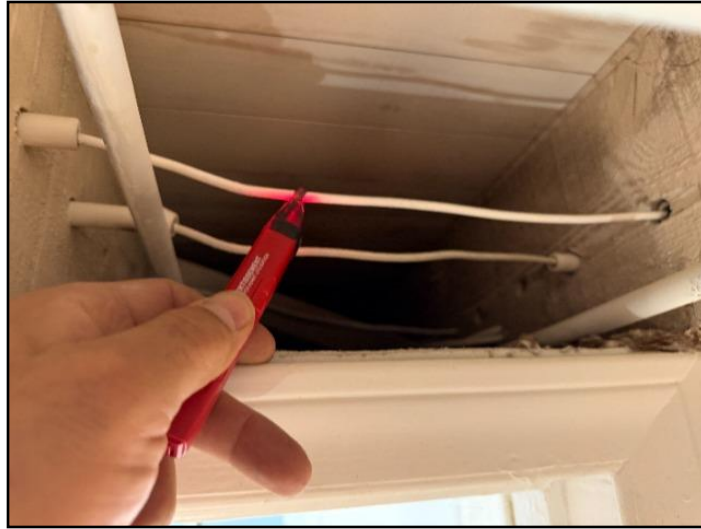
6. one example

Condition: • [Outdated -](#)

The Electrical Safety Authority (ESA) does not consider knob-and-tube wiring inherently unsafe. However, it is an insurance issue, as many providers require the wiring to be upgraded. Some insurers may request an electrical audit to determine the percentage still in use.

Time: As Soon As Possible

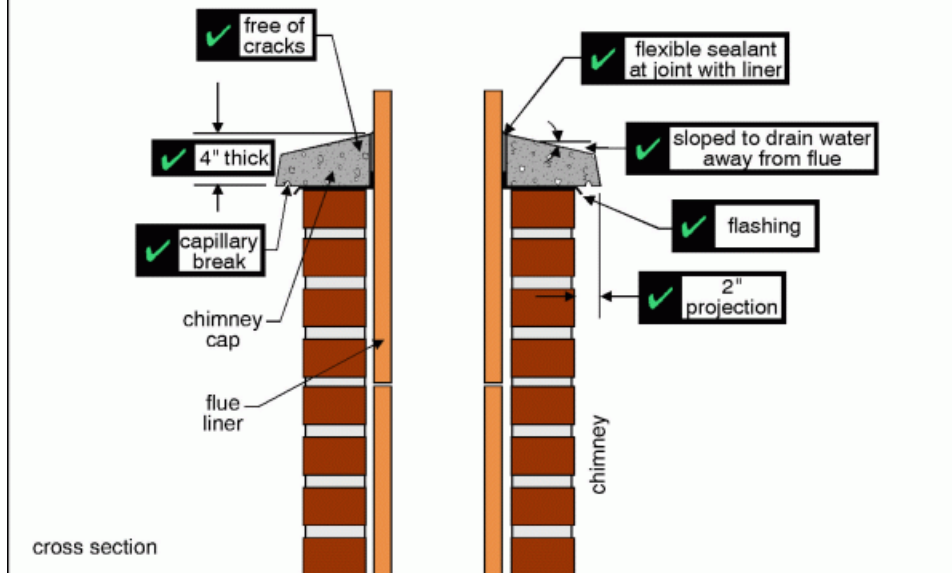
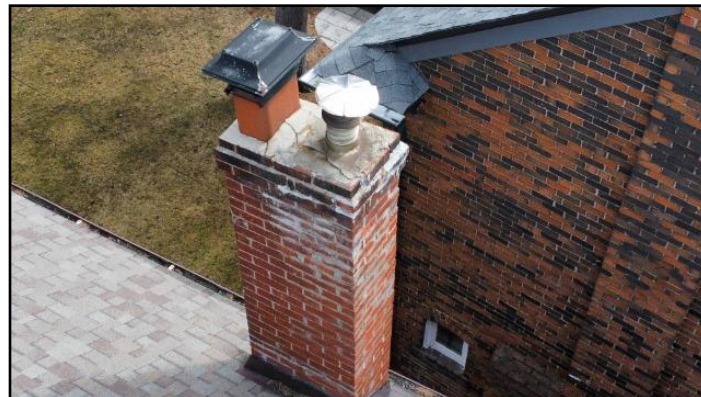
Condition: • [Cracked](#)

Implication(s): Chance of water damage to structure, finishes and contents | Shortened life expectancy of material

7. Cracked and no drip edge

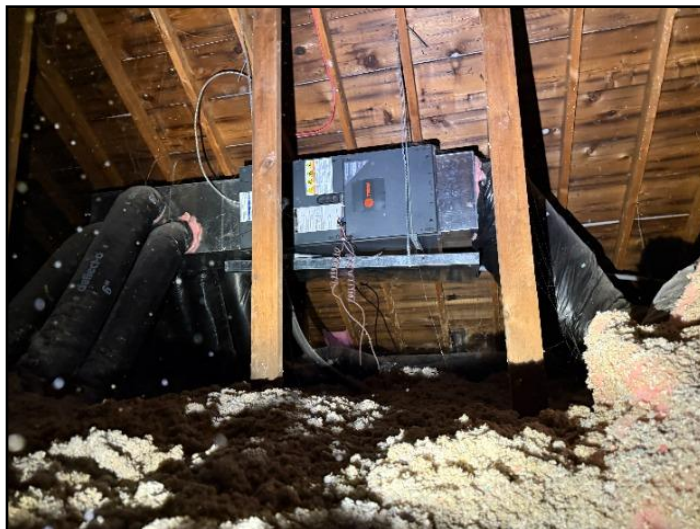
8. Air handler in attic

Compressor at exterior. Air handler located attic. Ducts to various areas to provide cooling.
