# YOUR INSPECTION REPORT

FOR THE PROPERTY AT:  
179 Pacific Avenue  
Toronto, ON M6P 2P6

INSPECTION DATE:  
Monday, September 8, 2025

RE: Report No. 8549, v.2  
179 Pacific Avenue  
Toronto, ON  
M6P 2P6

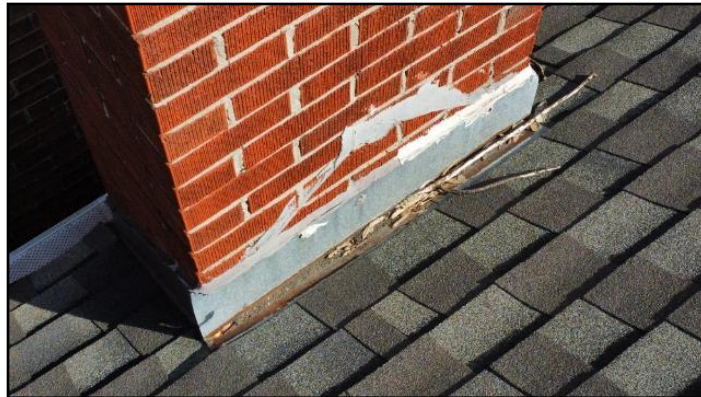
**Condition:** • [Cricket \(Saddle\) missing, loose, damaged](#)

4. Cricket (Saddle) missing

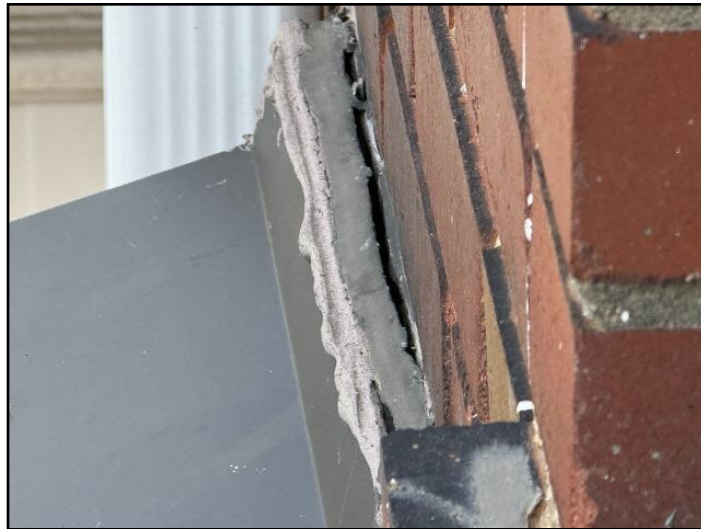
**Condition:** • [Damage, loose, open seams, patched](#)

5. Damage, loose, open seams, patched

**Task:** Repair

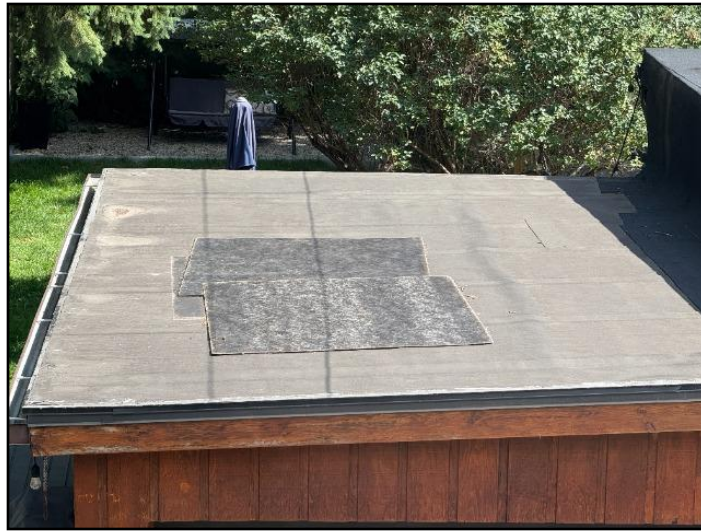
6.

**Condition:** • Roll roofing observed. Covering is aging. Additional material has been placed on top (purpose not confirmed). Interior staining noted at roof joists.

**Task:** Further evaluation at next annual servicing and repair/replace as required

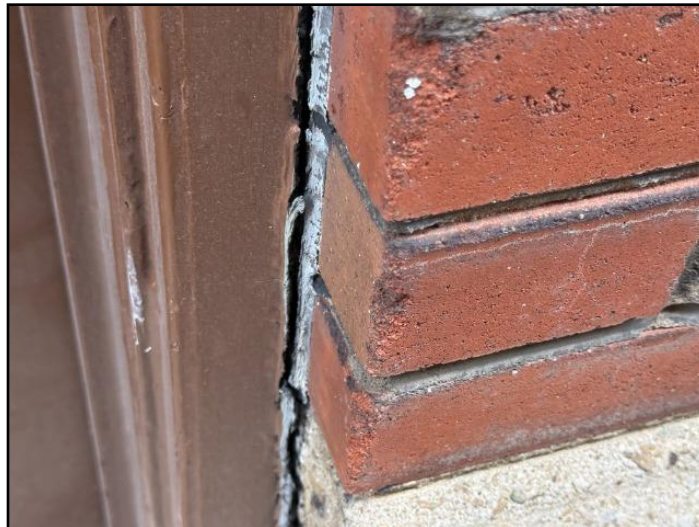
**Condition:** • FOR ALL HOMES - Caulking around windows, doors, and wall penetrations should be inspected regularly and improved as needed to prevent moisture entry and air leakage.

7. one example at door

**Task:** Improve

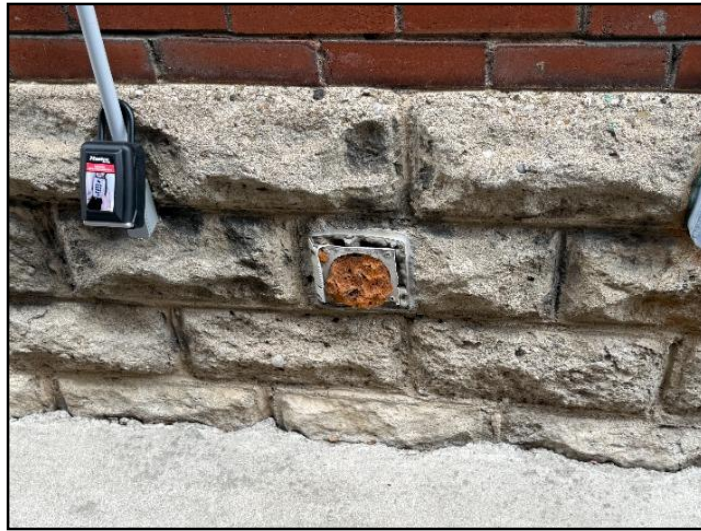
8. example

**Condition:** • Inappropriate material -

Spray foam was observed used to seal gaps in one or more areas. Spray foam is not considered a durable, long-term weather sealant. Recommend replacing or supplementing with proper exterior-grade sealant or flashing.

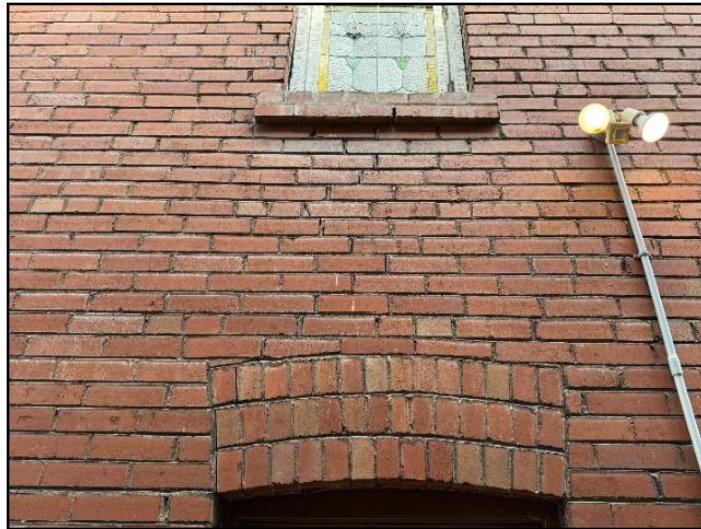
**Condition:** • FOR ALL HOMES - Most masonry walls have small cracks due to shrinkage or minor settlement. These will not be individually noted in the report, unless leakage, building movement or similar problems are noted

9. FOR ALL HOMES - one example of typical cracks

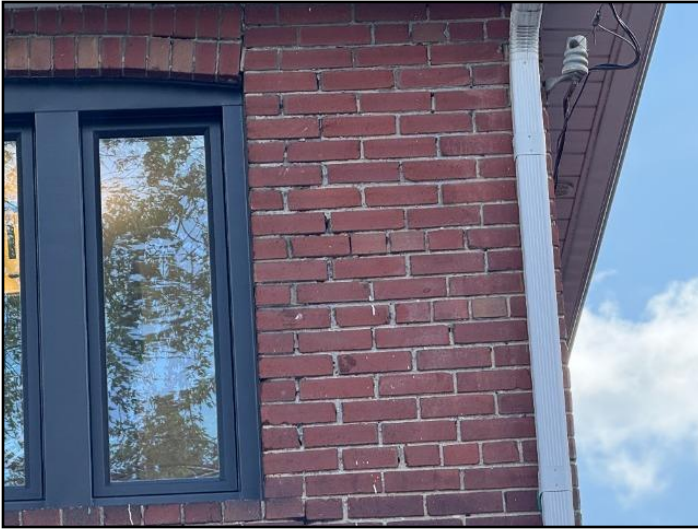
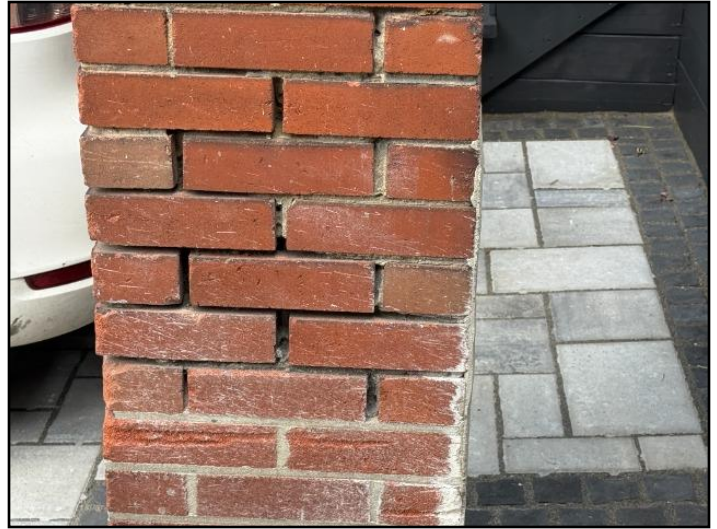
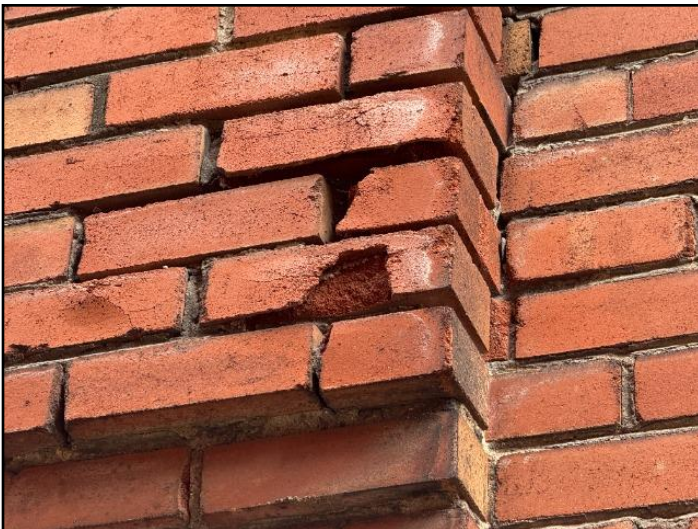
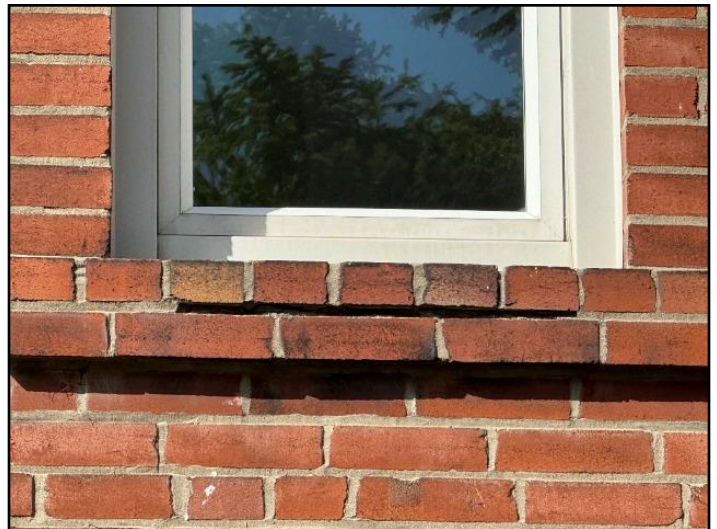
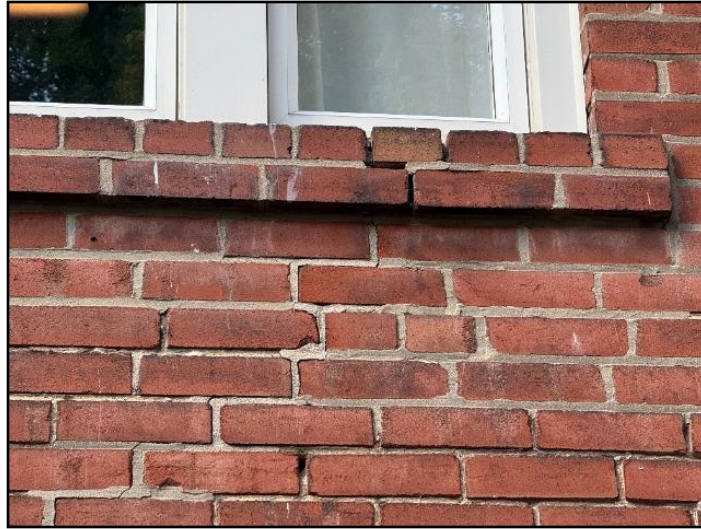
**Condition:** • Masonry and/or mortar deterioration

12. example of spalling

13. example at window sill

Tuckpoint / Repoint mortar and patch/repair spalled masonry. This is typical maintenance for a home of this age.

**Task:** Repair

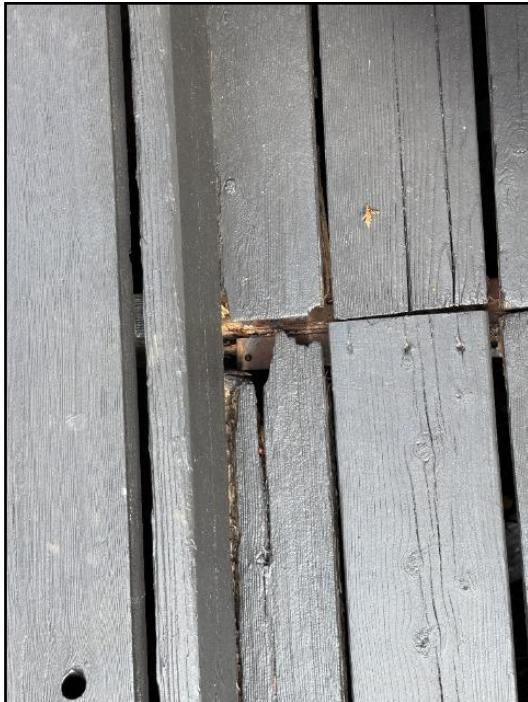
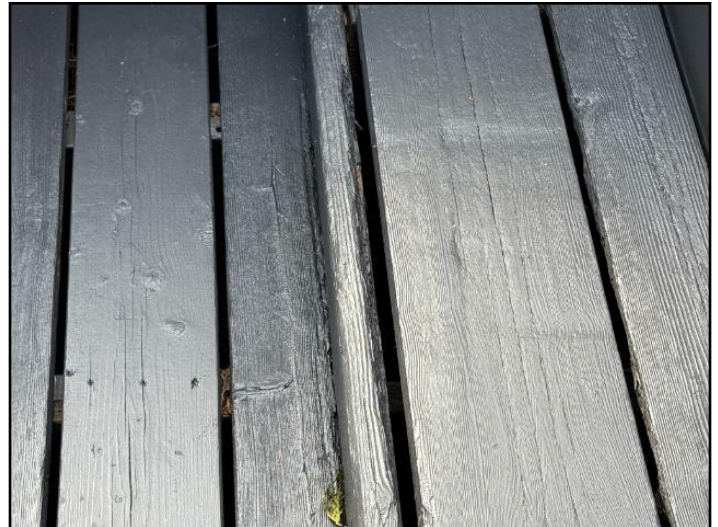
Some deck boards are older and showing deterioration. The deck has been painted, but wear remains evident. One vertical board by the step is not well-secured.

15. one example

16. vertical board not well secured

**Task:** Repair or replace / Secure vertical board by the step

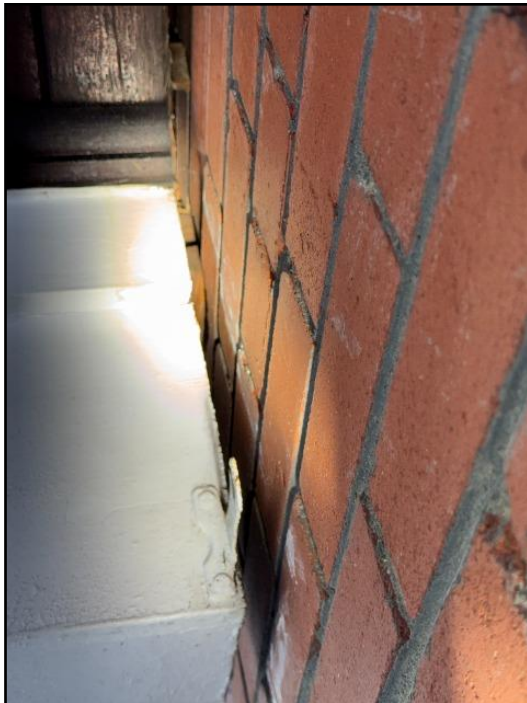
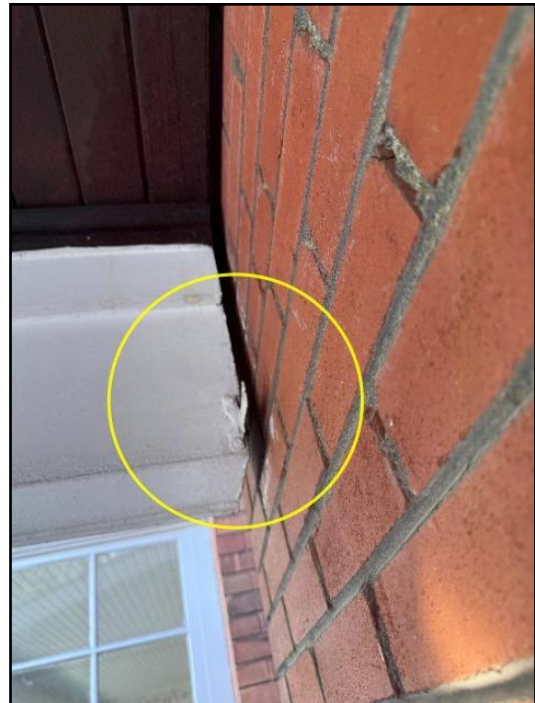
The porch roof is supported on masonry columns and the house wall. At the house wall, cladding over the support beam has pulled away from the structure by several inches. The actual beam is only partially visible, so its condition could not be fully assessed. Current homeowner reported the separation has been present without change during their ownership.

17. close up view

18. Settlement or other movement

**Task:** Repair if movement progresses or consult contractor to evaluate if support is required

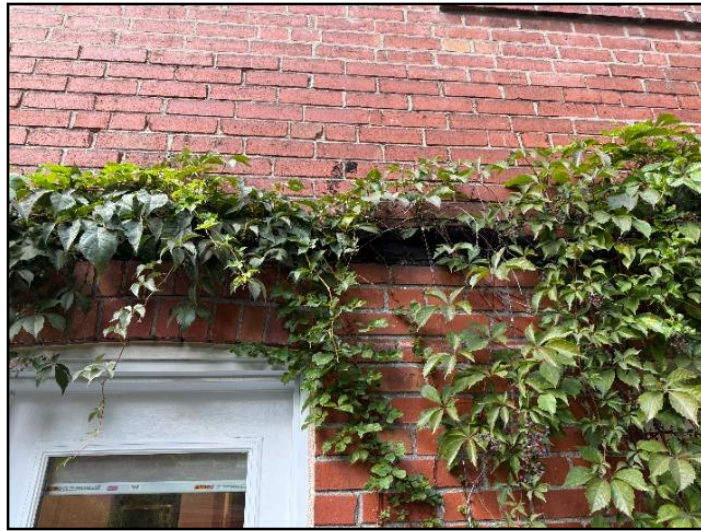
Vines observed on the rear wall, likely concealing tar residue from a previously removed awning. While they provide aesthetic cover, vines can trap moisture, damage walls, and allow pests entry.

19. Vines on building

**Task:** Remove vines and repair/finish underlying surface as needed

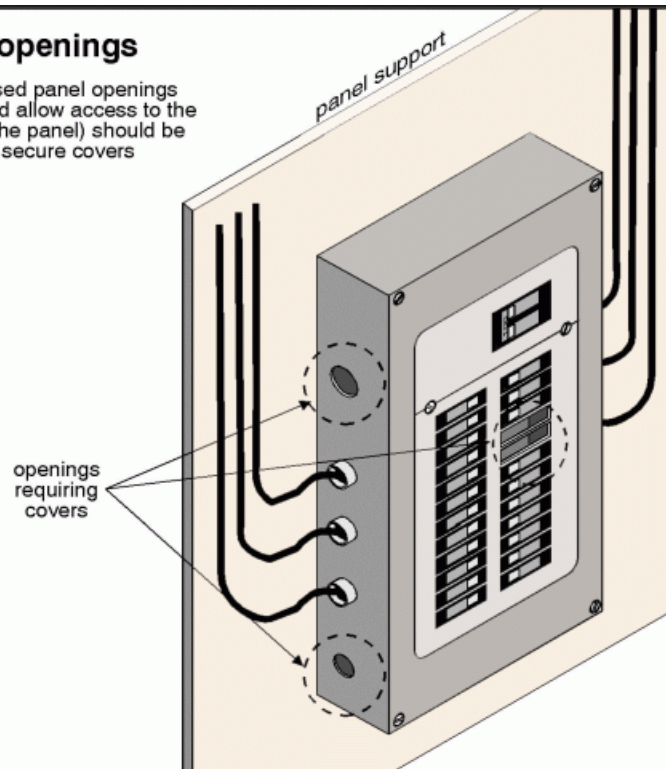
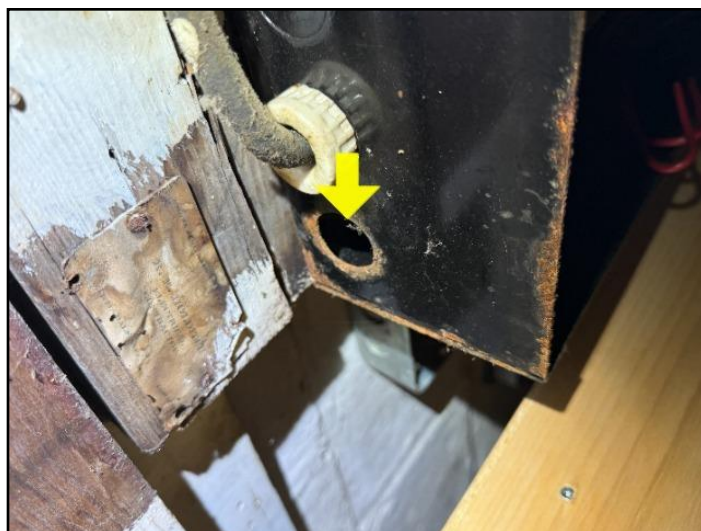
any exposed panel openings (that would allow access to the inside of the panel) should be fitted with secure covers

22. Unprotected openings

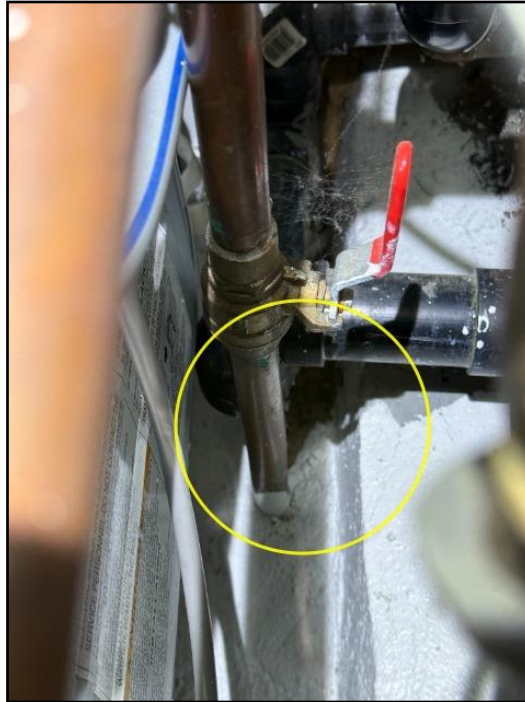
**Condition:** • Not visible

23. Not visible

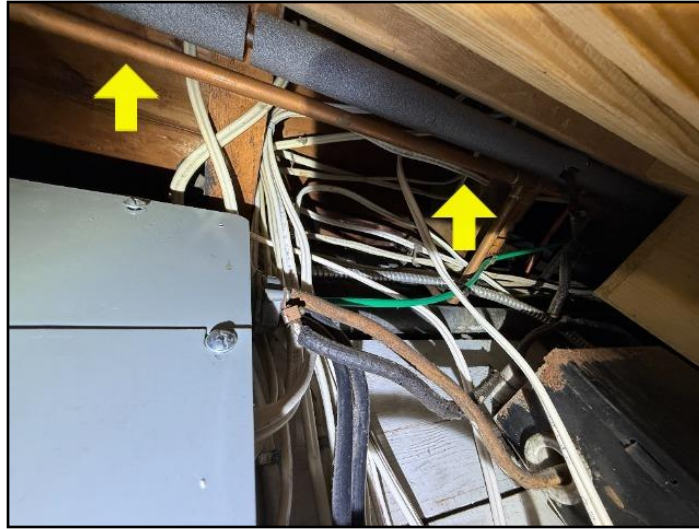
Plumbing supply piping was noted over the service box and panel. (Likely has been this way for many decades) This is not an ideal setup as there is a small risk of the plumbing leaking/dripping onto/into the panel. This could present an unsafe condition. Consult with plumber about rerouting the plumbing lines or providing an alternate solution

24. Plumbing supply lines above panel

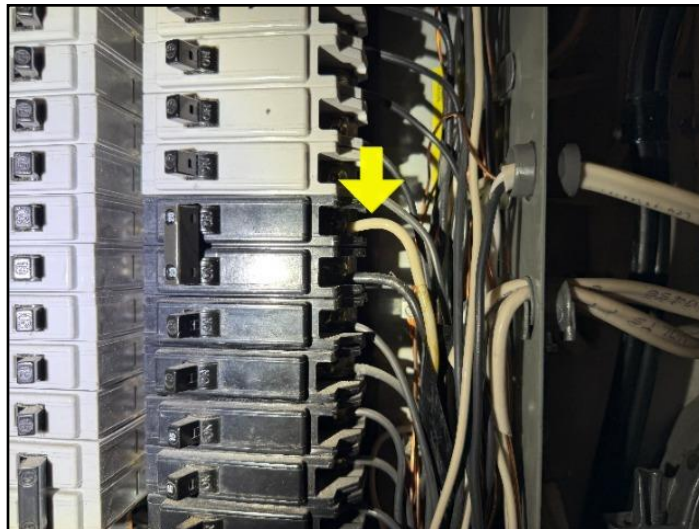
**Condition:** • White wires connected to breakers not identified as hot/live/ungrounded  
White wire used as hot wire not marked

25. White wires connected to breakers not...

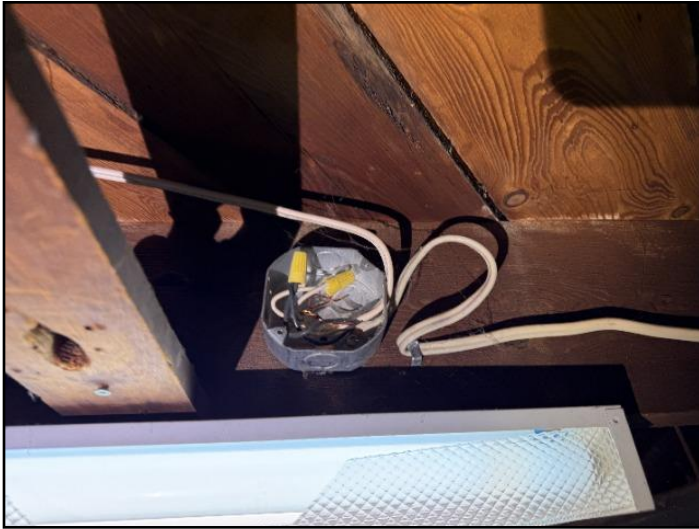
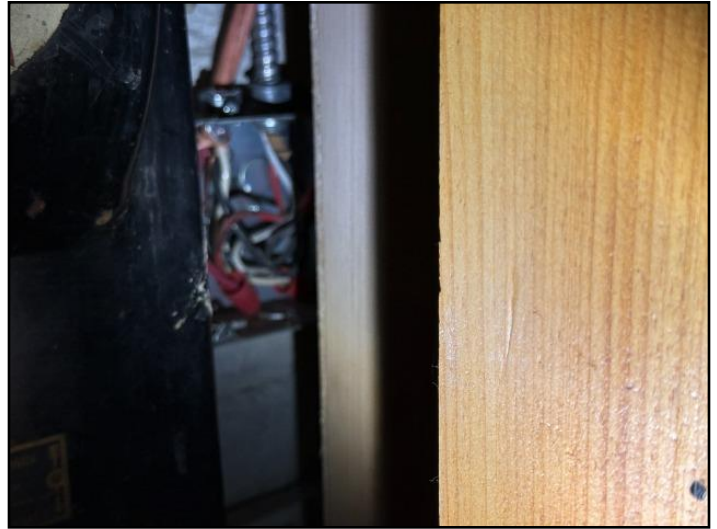
**Condition:** • Cover missing

26. Cover missing

27. Cover missing

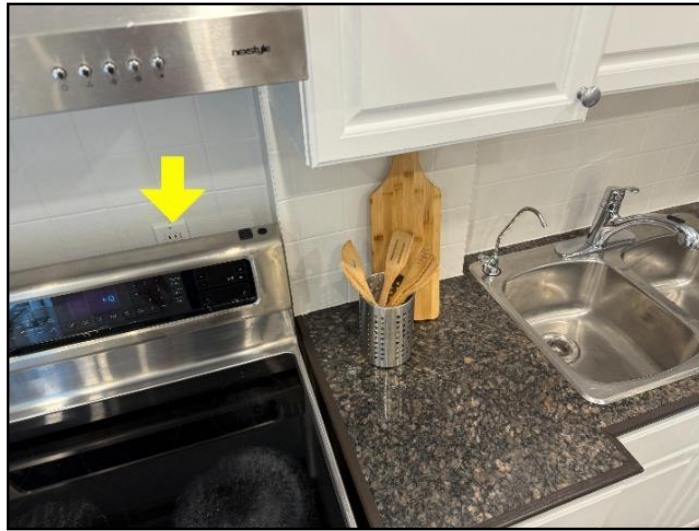
**Condition:** • Unsafe location

28. Unsafe location

**Task:** Relocate outlet

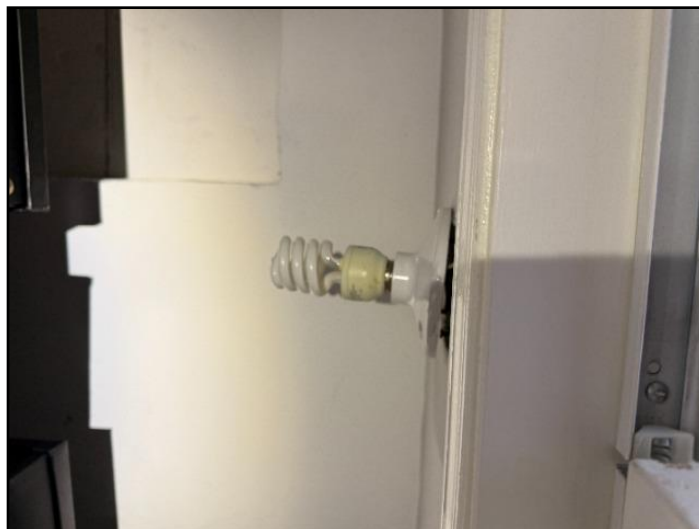
**Condition:** • [Loose](#)

29. Loose

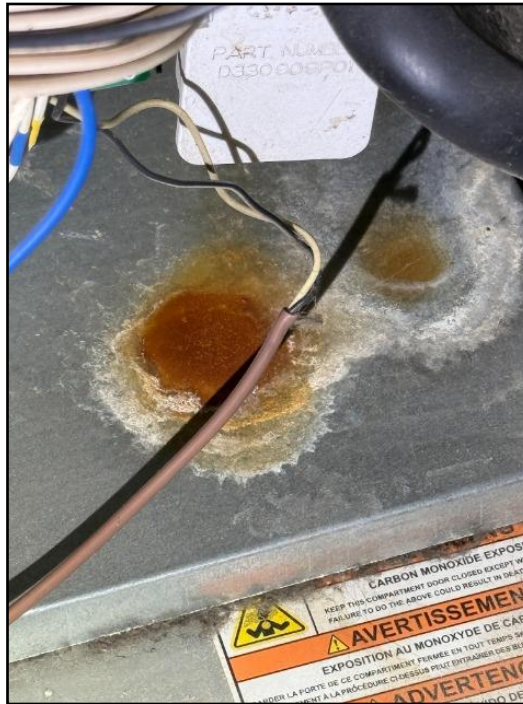
Rust was observed inside the bottom compartment, likely due to past condensate leaks (from furnace or evaporator leaks) No active leaks were detected at the time of inspection. Regular annual service is recommended.

30. Rust

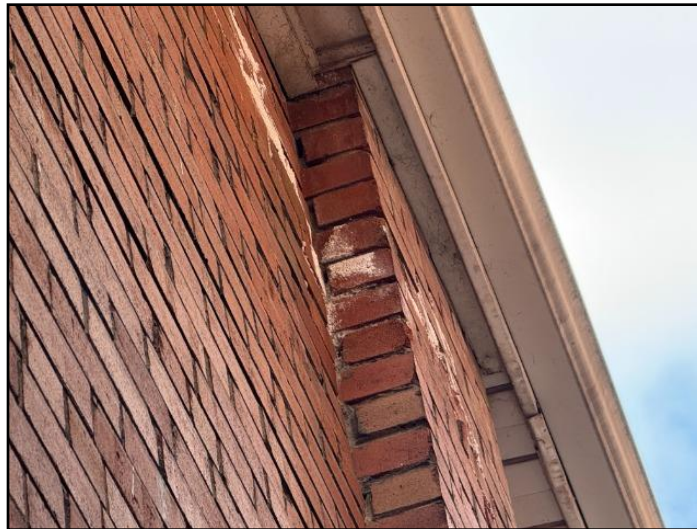
Condition: • [Efflorescence](#)

Location: Left Exterior Wall

31. Efflorescence

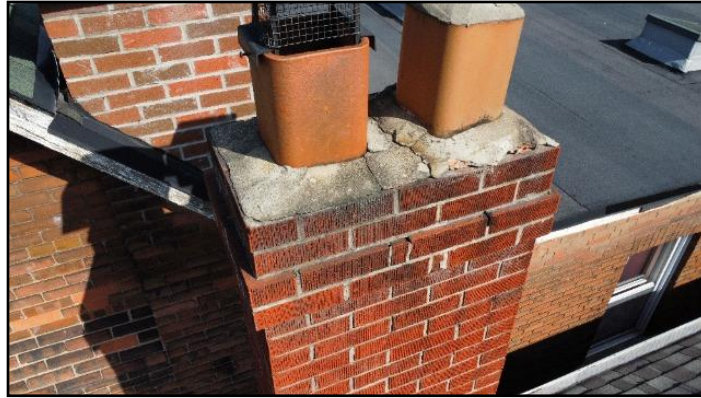
Condition: • [No drip edge on cap \(crown\)](#)

Additionally minor cracks were noted at top of chimney crown. Patch.

32. No drip edge on cap (crown)

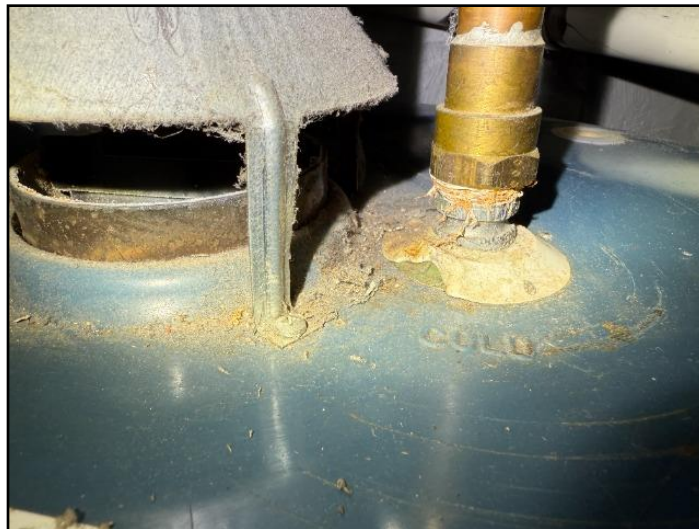
**Condition:** • [Spillage or backdraft at the draft hood](#)

This condition reinforces that the unit has passed its typical service lifespan (already noted elsewhere in this report).

34. Spillage or backdraft at the draft hood

**Task:** Replacement has already been advised under lifespan note

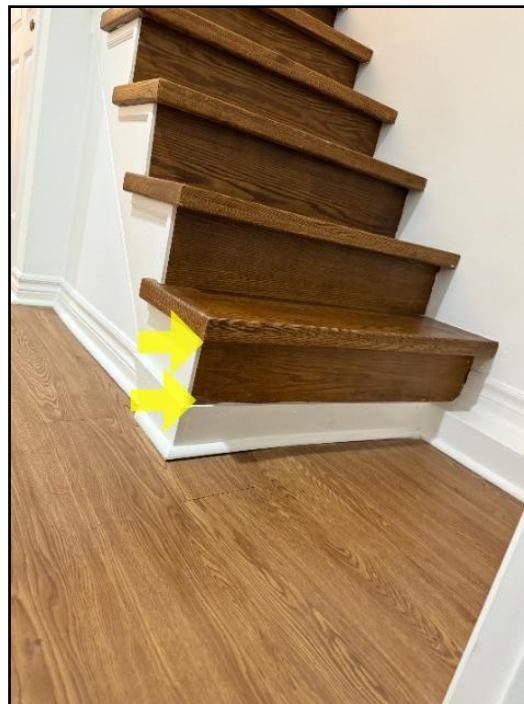
**Condition:** • [Rise excessive](#)

**Implication(s):** Trip or fall hazard

35. Rise excessive
