YOUR Inspection Report

123 Hometown Street
Anywhere, PE

Friday, April 2, 2010

RE: Report No. 1179, v.3
123 Hometown Street
Anywhere, PE

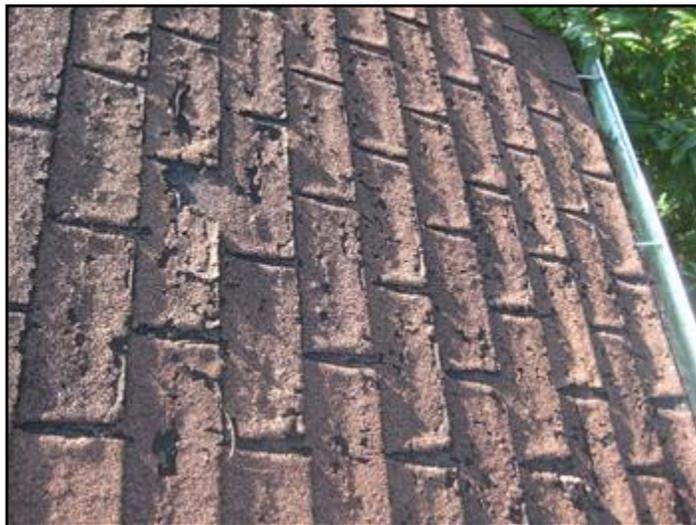
1. Condition: • Near end of life expectancy

Roof shingles are at or near the end of their life cycle. Implications: Chance of water damage to structure, finishes and contents.

Location: Throughout Roof

1. *Near end of life expectancy*

Task: Replace roof shingles

Time: Immediate

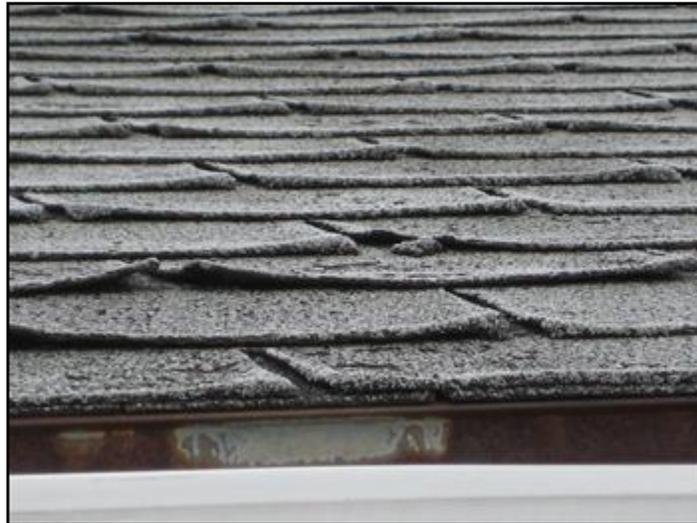
2. Condition: • Cupping, curling, clawing

Roof shingles are at or near the end of their life cycle. Implications: Chance of water damage to structure, finishes and contents.

Location: Throughout Roof

2. Cupping, curling roof shingles

Task: Consider replacing roof shingles

Time: ASAP

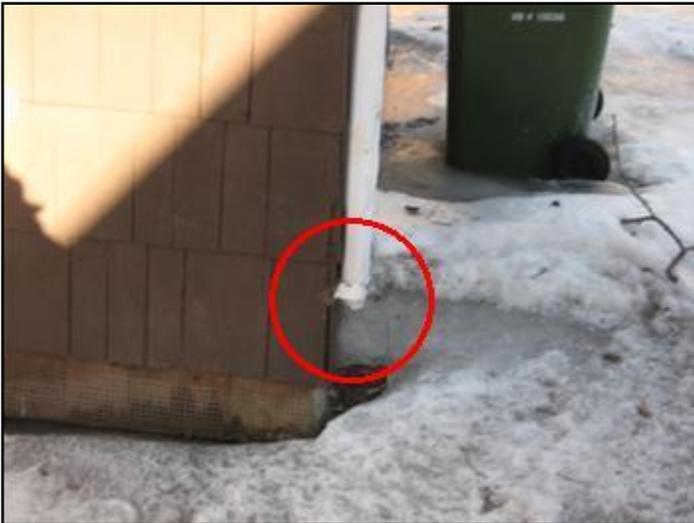
3. Condition: • Should discharge 6 feet from building

Implications: Chance of water damage to structure, finishes and contents.

Location: Northeast

3. Missing downspout kick out

Task: Provide

Time: Immediate

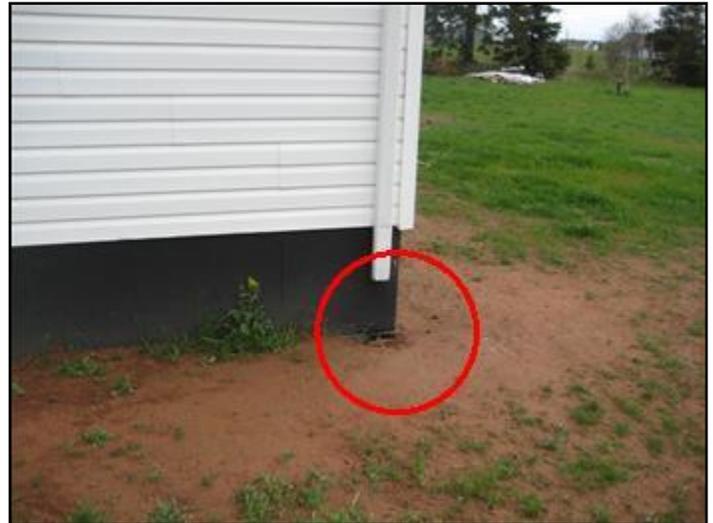
4. Missing downspout kick out

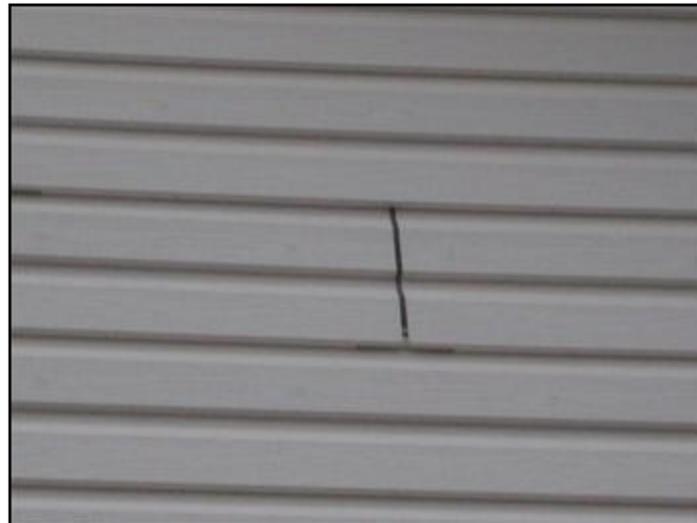
4. Condition: • Loose or missing pieces

Implications: Gap in the siding may allow rain water to penetrate the building envelope and damage contents, finishes and/or structure.

Location: East Exterior Wall

5. Loose vinyl siding

Task: Improve - Repair gap

Time: Immediate

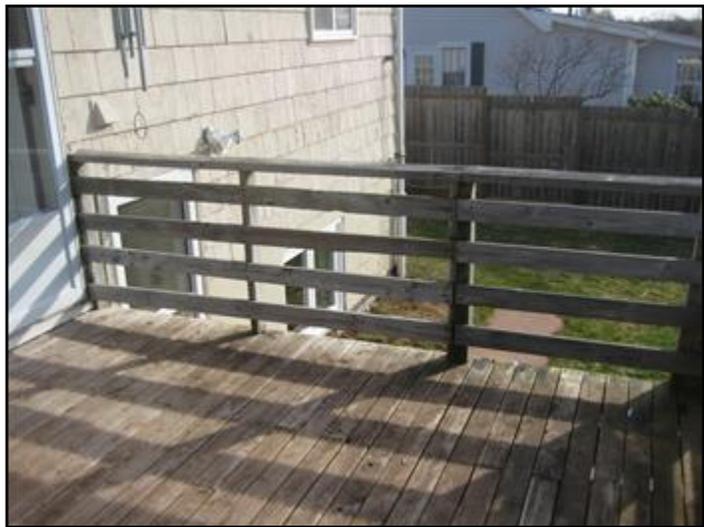
5. Condition: • The best building practice is for the handrail / guardrails to be oriented so that climbing is reduced / eliminated. Vertical Spindles with spacing no more than 4" and height of * 36" to 42" from the deck is acceptable practice. *Guardrails must be 36" above the deck if the deck is above 24" off the ground and below 6' from ground and 42" if deck is above 6' from ground. Implications: Fall hazard.

Implications: Considered unsafe for children to play, injury.

Location: Deck Guardrail

6. Guardrail climbable

Task: Replace guardrail to today's standards for safety

Time: ASAP, Prior to Children playing.

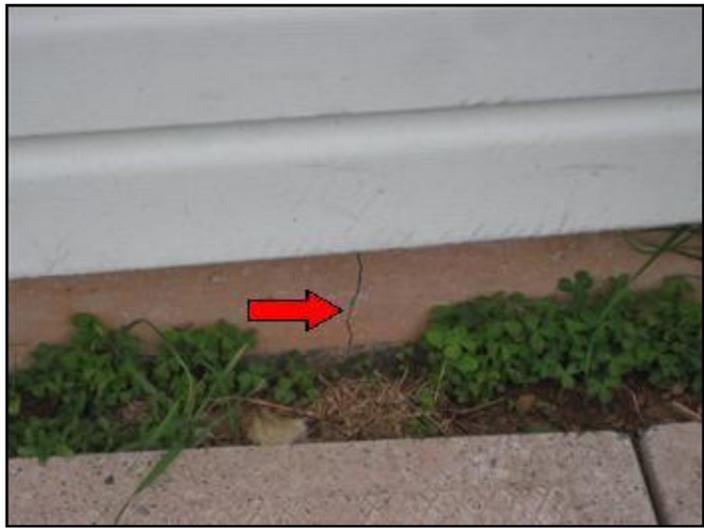
6. Condition: • Typical minor cracks

Implications: Chance of water entering building through crack.

Location: East Exterior Wall

7. Minor foundation crack

Task: Monitor for leaks

Time: Discretionary

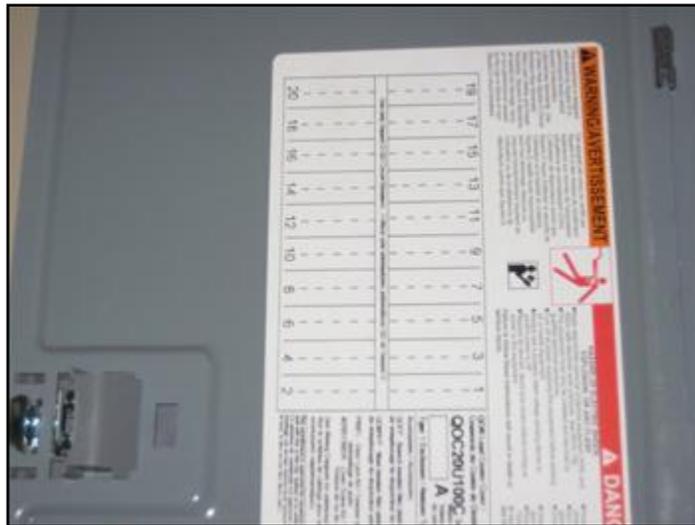
7. Condition: • Electrical circuit breakers not labeled

Circuit breakers on the electrical panel should be labeled for servicing and in case of emergency. Implications: Nuisance.

Location: Basement electrical panel

8. Add circuit breaker labels

Task: Provide - Add circuit breaker labels to electrical panel

Time: ASAP

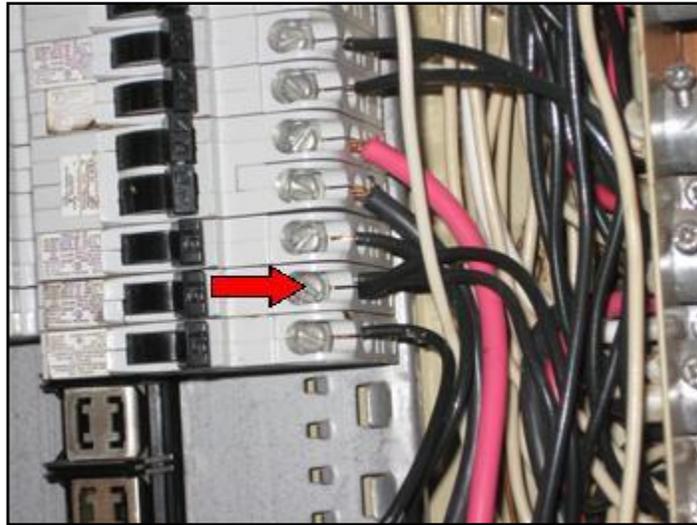
8. Condition: • Double taps

Implications: Fire hazard.

Location: Basement electrical panel

9. Double tap in the electrical panel

Task: Further evaluation / upgrade by a licensed electrician

Time: ASAP

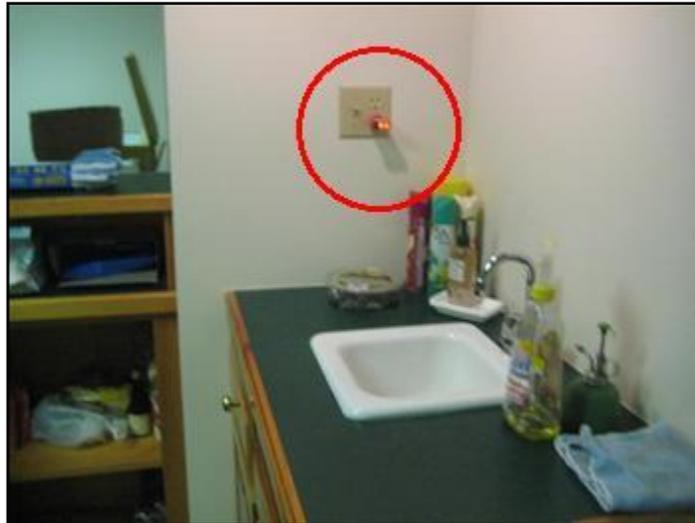
9. Condition: • No GFCI/GFI (Ground Fault Circuit Interrupter)

Implications: Electric shock.

Location: Bathroom outlet

10. Bathroom outlet missing GFI

Task: Provide GFI outlet for safety

Time: ASAP

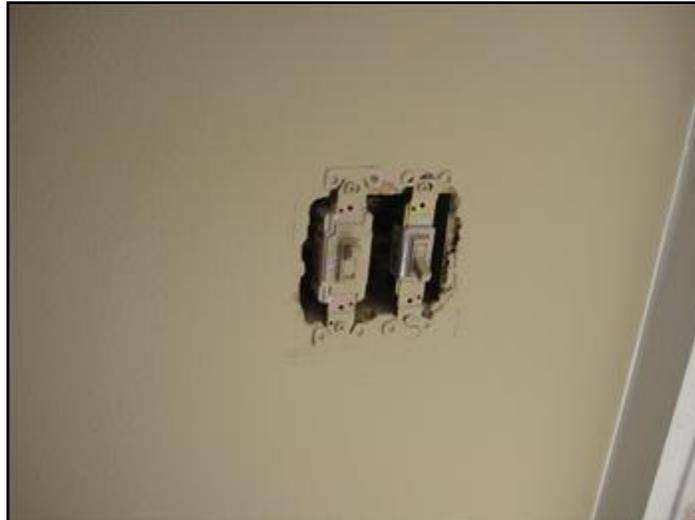
11.

10. Condition: • Missing

Implications: Risk of electrical shock

Location: First Floor Bedroom

Task: Provide cover for switches

Time: ASAP

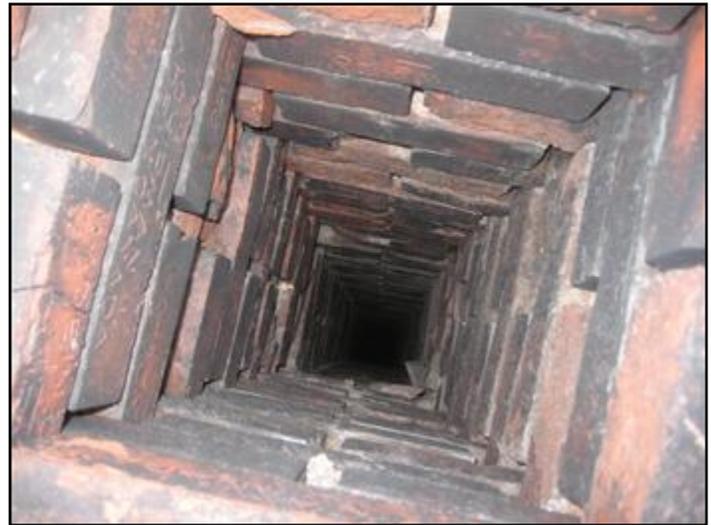
13. Condition: • This brick chimney appears to have no liner and lacks a proper chimney cap. It is recommend when burning wood that flu liner be installed inside the brick chimney. This flu liner, installed properly is a second layer of protection from fumes entering the home and flu fires. Flu fires can lead to structural fires. Your Insurance company may require a liner in the chimney. Implications: Carbon monoxide poisonous fumes entering the home, illness, Fire Hazard.

Location: Brick chimney

14. No liner inside brick chimney

Task: Provide a chimney liner

Time: ASAP

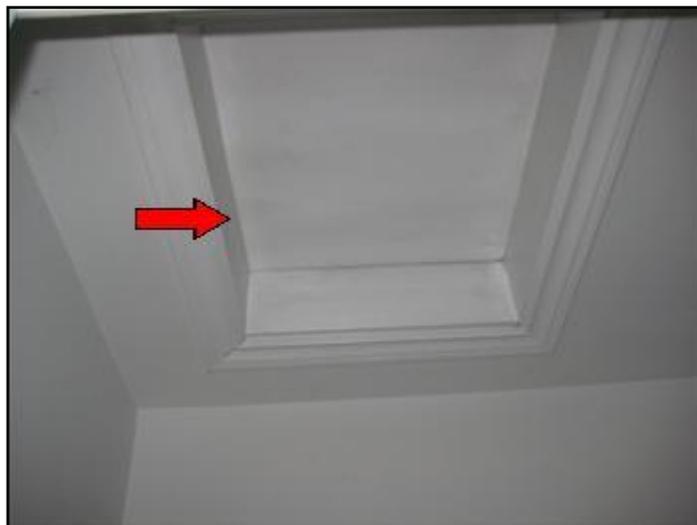
14. Condition: • Not insulated and not weatherstripped

Attic hatch Not insulated, weather stripped. Implications: Chance of condensation damage to finishes and/or structure, Increased heating and cooling costs, Reduced comfort.

Location: Master Bedroom closet ceiling

16. *Attic hatch Not insulated, weather stripped*

Task: Provide insulation and weather stripping

Time: Less than 1 year

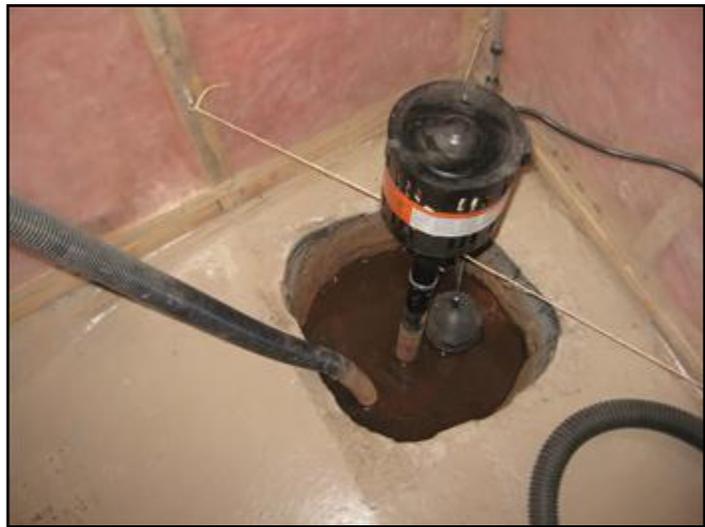
15. Condition: • Lid missing, rotted or not secure

Add cover to sump pump for safety. Implications: Trip or fall hazard, debris falling plugging sump pump.

Location: Basement sump pump

17. Cover missing

Task: Provide a cover for the sump pump

Time: Regular maintenance

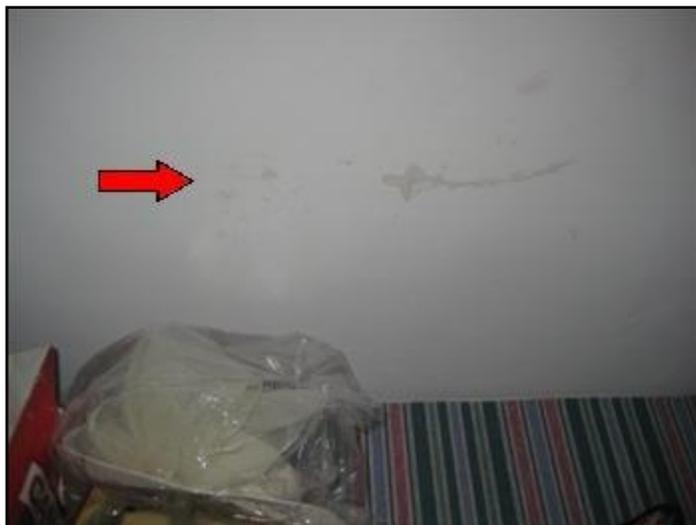
18. Condition: • Stains

This ceiling stain is dry at the time of inspection. Cause unknown? Implications: Chance of water damage to structure, finishes and contents.

Location: First Floor Bedroom closet ceiling

18. ceiling stain, dry at the time of inspection

Task: Further evaluation - Monitor, repaint when remodeling

Time: Regular maintenance

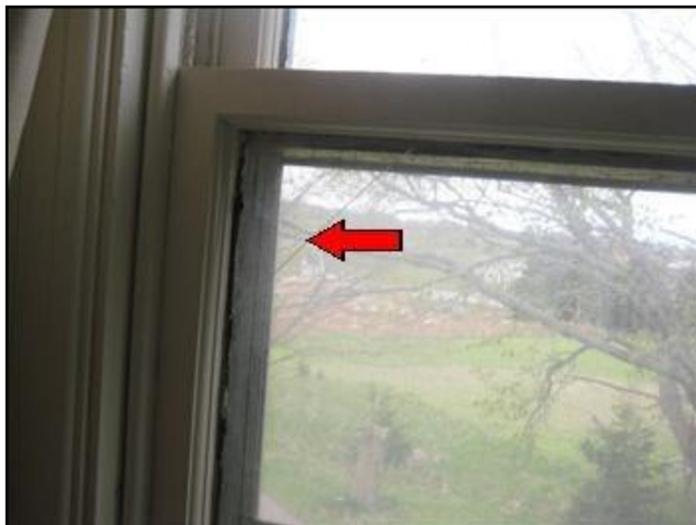
19. Condition: • Cracked

This living room window is cracked and has lost its seal. Note: The vendor has reported they will replace this window. Implications: Physical injury, window deteriorating.

Location: First Floor Living Room

19. Cracked window, Lost seal

Task: Replace window glass

Time: Regular maintenance

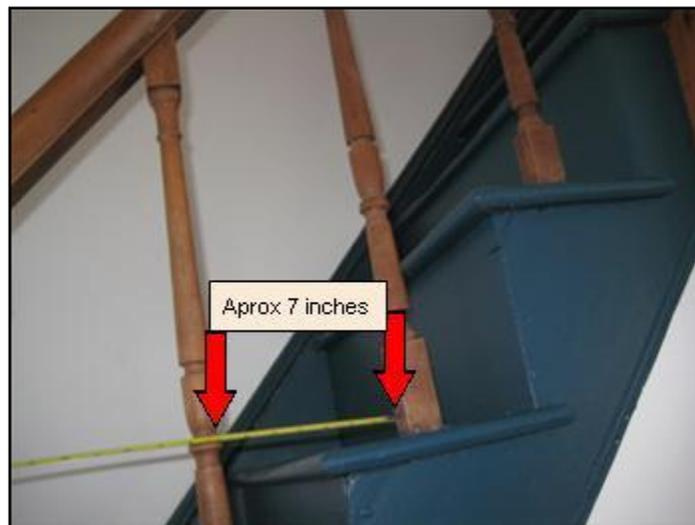
20. Condition: • Too far apart

Today's standard for stair construction is for spindles to be spaced no more than 4" apart for safety. Implications: Fall hazard, injury.

Location: First Floor stair handrail

20. Spindled too far apart

Task: Upgrade to 4" spacing for safety

Time: ASAP
