YOUR INSPECTION REPORT

FOR THE PROPERTY AT:
80 Edinborough Court
Toronto, ON M6N 2E8

INSPECTION DATE:
Monday, September 8, 2025

RE: Report No. 8550
80 Edinborough Court
Toronto, ON
M6N 2E8

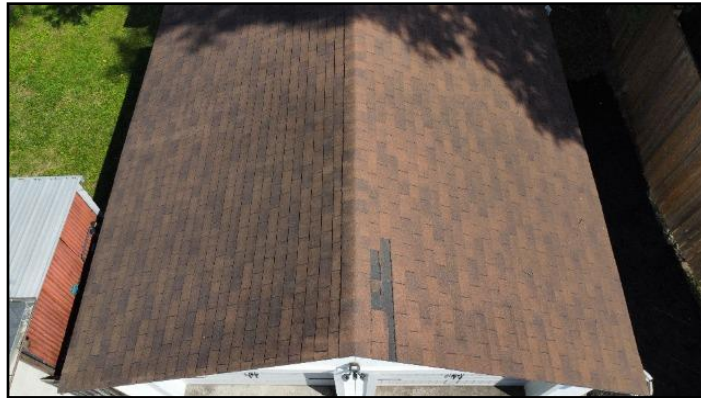
1. Asphalt shingles

• Asphalt shingles -- Good condition

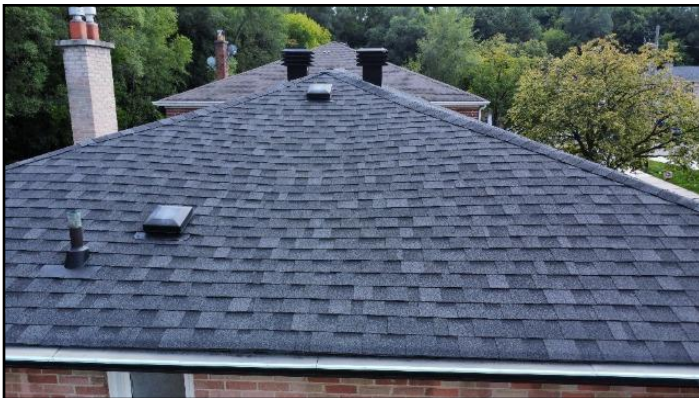
2. Asphalt shingles -- Good condition

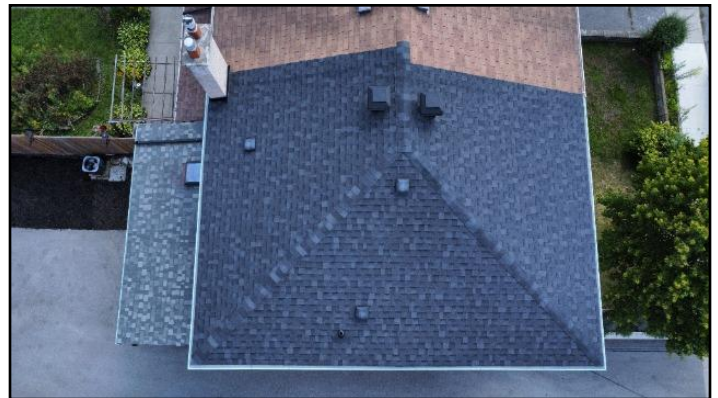
3. Asphalt shingles -- Good condition

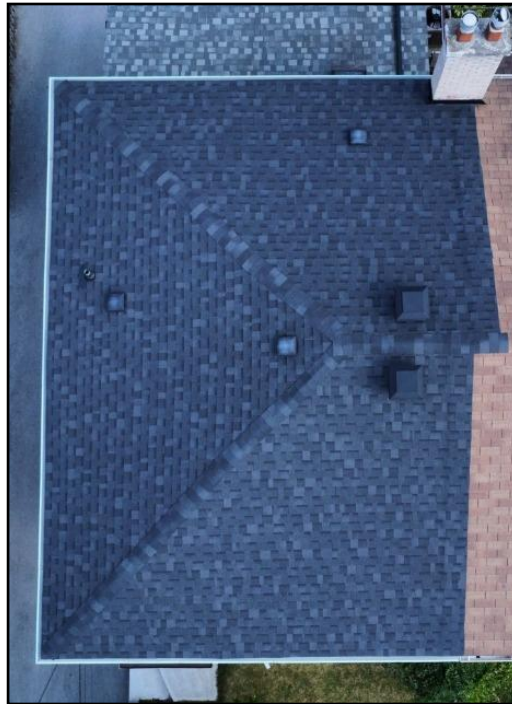
4. Asphalt shingles -- Good condition

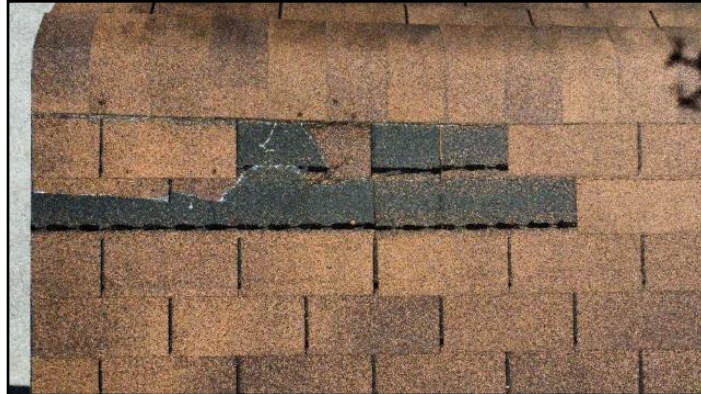
Condition: • [Missing, loose or torn](#)

Implication(s): Chance of water damage to structure, finishes and contents

5. Missing, loose or torn

Task: Repair

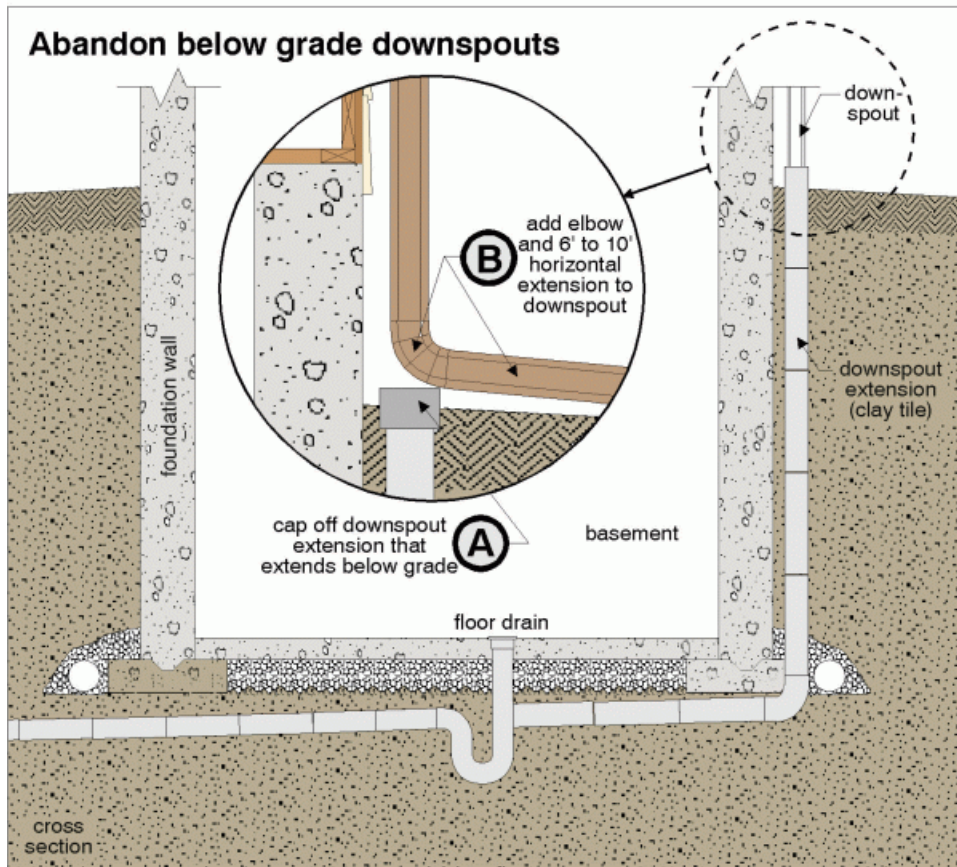
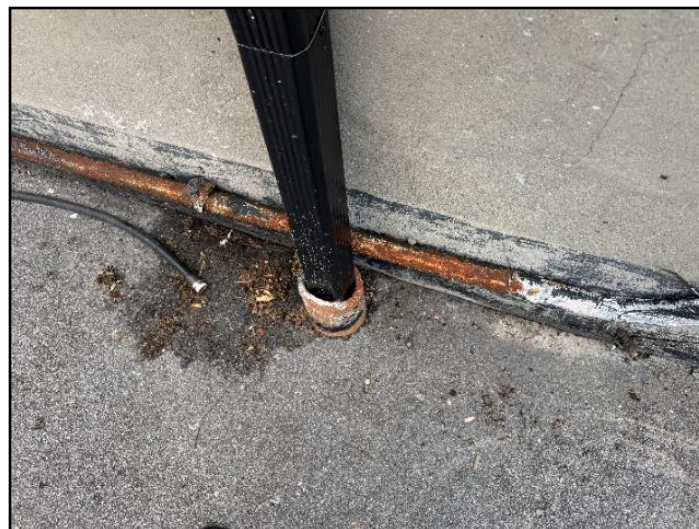
Condition: • Discharge below grade

Implication(s): Chance of water damage to contents, finishes and/or structure

6. Discharge below grade

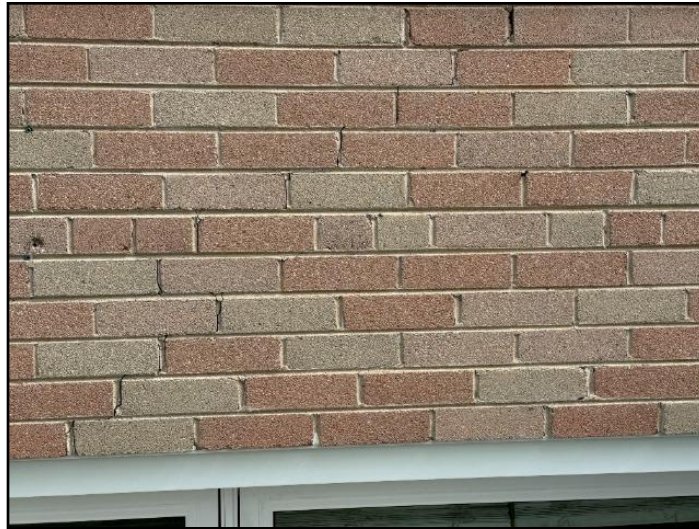
Condition: • FOR ALL HOMES - Most masonry walls have small cracks due to shrinkage or minor settlement. These will not be individually noted in the report, unless leakage, building movement or similar problems are noted

7. FOR ALL HOMES - one example of typical minor

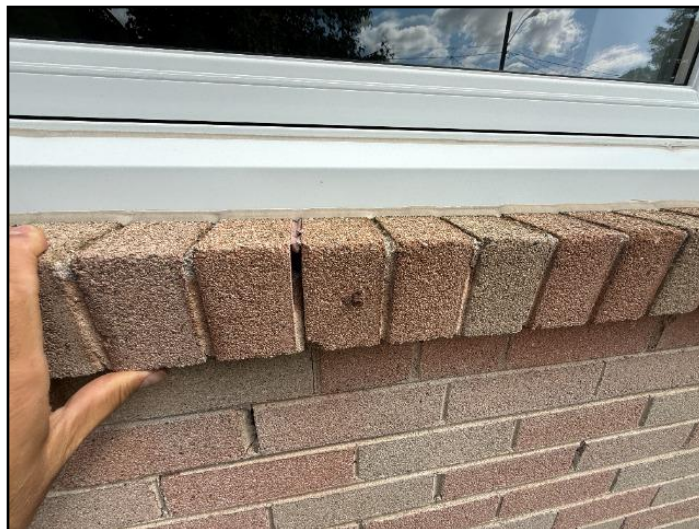
8. example

Condition: • Masonry and/or mortar deterioration

Task: Repair

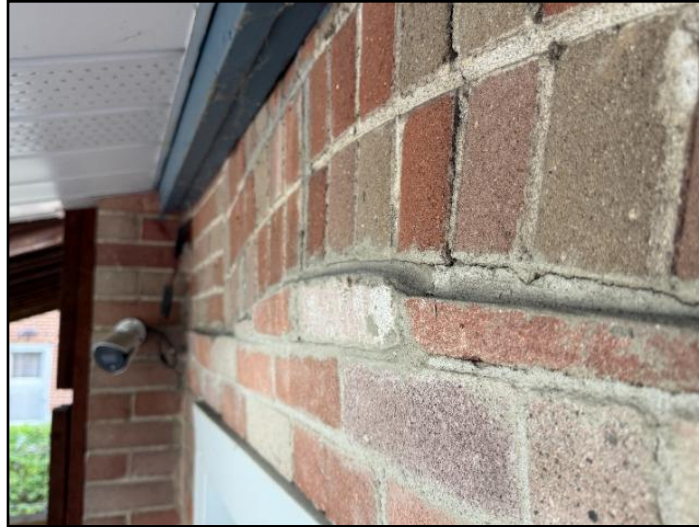
9.

Condition: • Altered opening / atypical brick header

Location: Rear Exterior Wall above sliding door

Task: For Your Information / Monitor for changes and upgrade with lintel support if future movement or cracking is observed

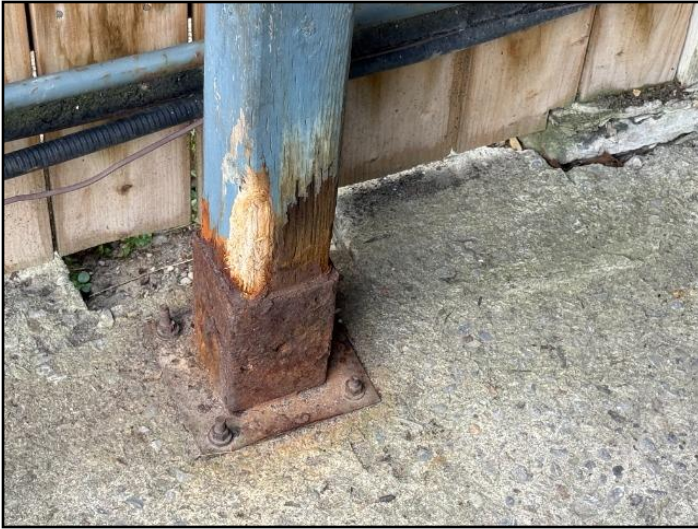
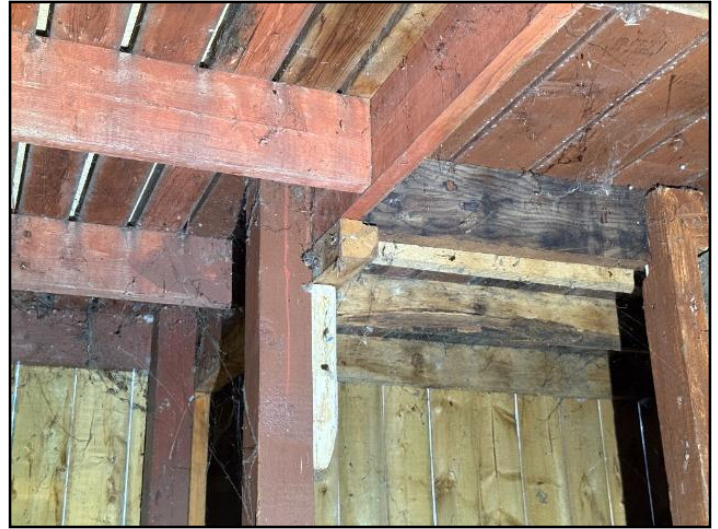
Condition: • The deck supporting structure show a few deficiencies typical of older deck construction:

- Joists not fully supported with modern joist hangers
- Amateur support methods noted (e.g., blocks under beams)
- Guardrails lower than current standards
- One column base rusted at steel bracket

11. example of column/beam supports

Task: Improve/repair supports and components as needed; upgrade for safety where possible

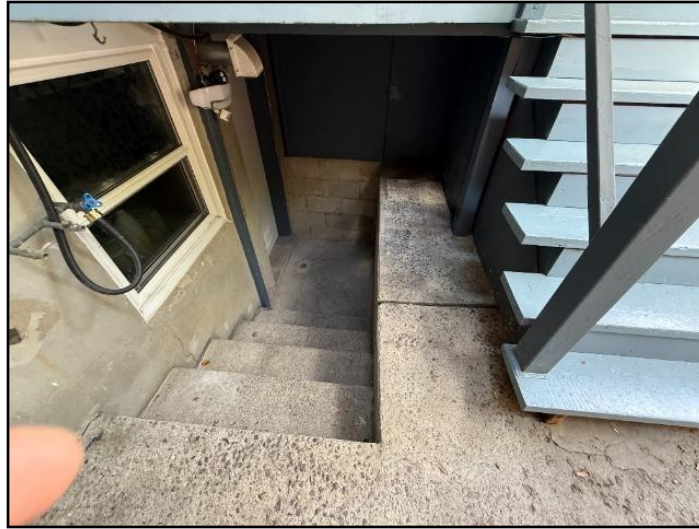
Condition: • [Guard and handrail problems](#)

Implication(s): Fall hazard

12. Guard and handrail problems

Task: Provide Hand and Guardrails

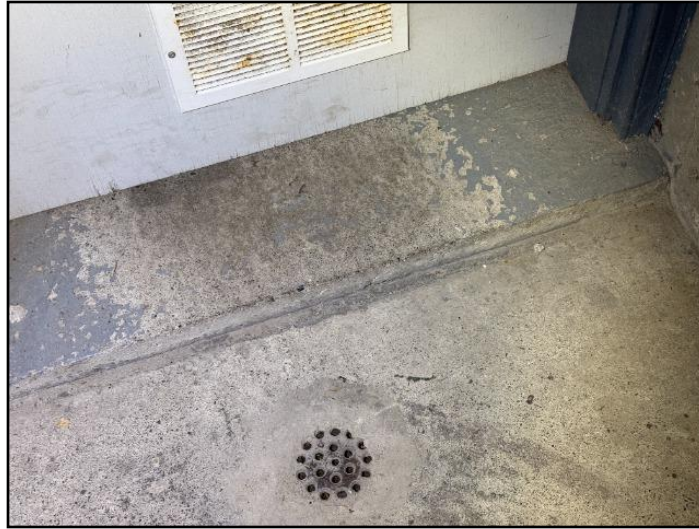
Condition: • [Door threshold missing, too low, not watertight](#)

Implication(s): Chance of water damage to structure, finishes and contents

13. Door too low

Task: Monitor for moisture / water intrusion and improve as needed

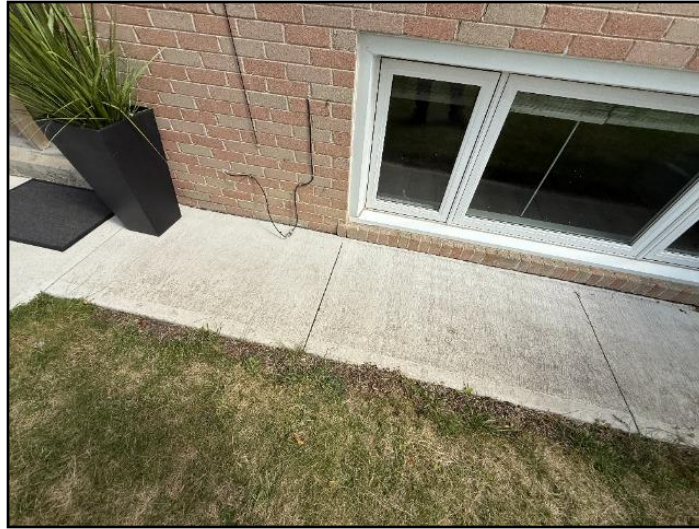
Condition: • [Masonry too close to grade](#)

Good building practice requires that the foundation extend above grade by 4-6 inches to help prevent water damage/intrusion and/or damage to bricks. We often find patios/walkways/landscaping that have been built up above the foundation. At present the brick is in good condition.

14. Masonry too close to grade

Task: Monitor for masonry deterioration / Improve

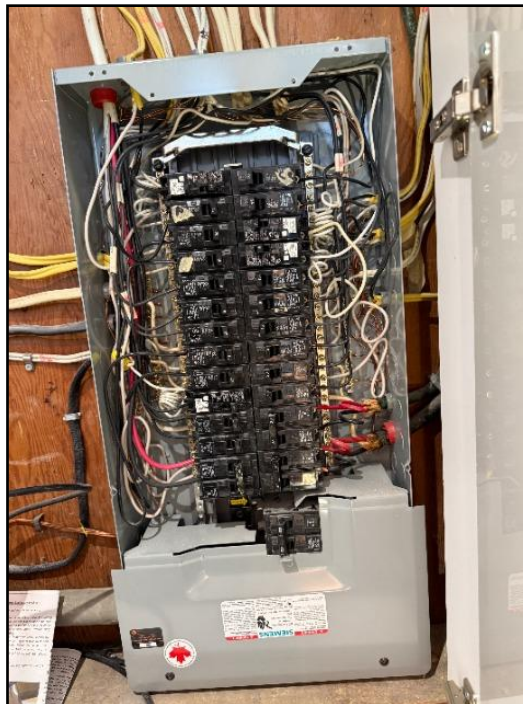
Good condition overall

15. Breakers - basement

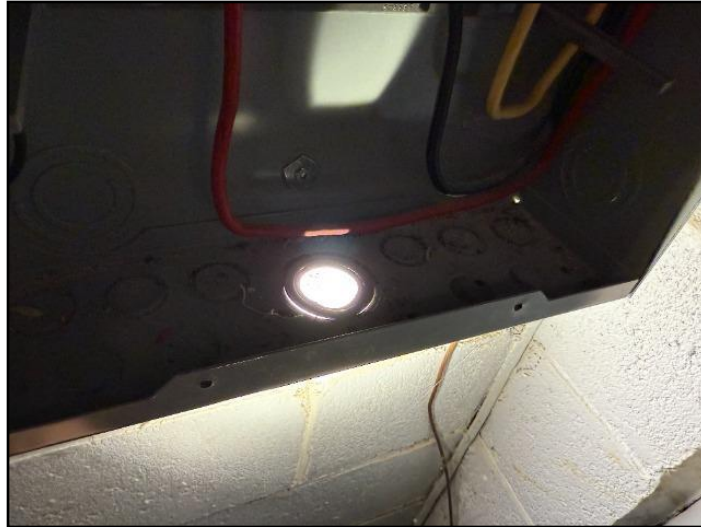
Condition: • Unprotected Opening(s)

17. Unprotected Opening(s)

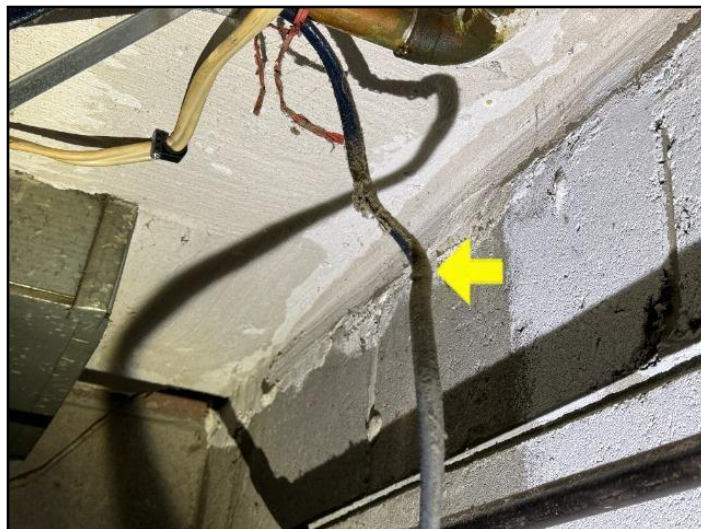
18. one example

Condition: • [Not well secured](#)

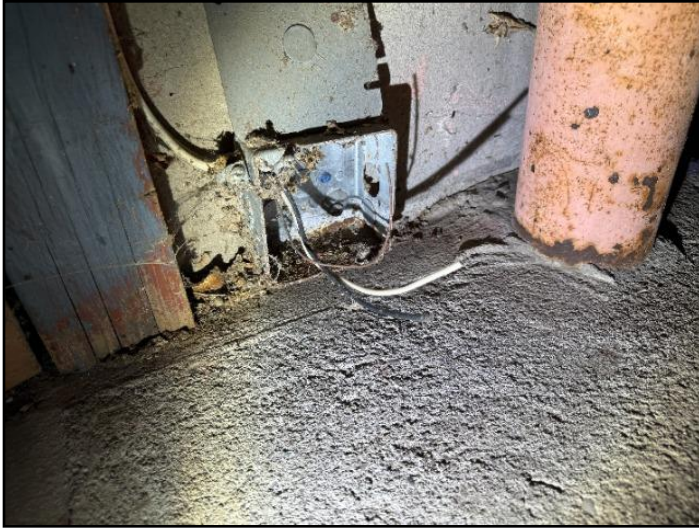
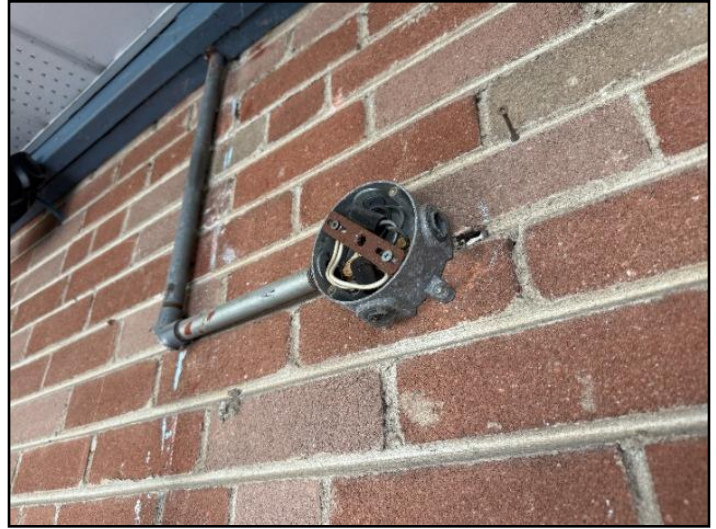
Condition: • Cover missing

19. Cover missing

20. Cover missing

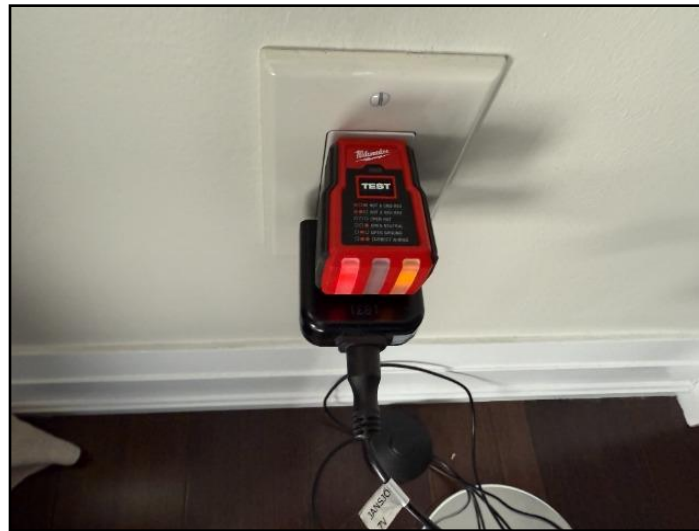
Condition: • [Reversed polarity](#)

21. Reversed polarity

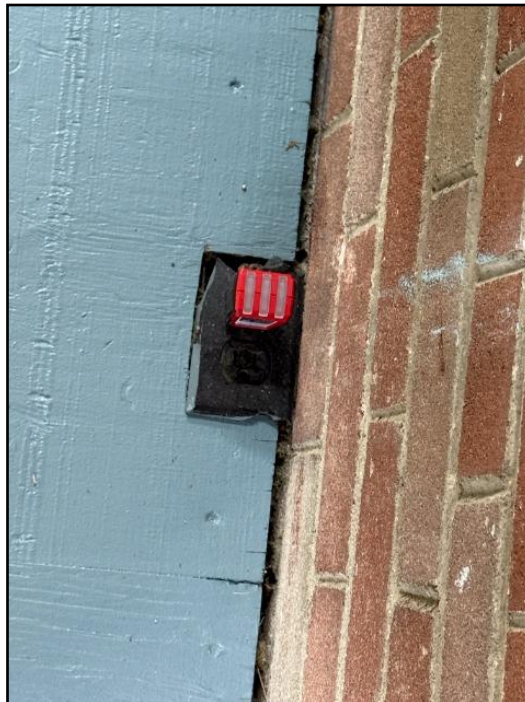
Condition: • Unsafe location

22. Unsafe location

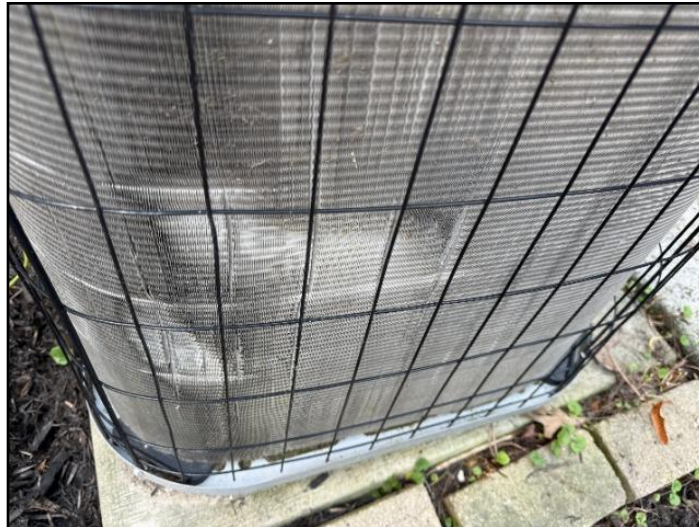
Condition: • [Damage](#)

Some of the fins are damaged/bent. Improve during routine annual servicing

23. Damage

Task: Service annually

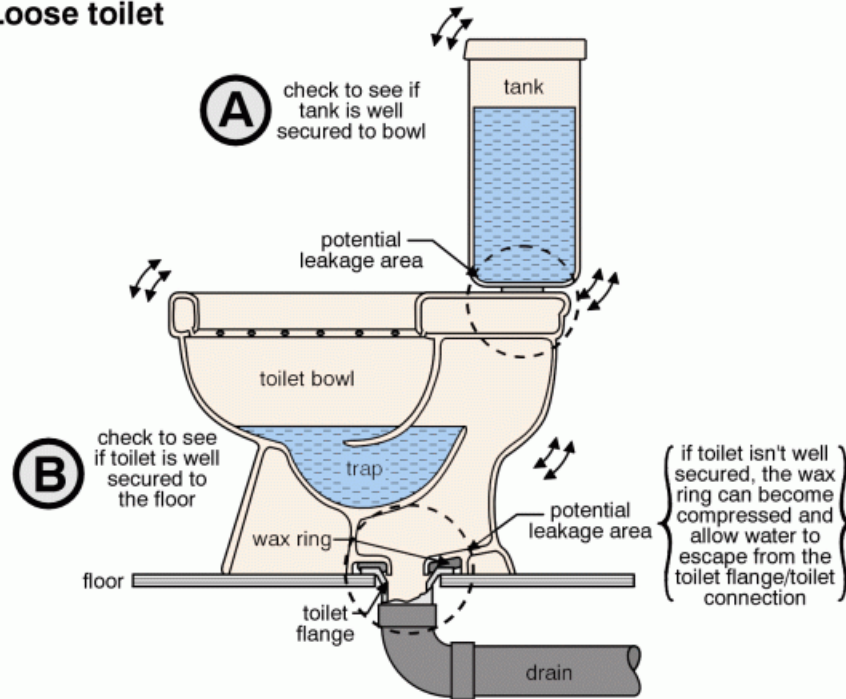
Condition: • [Loose](#)

Implication(s): Chance of water damage to structure, finishes and contents | Sewage entering the building | Possible hidden damage

Loose toilet
