YOUR INSPECTION REPORT

FOR THE PROPERTY AT:
581 Beresford Avenue
Toronto, ON M6S 3C2

INSPECTION DATE:
Wednesday, February 25, 2026

RE: Report No. 9055, v.2
581 Beresford Avenue
Toronto, ON
M6S 3C2

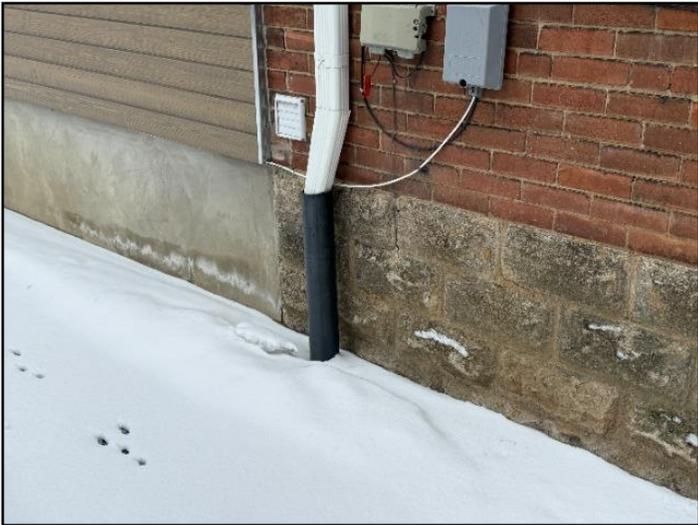
Condition: • Discharge below grade

2. Discharge below grade

Time: If necessary

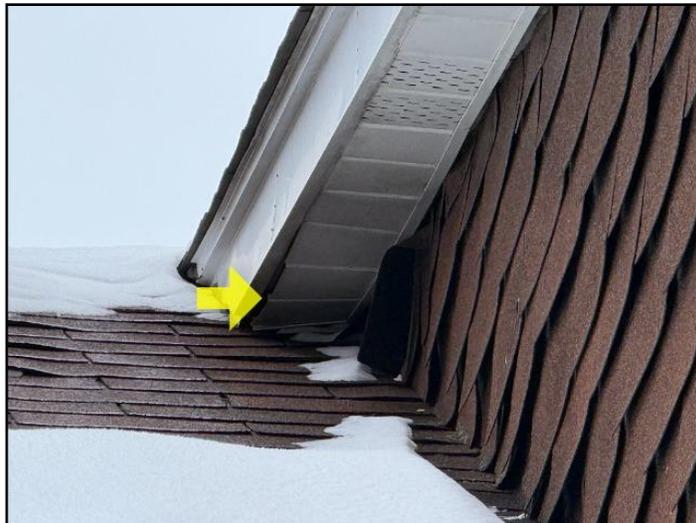
Condition: • [Loose or missing pieces](#)

3. Loose

Task: Secure

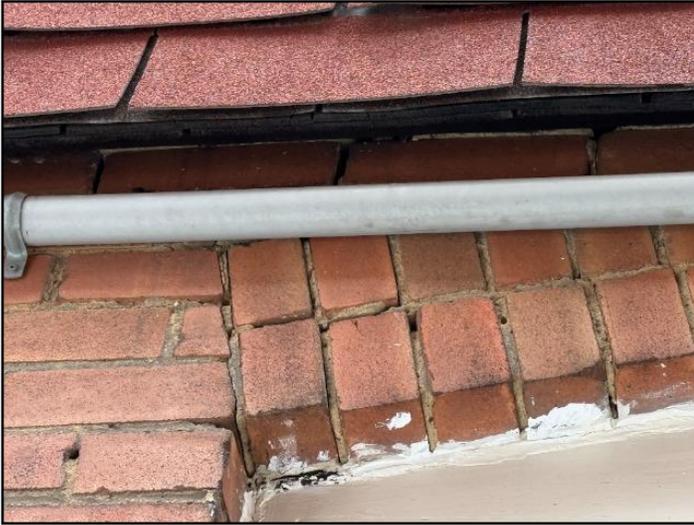
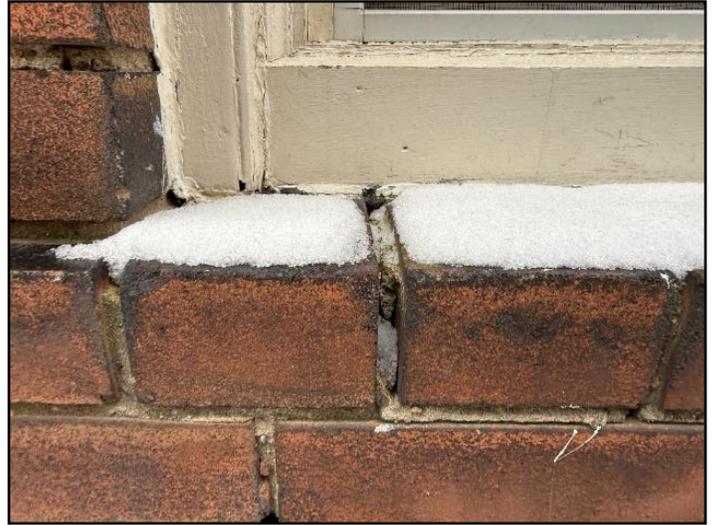
Condition: • Masonry and/or mortar deterioration

4. Masonry and/or mortar deterioration

5. Masonry and/or mortar deterioration

Tuckpoint / Repoint mortar and patch/repair masonry. This is typical maintenance for a home of this age.

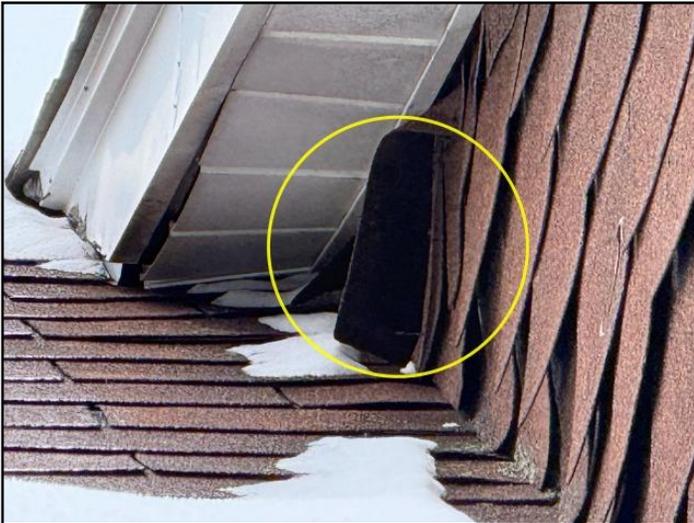
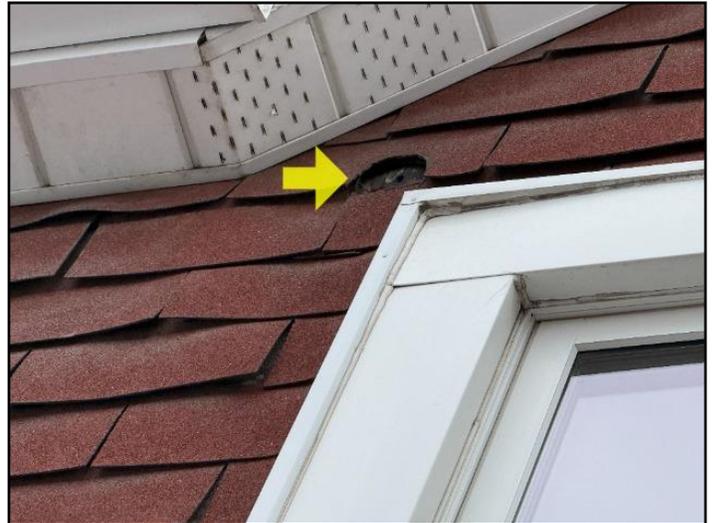
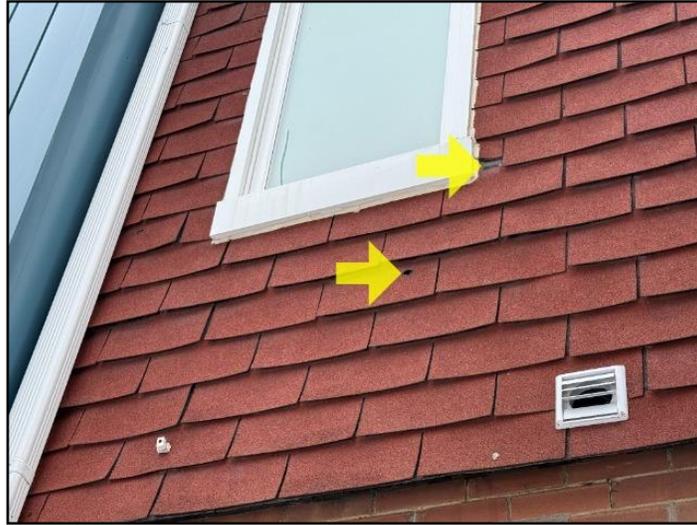
Condition: • [Loose, missing or torn tabs](#)

6. Loose, missing or torn tabs

7. Loose, missing or torn tabs

8. Loose, missing or torn tabs

Task: Repair

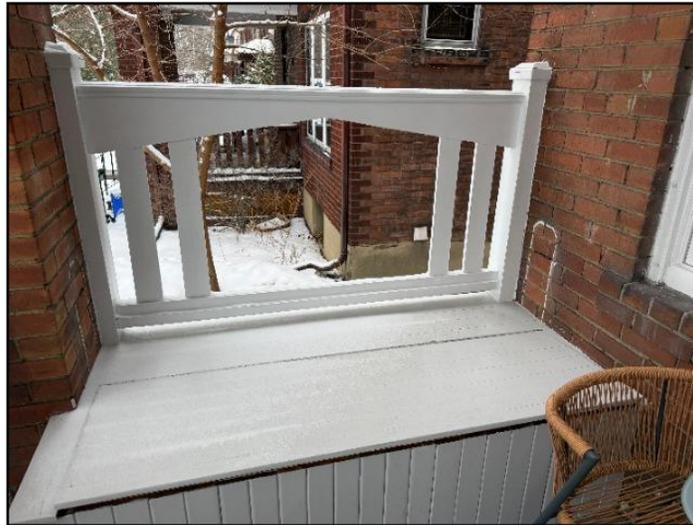
Condition: • [Spindles \(balusters\) missing](#)

Implication(s): Fall hazard

9. Spindles (balusters) missing

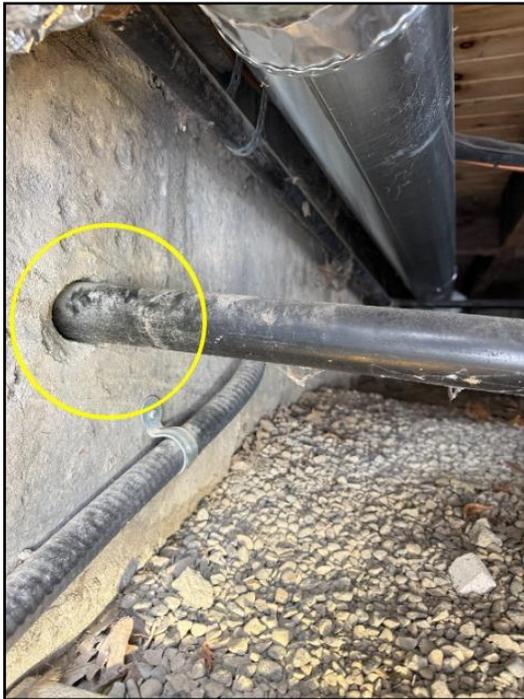
10. Gap requires seal

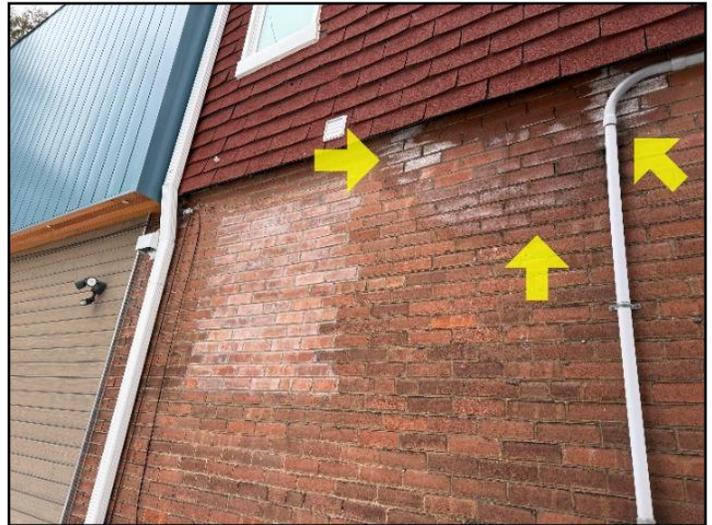
11. example of efflorescence

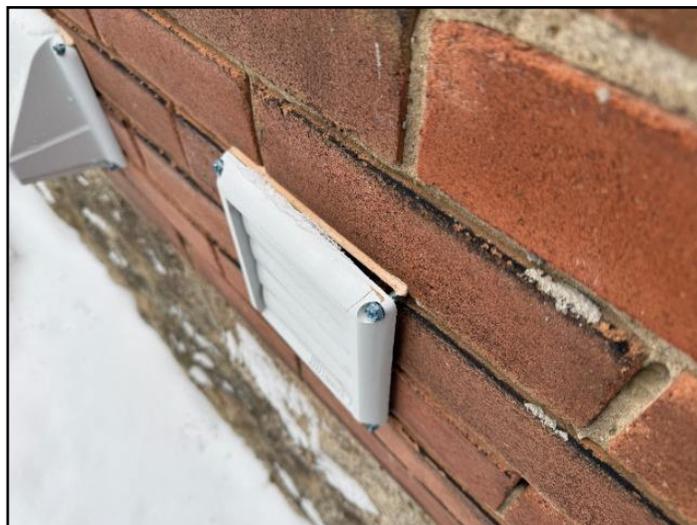
12. Seal vent

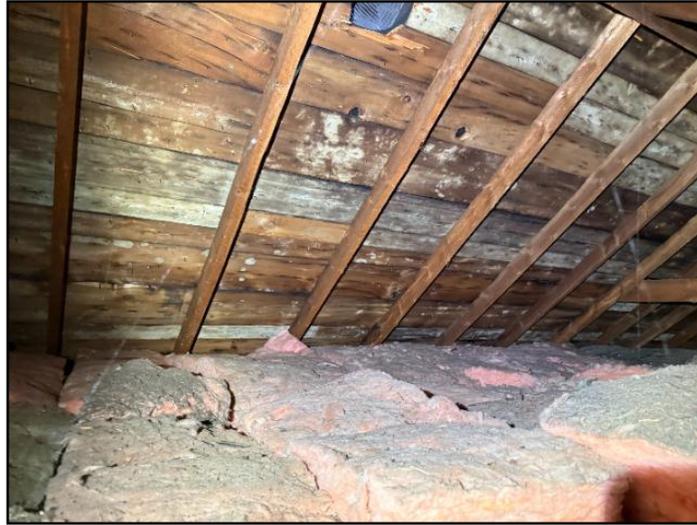
Condition: • Water stains or discoloration - Attic plank boards

Discoloration or water staining was noted on the plank board sheathing in the attic. This is a common observation in older homes and is typically the result of historical moisture exposure, condensation, or natural aging and weathering of the wood.

13. Water stains or discoloration - Attic plank...

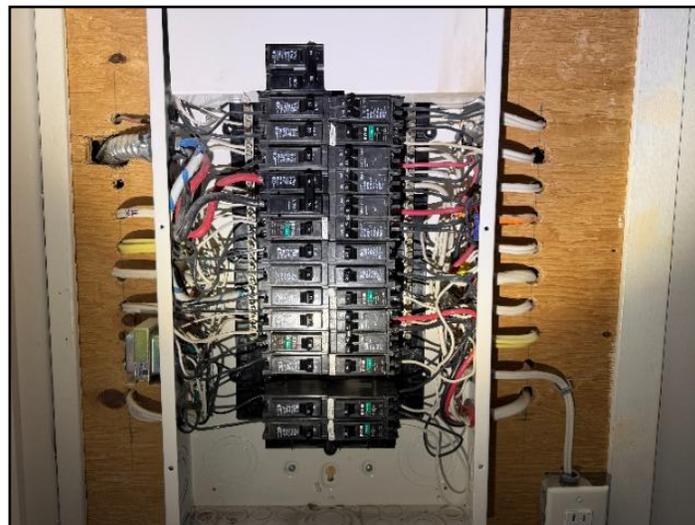
Good condition overall

14. Breakers - basement

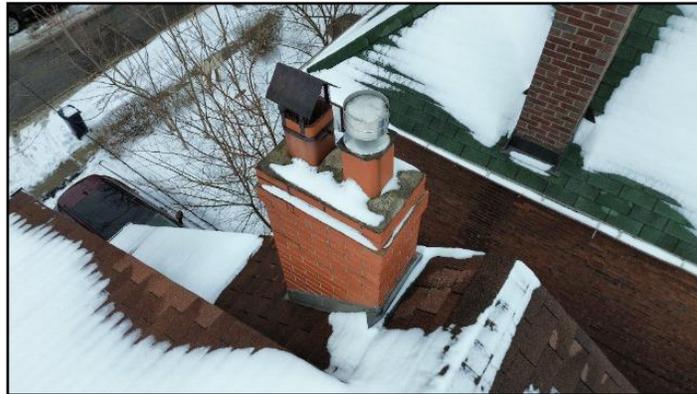
Condition: • [No drip edge on cap \(crown\)](#)

15. No drip edge on cap (crown)

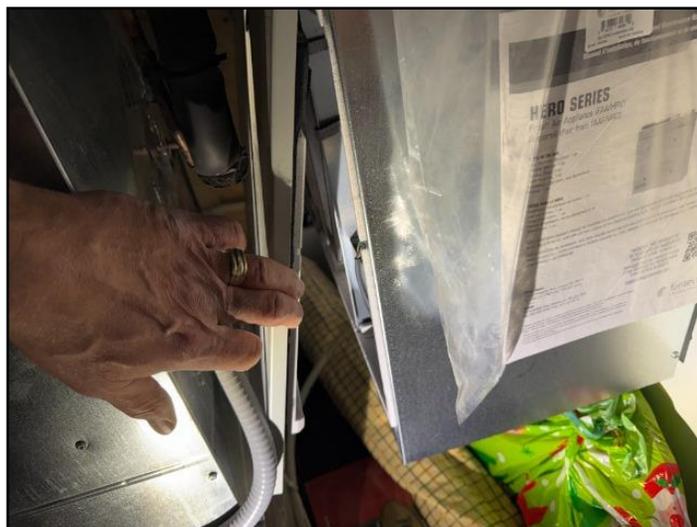
16.

Condition: • Limited service clearance

Task: Improve service clearance if future maintenance becomes difficult

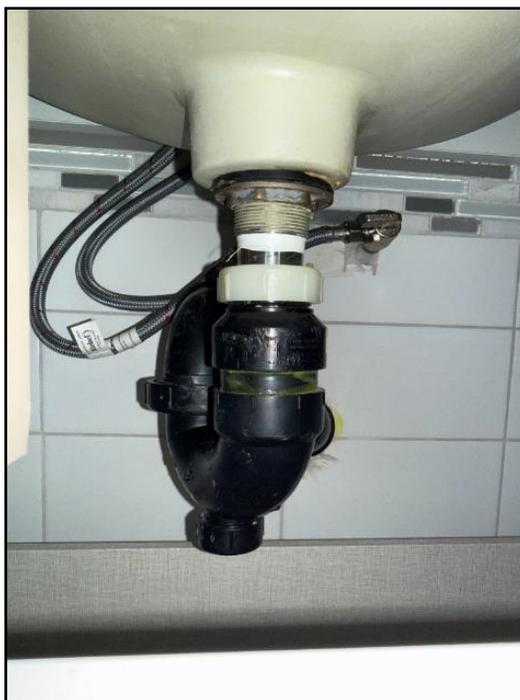
Condition: • Nonstandard shape or material

18. Nonstandard shape

Task: Monitor for siphoning or slow draining and Improve if needed

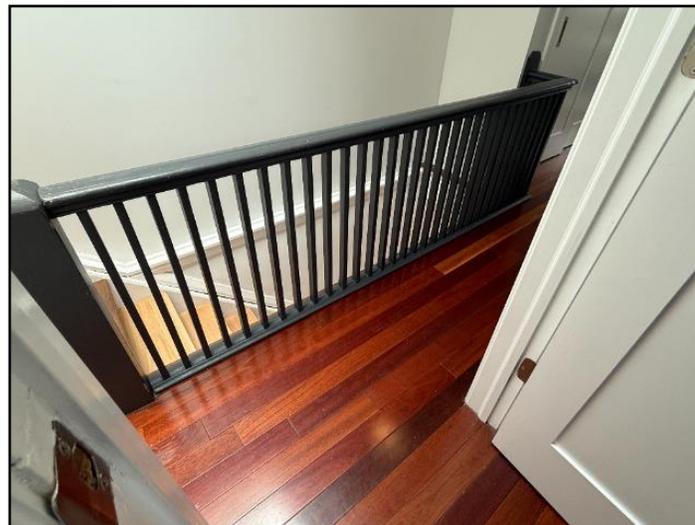
Condition: • [Too low](#)

Implication(s): Fall hazard

19. Too low
