# YOUR INSPECTION REPORT

FOR THE PROPERTY AT:  
58 Gilmour Avenue  
Toronto, ON M6P 3A9

INSPECTION DATE:  
Monday, March 24, 2025

RE: Report No. 8215  
58 Gilmour Avenue  
Toronto, ON  
M6P 3A9

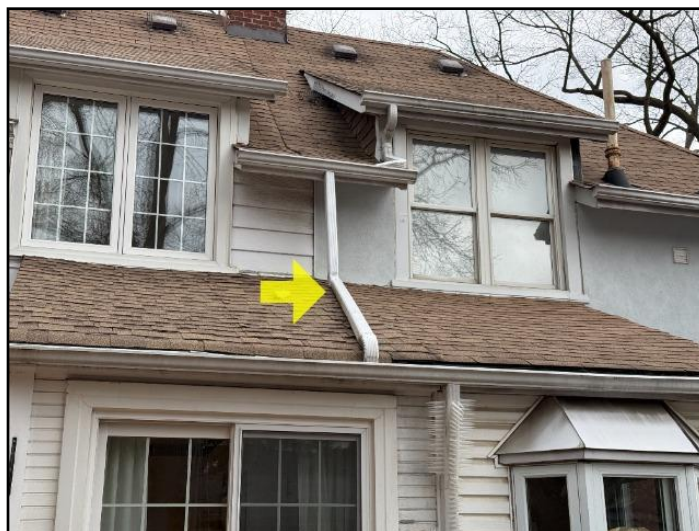
**Condition:** • Loose

3. Loose

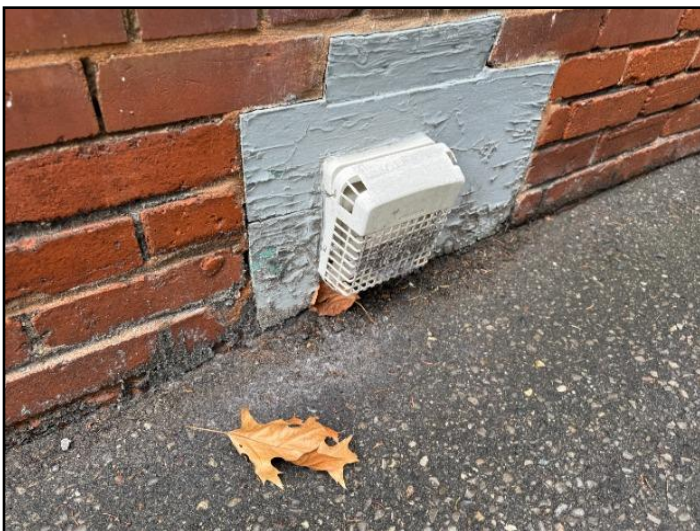
- Vent at right side is too close to grade and may become snow-covered. Monitor and keep area clear.
- Downspout drains below grade. Seller noted exemption from the city - consult seller's representative for details.
- Patch or repoint deteriorated masonry at select window sills.
- Prior wall/foundation repairs noted - common for age.
- Masonry spalling and mortar deterioration at various areas - routine maintenance recommended.
- Torn screen door at rear
- Basement windows are at or near grade and below modern clearance standards. Consider adding window wells if regrading in future.
- Basement window at rear deck - consider a clear plastic window well cover to help manage snow and water.
- Rear deck threshold is too low. Modern standards require a 6-inch step-up. Maintain weatherstripping and caulking at this location.

4. Vent near grade

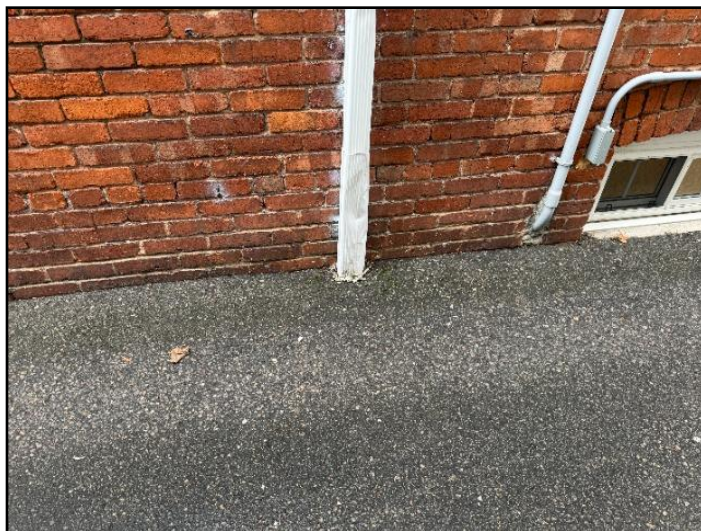
5. Downspout discharge below grade

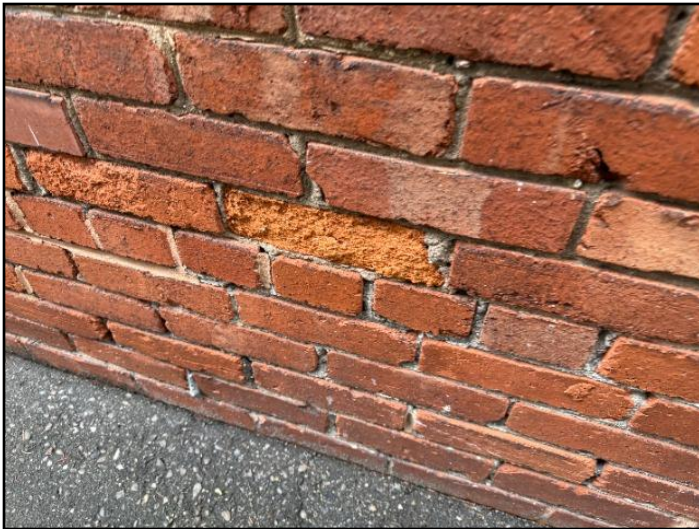
6. one example of spalling

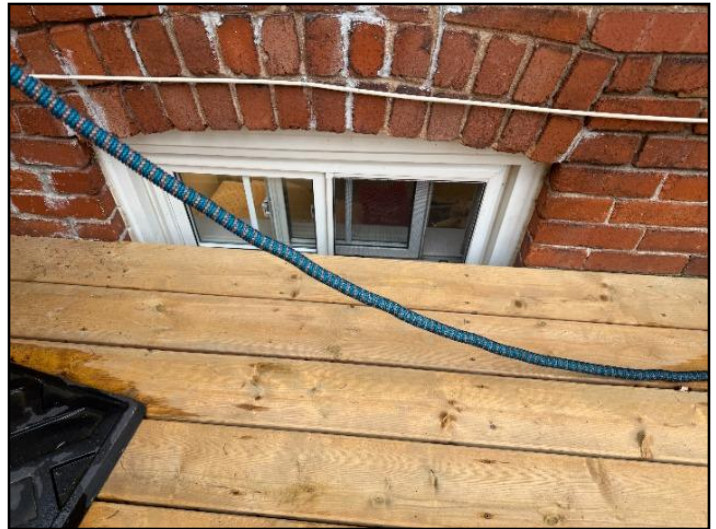
7. Window plastic cover recommended

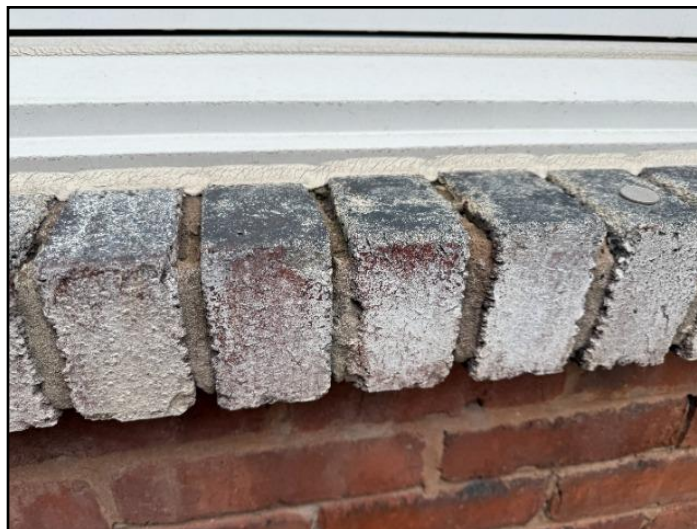
8. example of mortar deterioration at sill

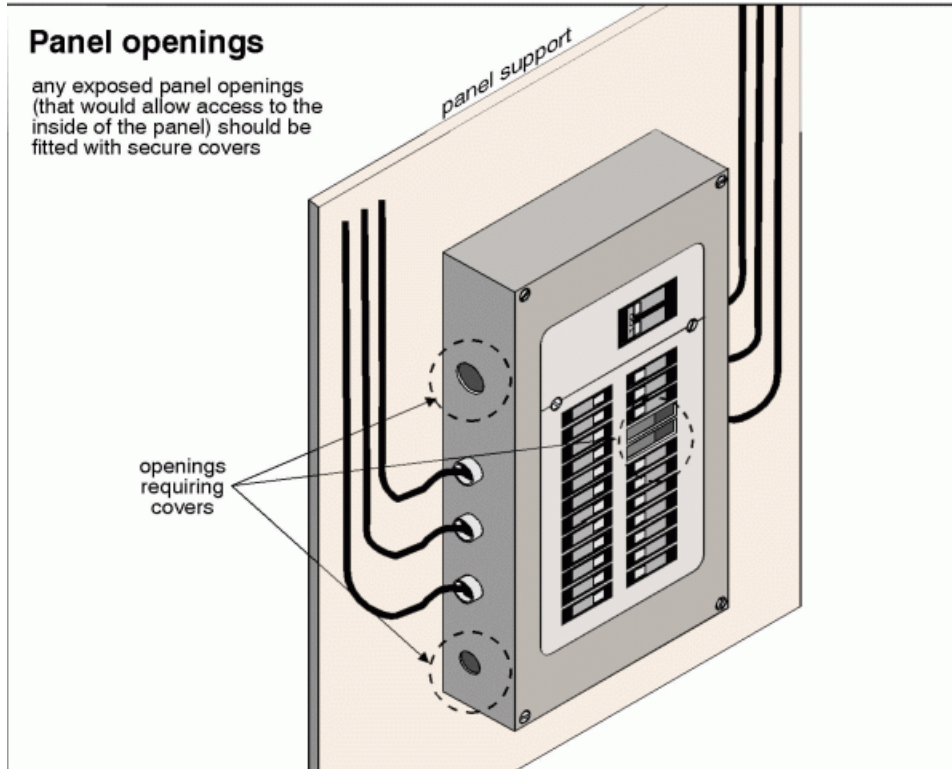
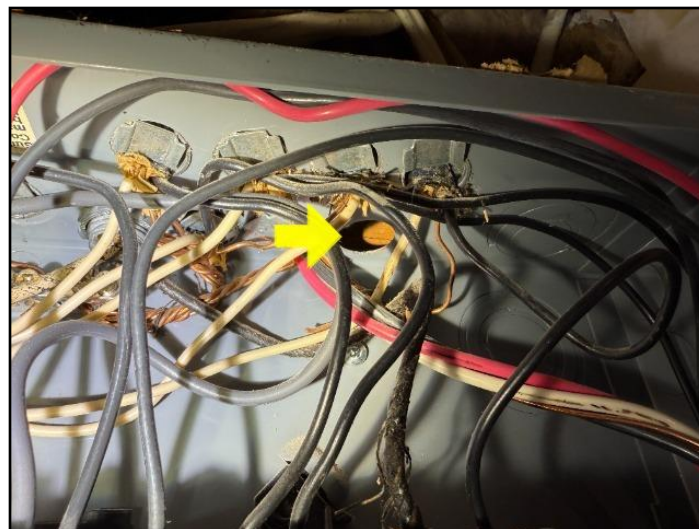
**Condition:** • [Openings in panel](#)

10. Openings in panel

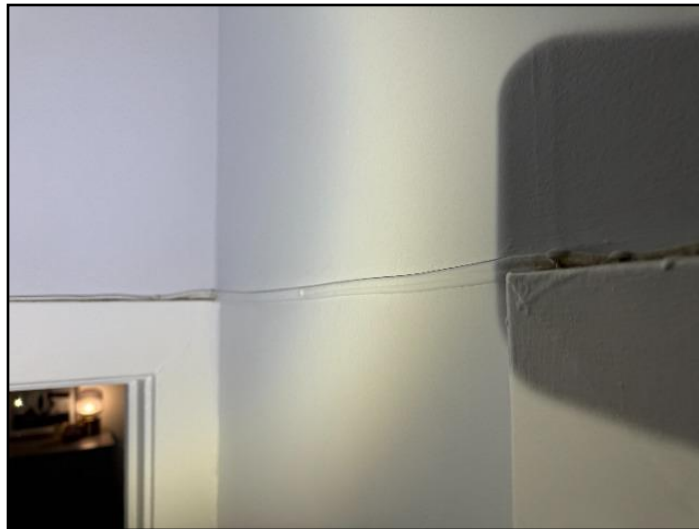
**Condition:** • [Exposed on walls or ceilings](#)

11. *Exposed on walls or ceilings*

**Task:** Correct

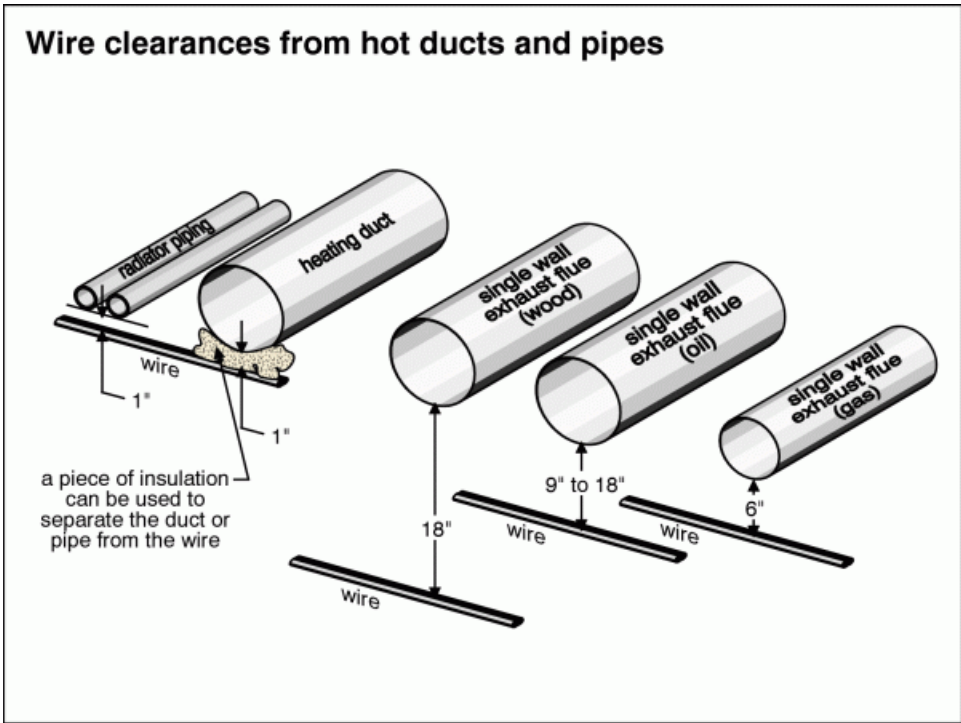
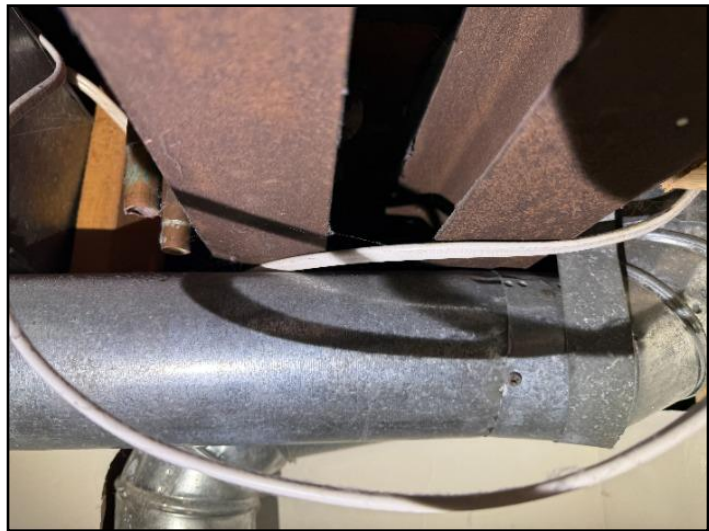
**Condition:** • [Too close to/touching ducts, pipe, chimneys, etc.](#)

12. one example

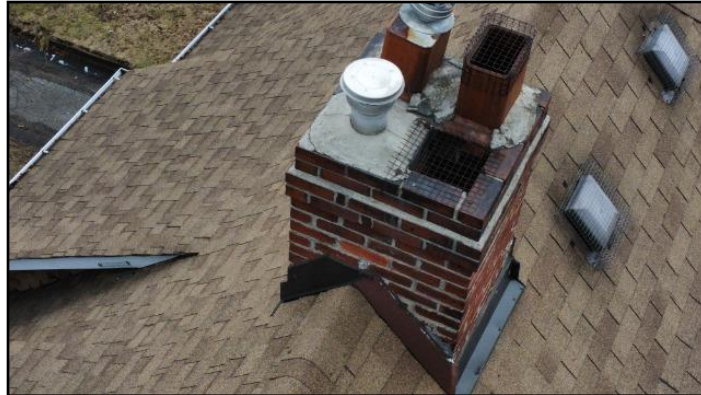
**Condition:** • [No drip edge on cap \(crown\)](#)

\*Also rain cap is missing on one flue opening. Provide cap or seal.

**Implication(s):** Chance of water damage to structure, finishes and contents | Shortened life expectancy of material | Material deterioration

13. No drip edge on cap (crown)

**Task:** Provide  
**Time:** Less than 1 year  
**Cost:** \$800 - and up

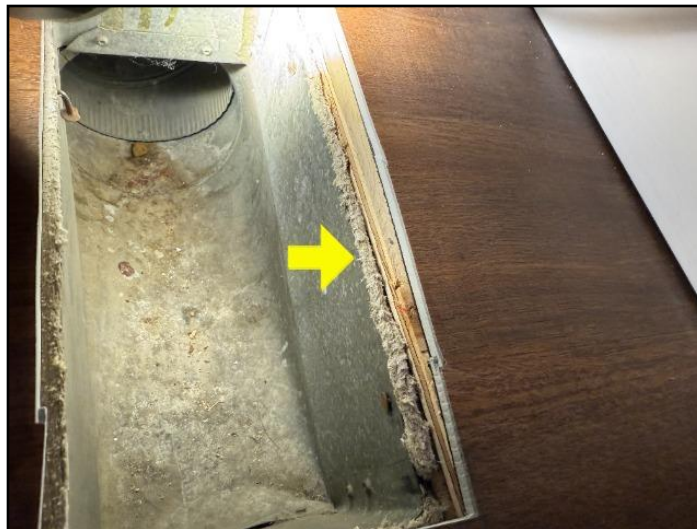
**Condition:** • Possible asbestos containing materials

In homes of this age, it was common to wrap floor registers in insulation to prevent floor overheating. This insulation may contain asbestos, but determining this is outside the scope of a home inspection. Health Canada advises that suspected asbestos materials be left undisturbed. If you plan renovations or are concerned, consult a qualified specialist for testing and recommendations.

15. one example
