INSPECTION REPORT

For the Property at:
123 RAFTER RD.
MY VILLAGE, ON

Prepared for: TRUSS TRUSTY
Inspection Date: Friday, February 2, 2024
Prepared by: Nicholas Lentz

RE: Report No. 1012, v.5
123 Rafter Rd.
My Village, ON

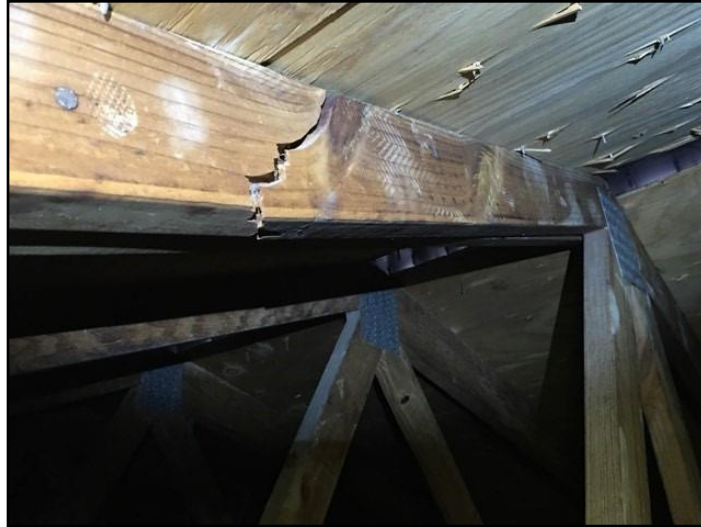
1. Condition: • Split

Top chord of roof truss is cracked through, possibly due to excess load on roof.

Implication(s): Weakened structure | Chance of structural movement

Split

Task: Repair

Time: Immediate

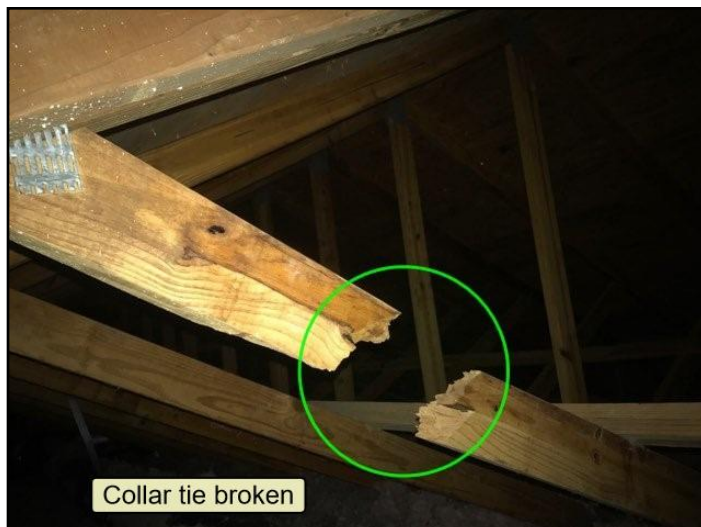
2. Condition: • Mechanical damage

Collar tie has failed and broken, possibly due to low quality wood and/or overloading of roof structure.

Implication(s): Weakened structure | Chance of structural movement

Mechanical damage

Task: Replace

Time: Immediate

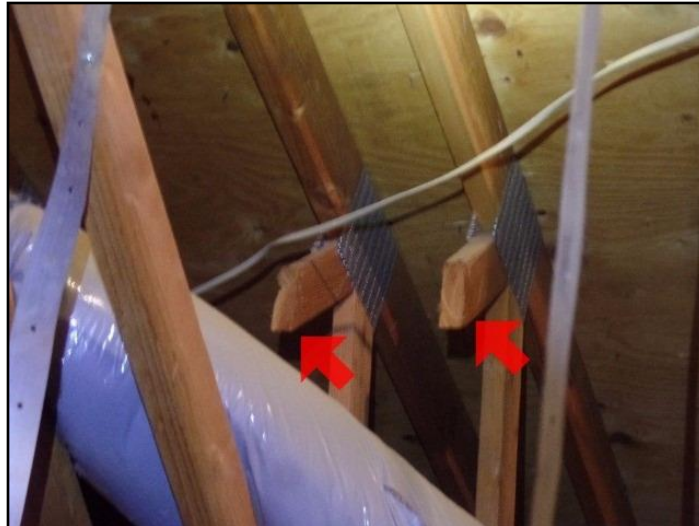
3. Condition: • Mechanical damage

Two truss webs (supports) have been cut and removed to accommodate duct work. Trusses are engineered roof supports and any cutting, holes or notches made in them severely compromises their strength.

Implication(s): Weakened structure | Chance of structural movement

Mechanical damage

Task: Further evaluation

Time: As soon as possible

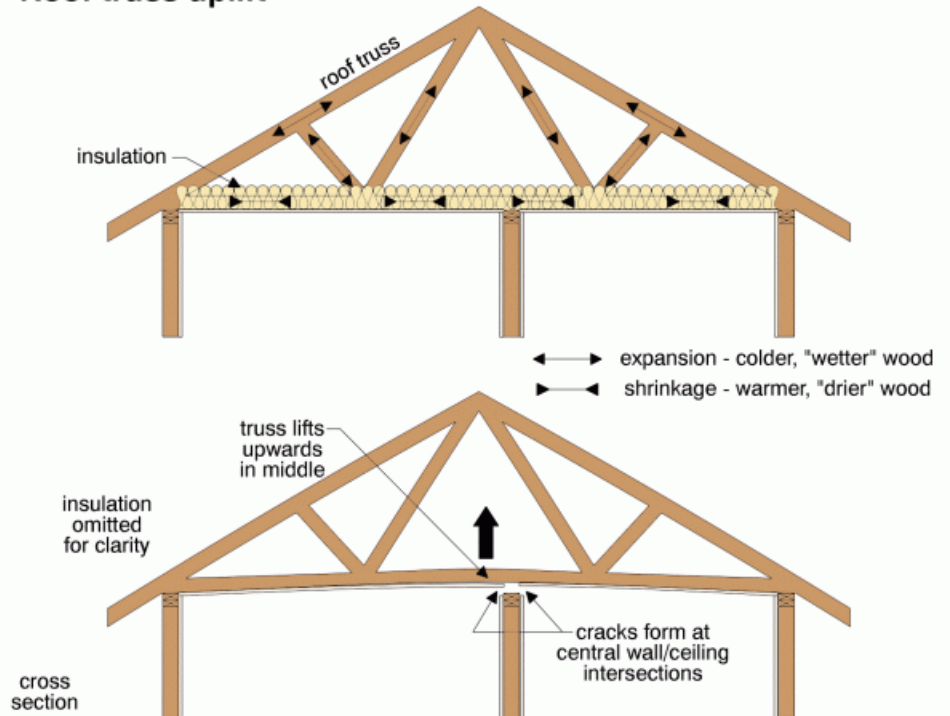
Roof truss uplift

4. Condition: • Truss uplift

Truss uplift is a seasonal issue in cold climates that is primarily cosmetic. It only occurs in the winter. One explanation is the expansion of wood framing members in the attic due to the significant humidity changes that occur during the winter. This crack will likely appear in the winter, but then should disappear in the spring as the bottom of the truss settles back down.

Implication(s): Cosmetic issue only

Task: Monitor

Time: Ongoing

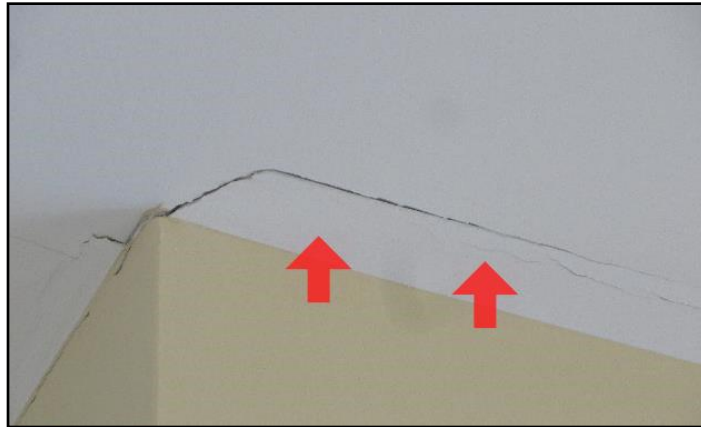
Truss uplift

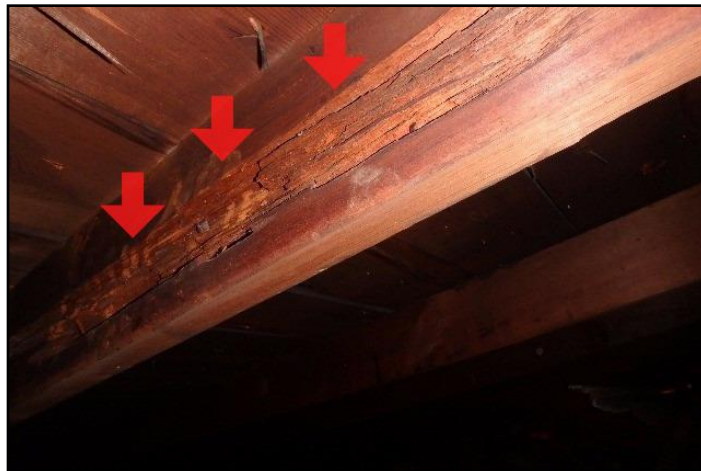
5. Condition: • Rot

Severe rot noted in this rafter. In this condition, it will not be able to carry its load properly. Recommend repair or replacement.

Implication(s): Weakened structure

Rot

Task: Replace

Time: Immediate

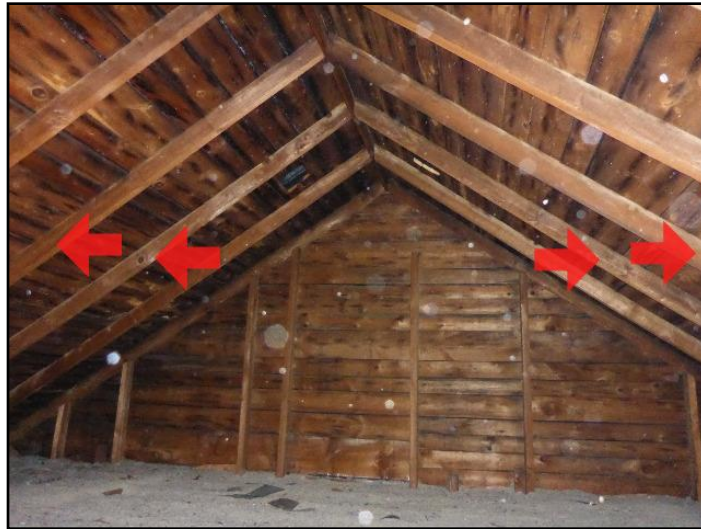
6. Condition: • Missing

Recommend installation of collar ties between opposing rafter pairs to prevent rafter sag. Currently no evidence of sag, but this would be a low cost yet very beneficial upgrade.

Implication(s): Weakened structure | Chance of structural movement

Missing

Task: Provide

Time: discretionary

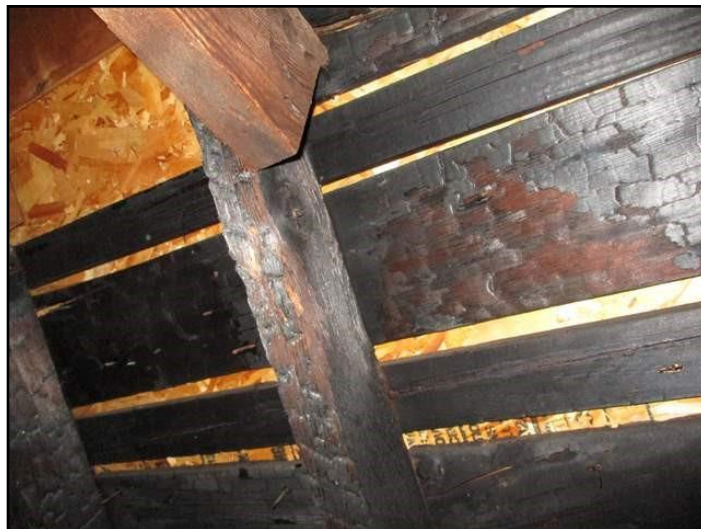
7. Condition: • Fire damage

Widespread fire damage was noted in the attic. Wood that is charred already could be more susceptible to further fires, should they occur. Wood structures that have endured fire are also weakened by it. Recommend further evaluation.

Implication(s): Weakened structure

Fire damage

Task: Further evaluation

Time: Immediate

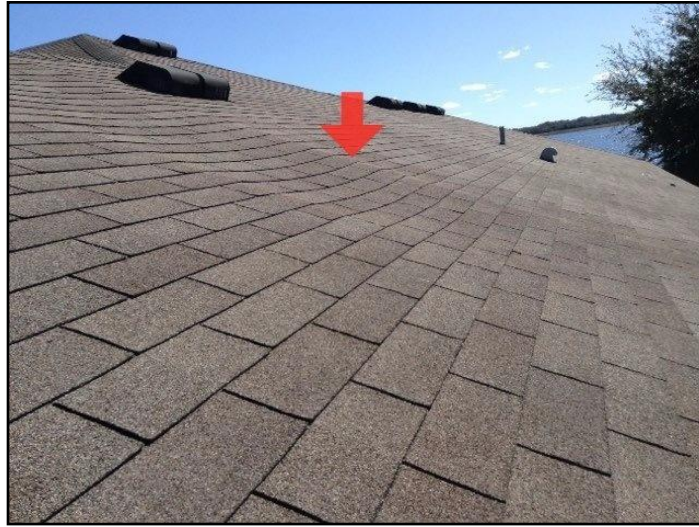
8. Condition: • Sagging

Generalized sagging or dishing of roof sheathing between rafters. Suggest further evaluation by a qualified roofing contractor

Implication(s): Weakened structure | Chance of structural movement

Sagging

Task: Monitor

Time: Ongoing

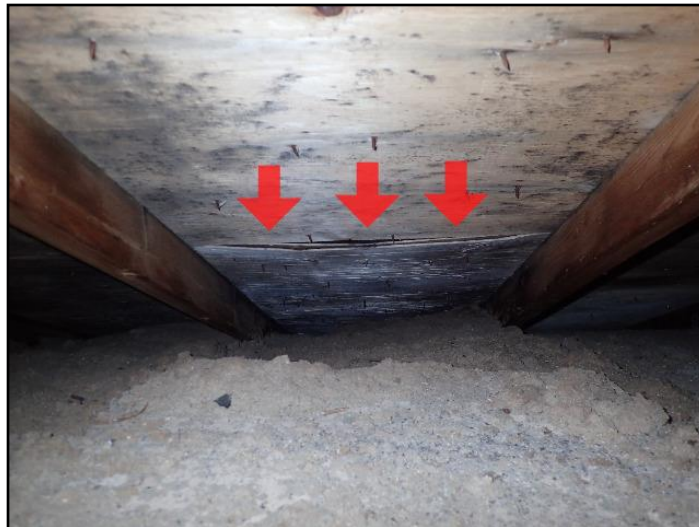
9. Condition: • Sagging

Ongoing moisture penetration through the roof covering has severely deteriorated the roof sheathing here. Plywood is delaminating and there is also widespread evidence of rot. Repairs should be performed as soon as possible.

Implication(s): Weakened structure | Chance of structural movement

Sagging

Task: Repair

Time: Immediate

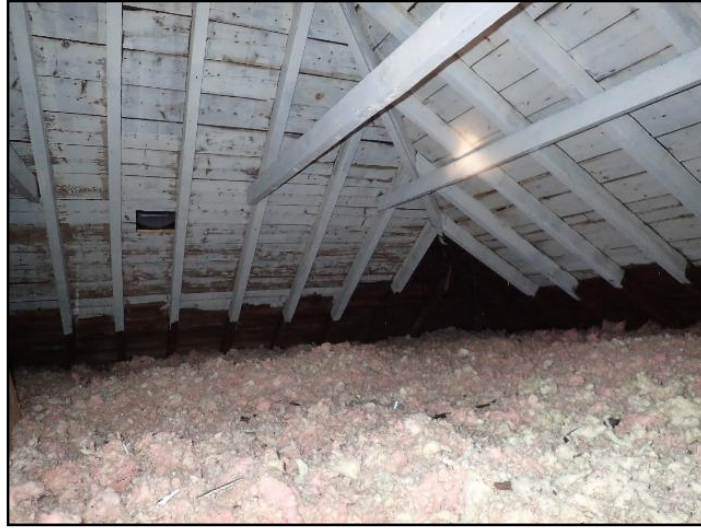
10. Condition: • Attic has been painted throughout. This may have been an attempt to treat mold or mildew as a result of condensation issues in the attic. Recommend ongoing monitoring.

attic painted

Task: Monitor

Time: Ongoing
