Your Inspection Report

7 Innisfree Crt
Toronto, ON M6S 3N7

PREPARED BY:
Scott Lutz, RHI

RE: Report No. 97297
7 Innisfree Crt
Toronto, ON
M6S 3N7

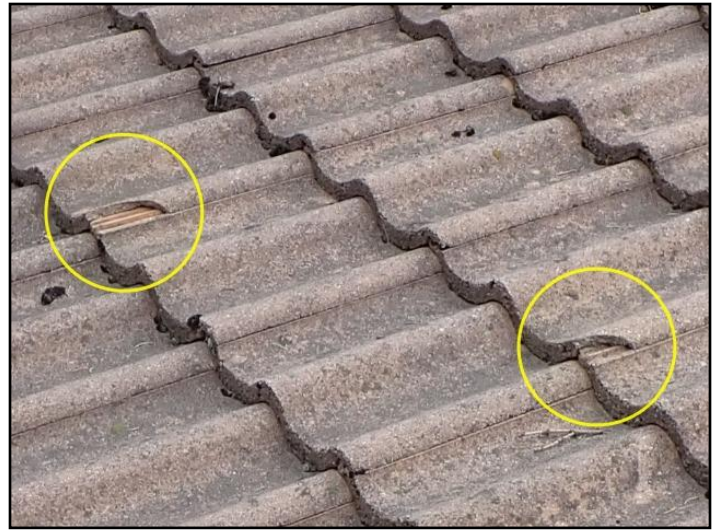
Condition: • Chipped

Chipped

Task: Repair

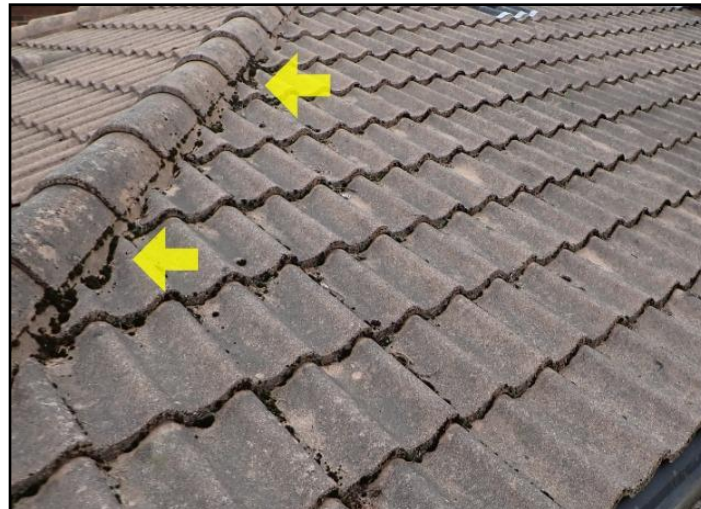
Condition: • Moss, Mildew

Moss

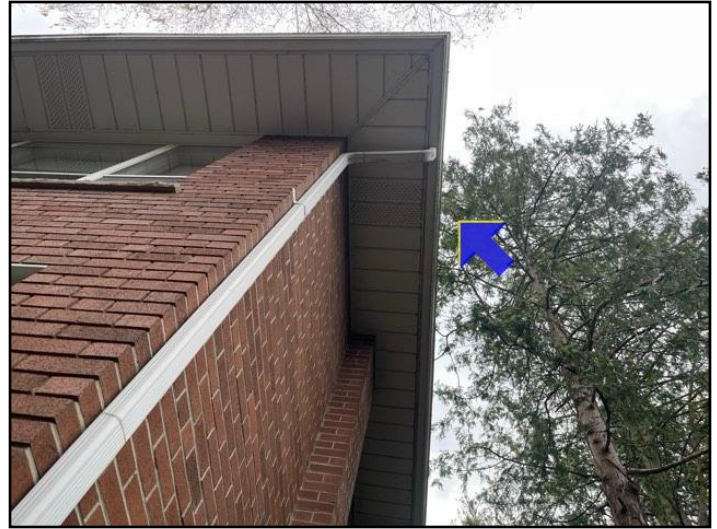
Condition: • Tree branches touching roof

Branches close / touching

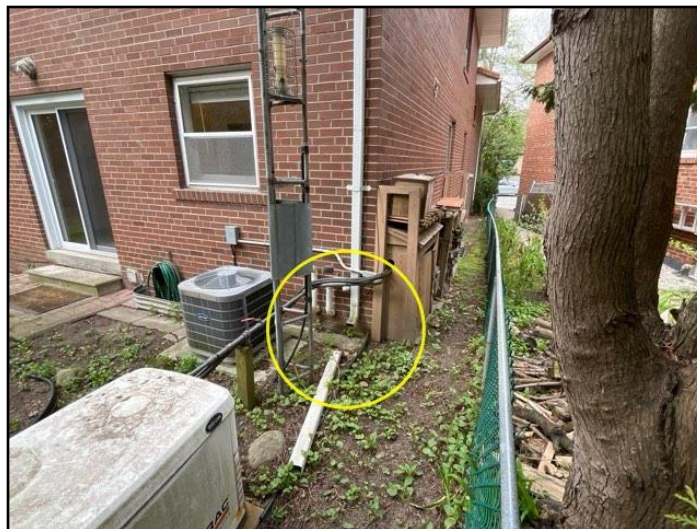
Condition: • [Connections loose](#)

Connections loose

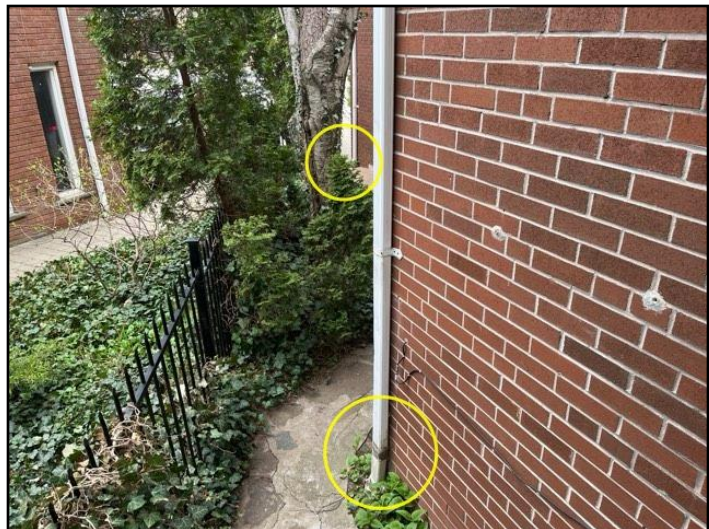
Condition: • [As of Dec 2016, a Toronto by-law requires downspouts to discharge above grade. Exemptions may be available in some cases. Below-grade downspouts may leak or be clogged, resulting in basement leakage. Click the line above for details.](#)

Toronto - Discharge below grade

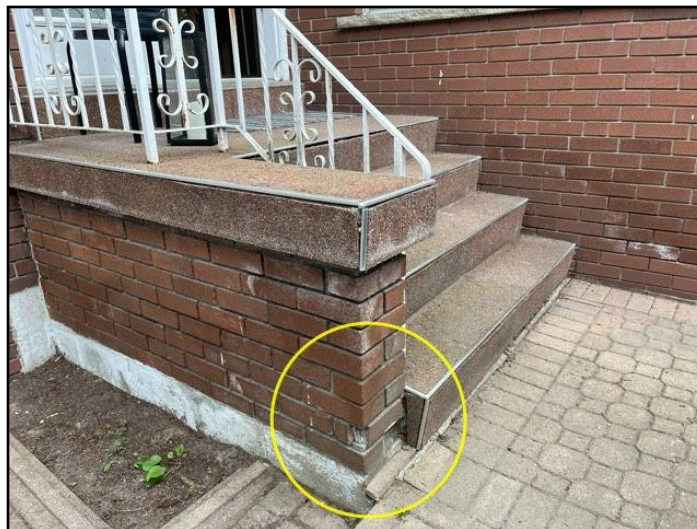
Condition: • Masonry deterioration

Masonry deterioration

Task: Repair
Time: Less than 1 year
Cost: Minor

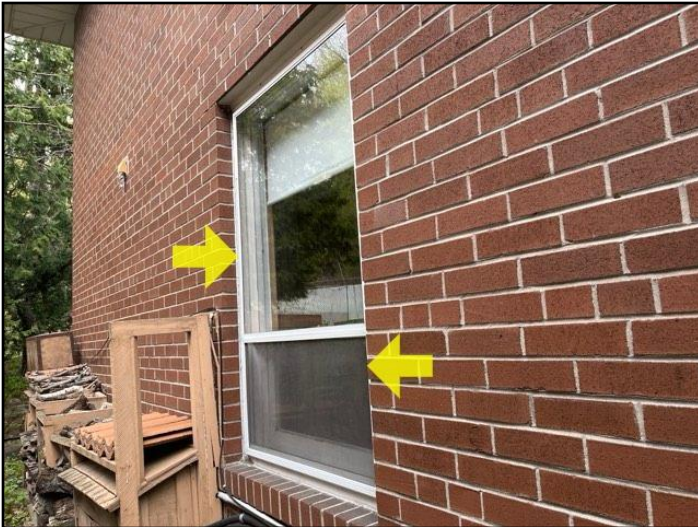
Condition: • Caulking deteriorated

Ex., Left side: Caulking deteriorated

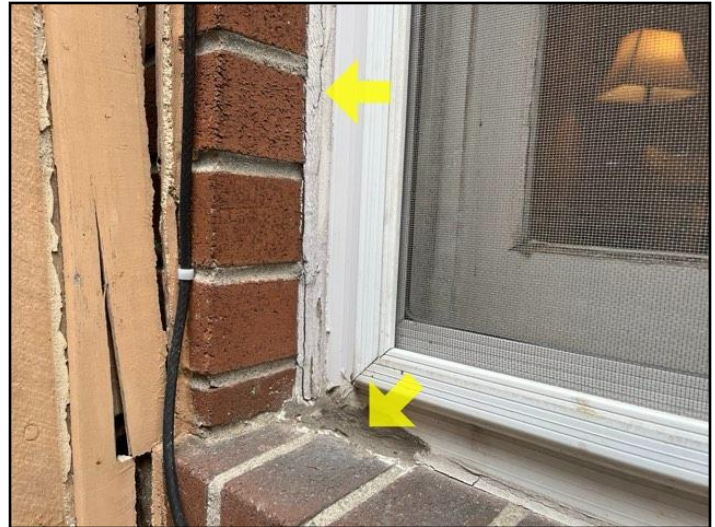
Detail: Caulking deteriorated

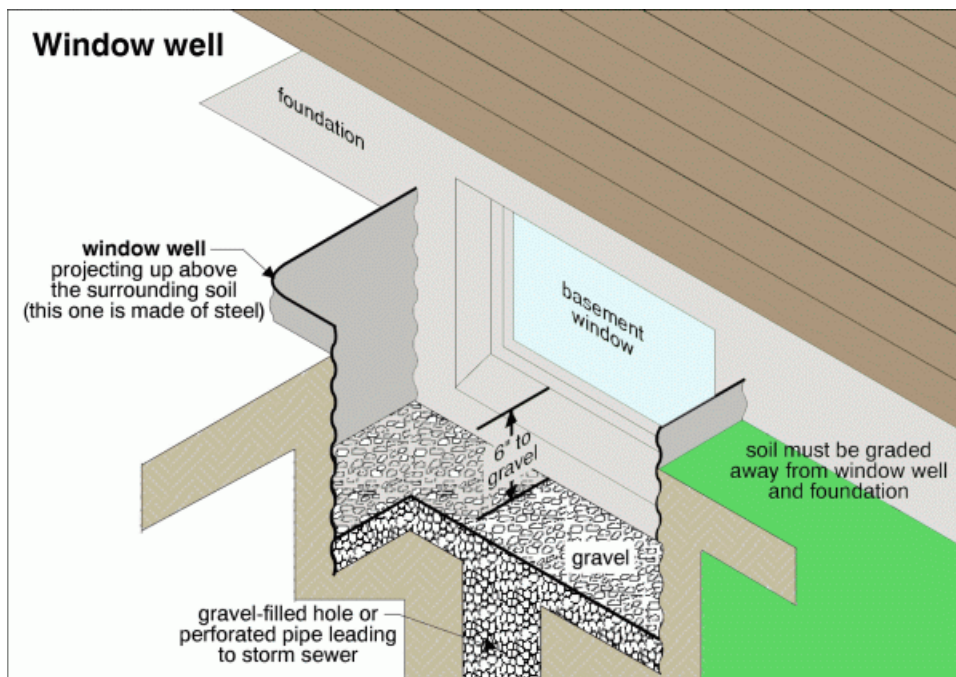
Condition: • Window close to grade in well

Window close to grade in well

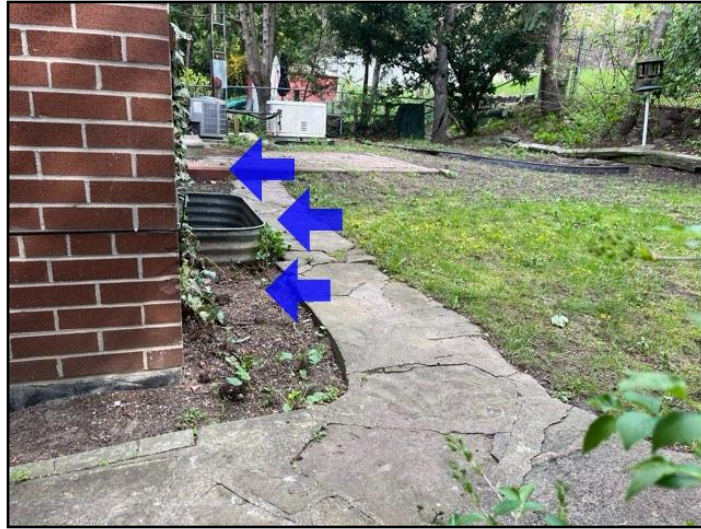
Condition: • [Improper slope or drainage](#)

Improper slope or drainage

Task: Improve slope to at least 1 inch per foot for the first 6 feet away from the home. Note: Less slope is needed on hard surfaces like driveways

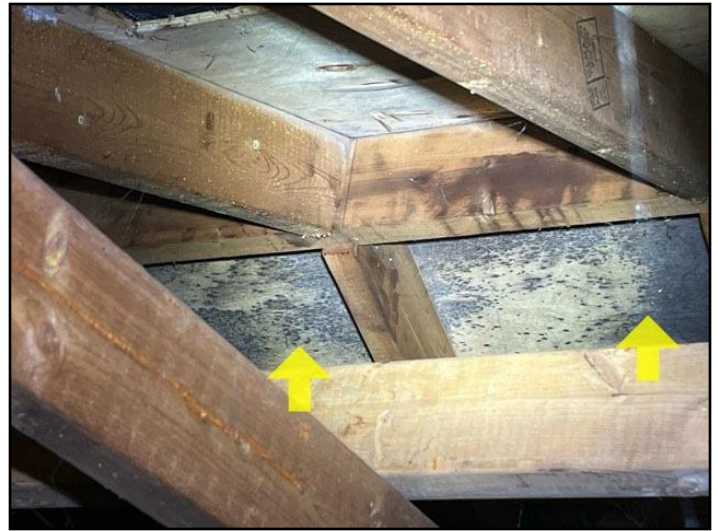
Condition: • Mould

Mould - Upper, Peak

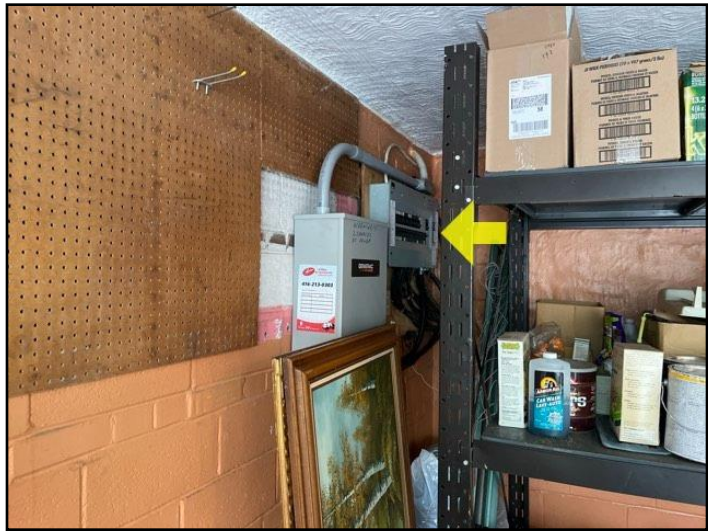
Condition: • [Poor access](#)

Poor access

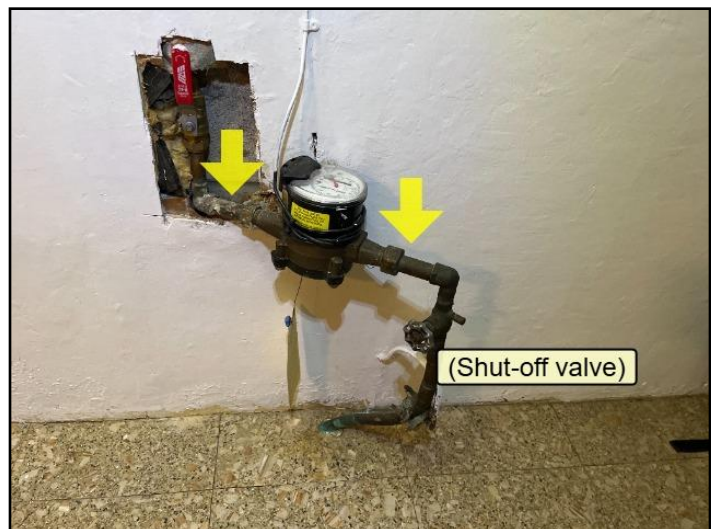
Condition: • [No jumper for meters and valves](#)

No jumper for meters and valves

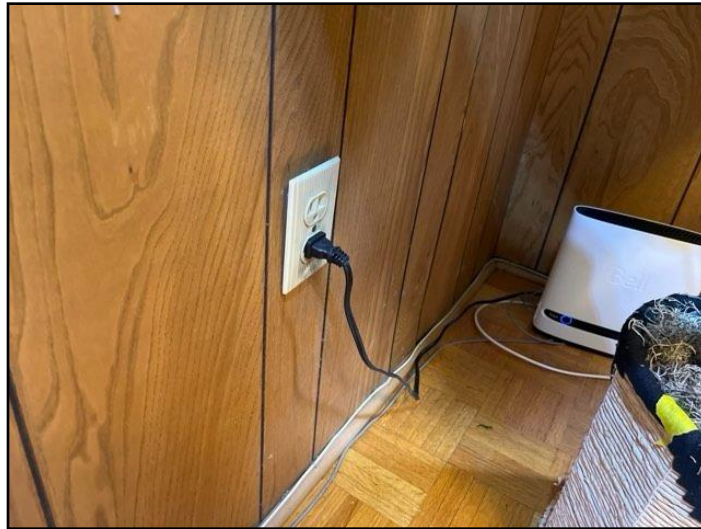
Condition: • [Loose](#)

Loose

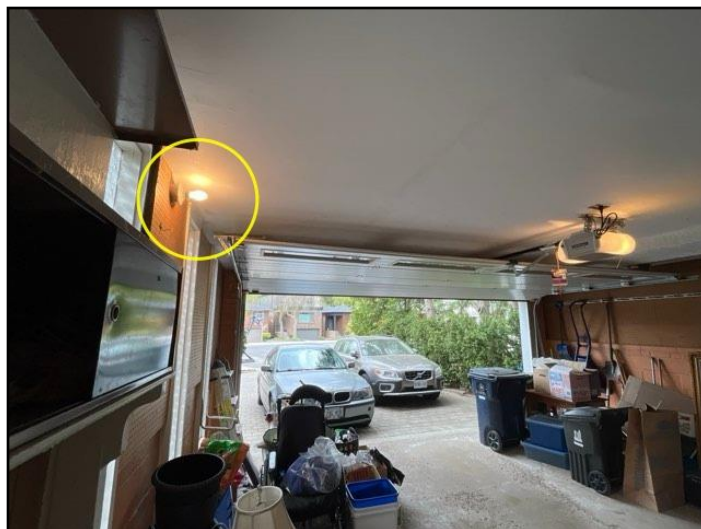
Condition: • Exposed to mechanical damage (No cage or protective lens).

Exposed bulbs

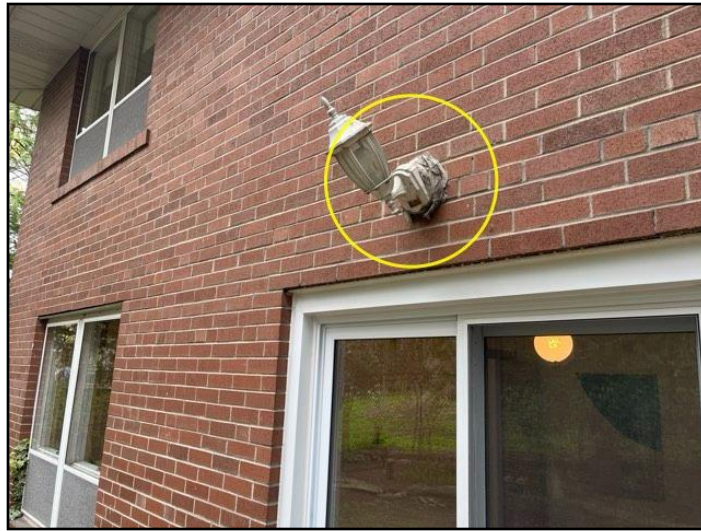
Condition: • [Loose](#)

Loose

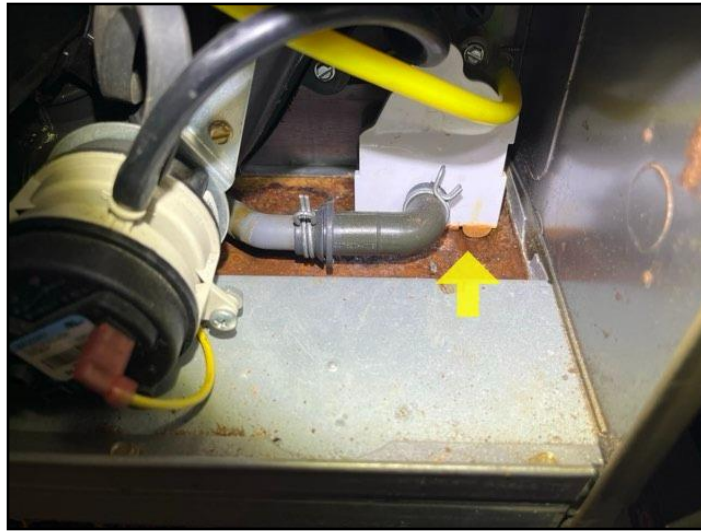
Condition: • Condensate leak

Condensate leak - active

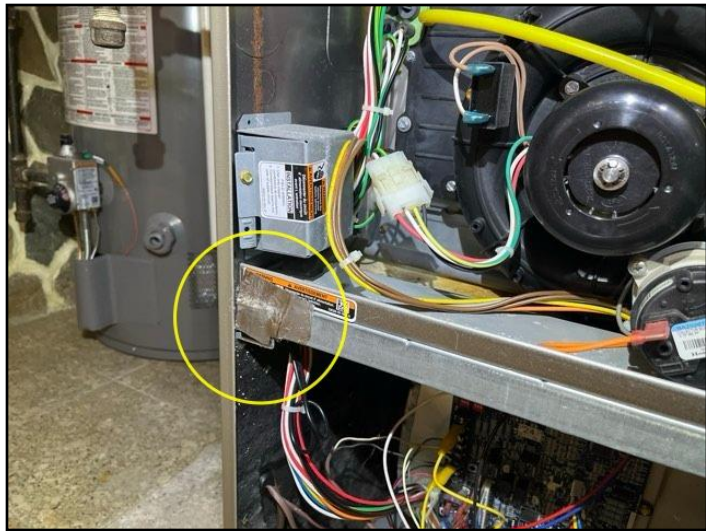
Condition: • Fan cover/access door interlock/safety switch inoperative

Interlock/safety switch taped down

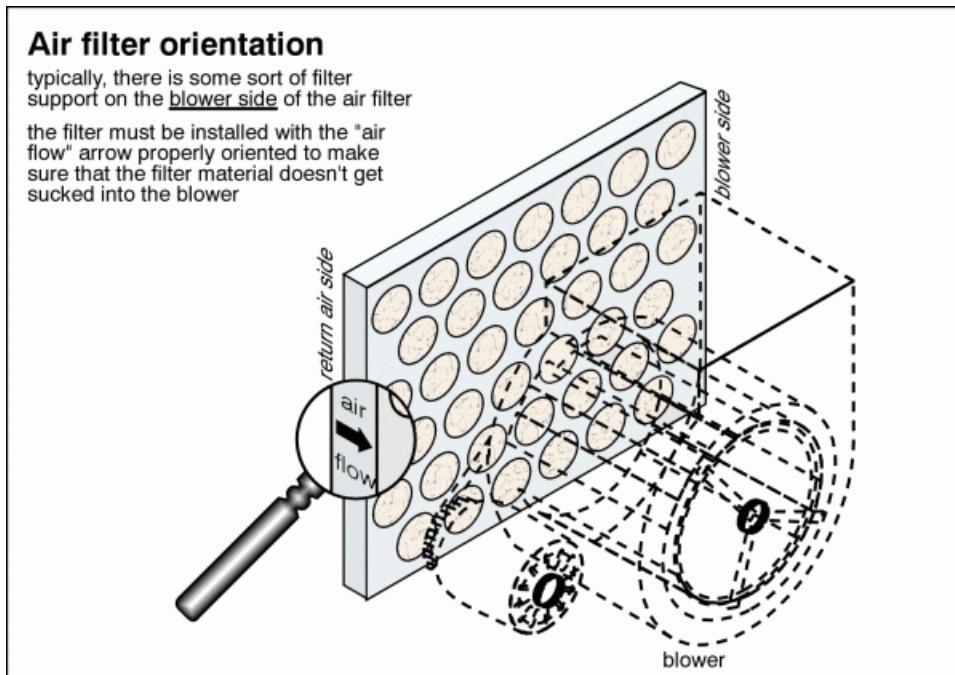
Condition: • [Installed backwards](#)

Installed backwards

Task: Replace

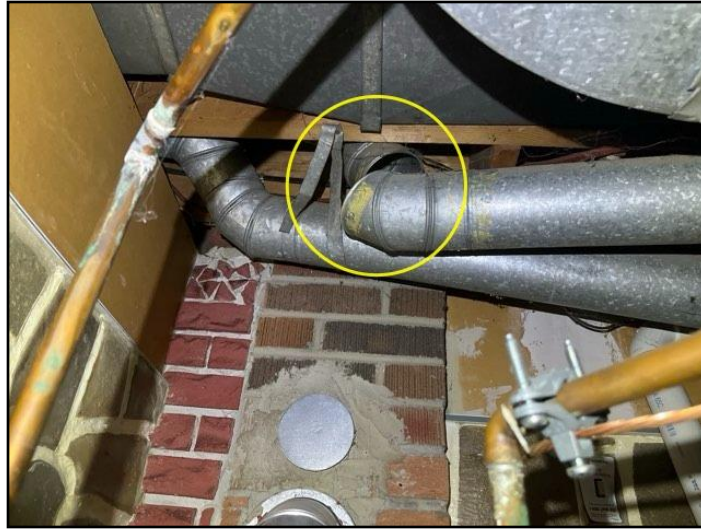
Condition: • [Disconnected ducts](#)

Disconnected ducts

Task: Further evaluation / Repair

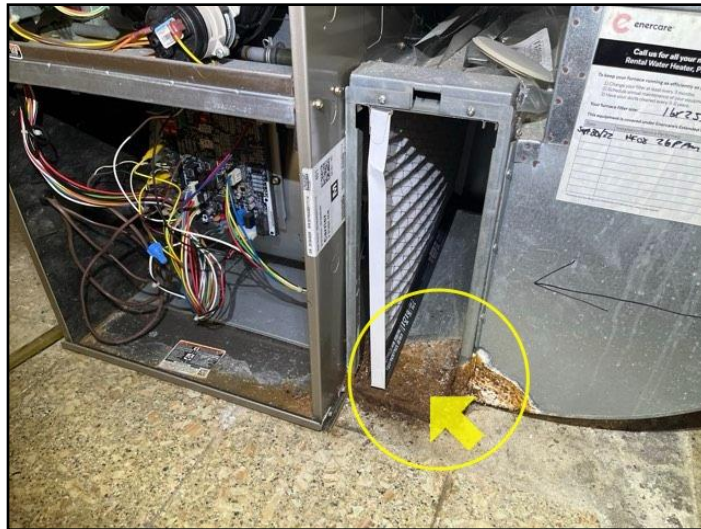
Condition: • Corrosion
Location: Basement Furnace
Task: Repair / Replace
Time: As soon as practical
Cost: Not determined

Corrosion

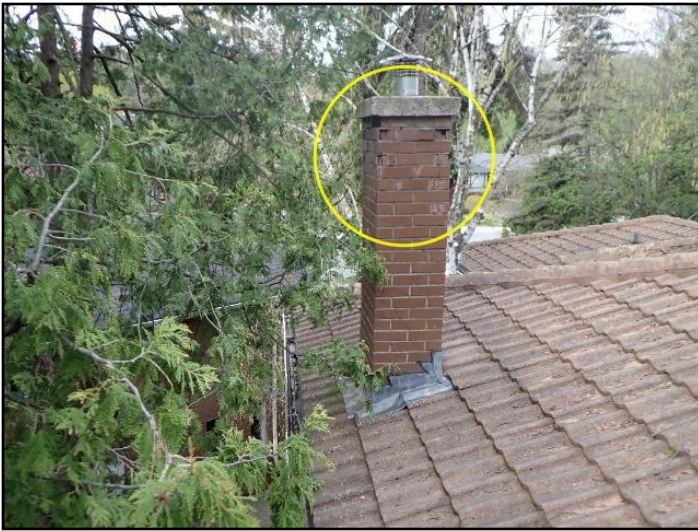
Condition: • Loose, missing or deteriorated masonry
Location: Left and Right Chimneys
Task: Repair
Time: Less than 1 year
Cost: \$1,500 - and up

Example, Right side: Loose, Missing Masonry

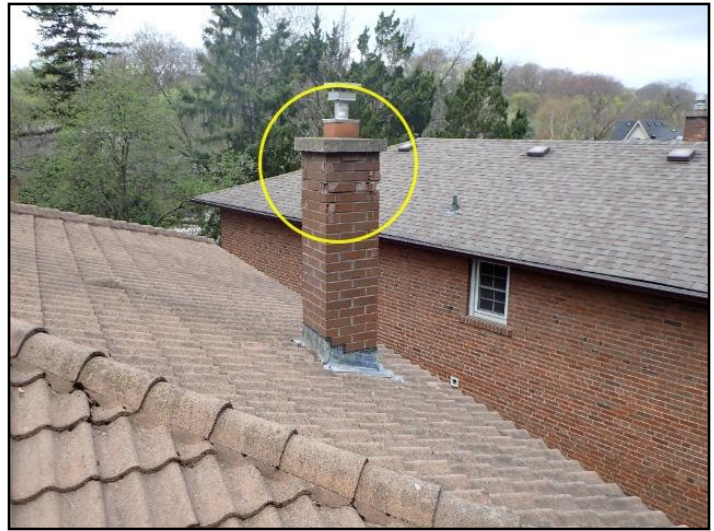
Example, Left side: Loose, Missing Masonry

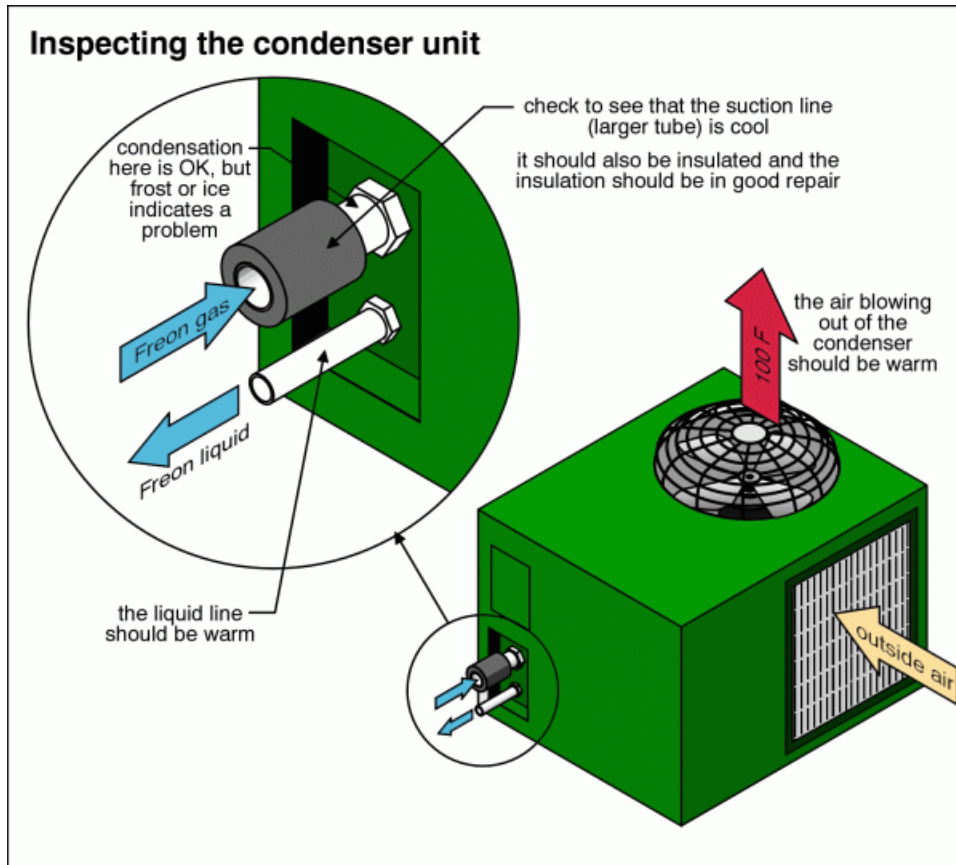
Condition: • [Dirty](#)

Dirty

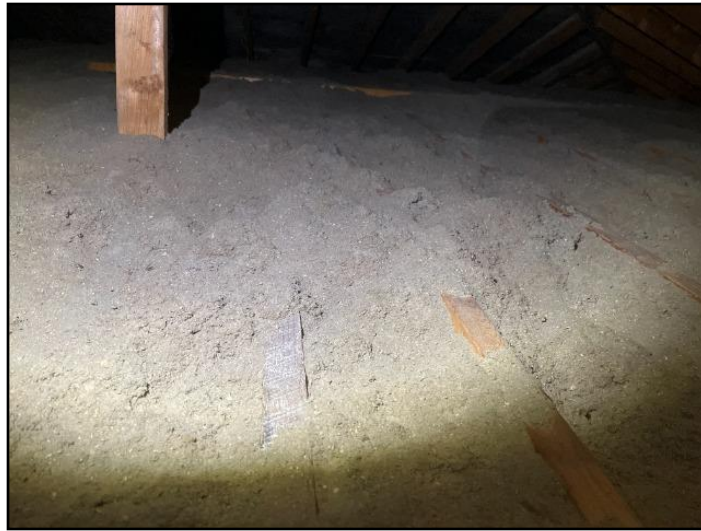
Condition: • [Amount less than current standards](#)

Insulation levels are below modern standards (R50-R60). In many cases, it is not practical (or cost effective) to improve it unless the opportunity presents itself (e.g. during renovations). Improvements may lead to lower heating/air conditioning costs and improved comfort.

Amount less than current standards

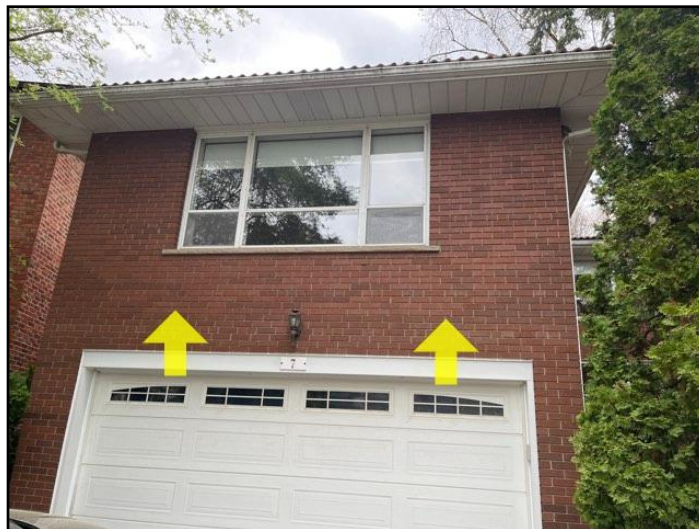
Condition: • Floors above unheated areas are typically cooler than other floors in the home. This is something to be aware of, although no action is typically needed. A specialist can help if improvements are needed.

Floors above unheated areas are typically...

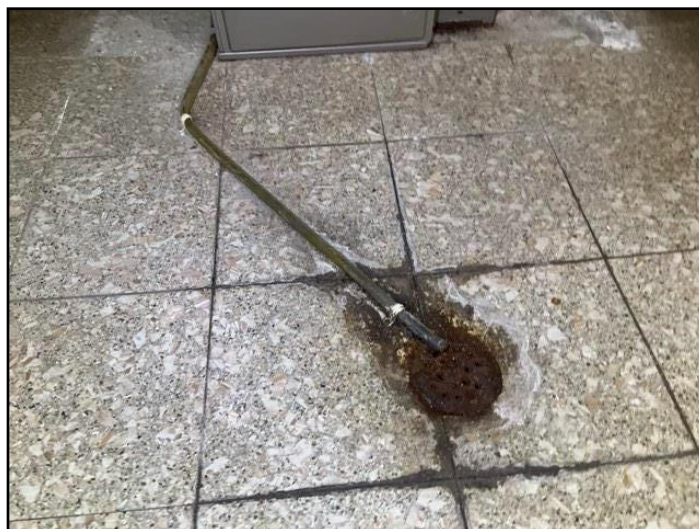
Condition: • [Grate missing, rusted or obstructed](#)

Grate missing, rusted or obstructed

Task: Replace

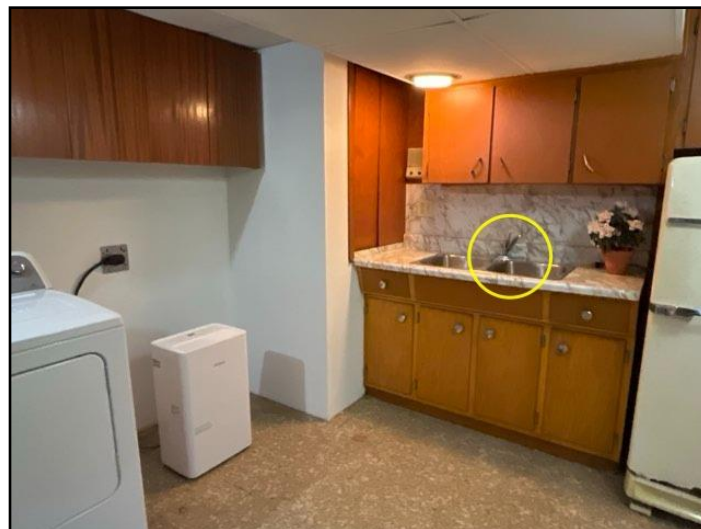
Condition: • Inoperative

Inoperative

Task: Repair / Replace

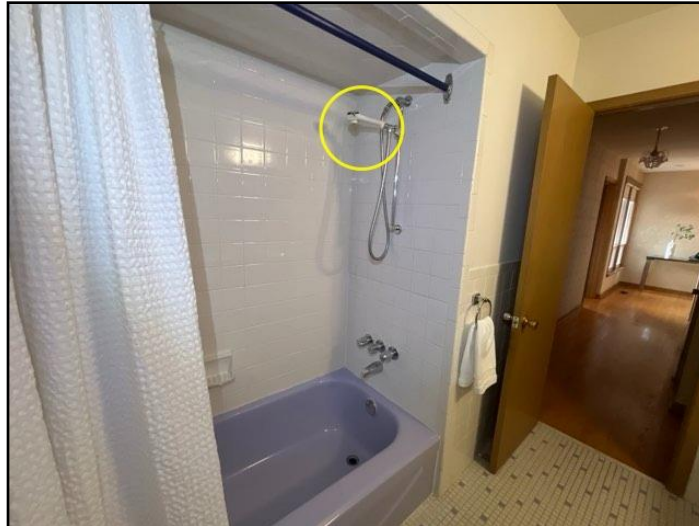
Condition: • Leaky hand shower

Leaky hand shower

Task: Repair / Replace

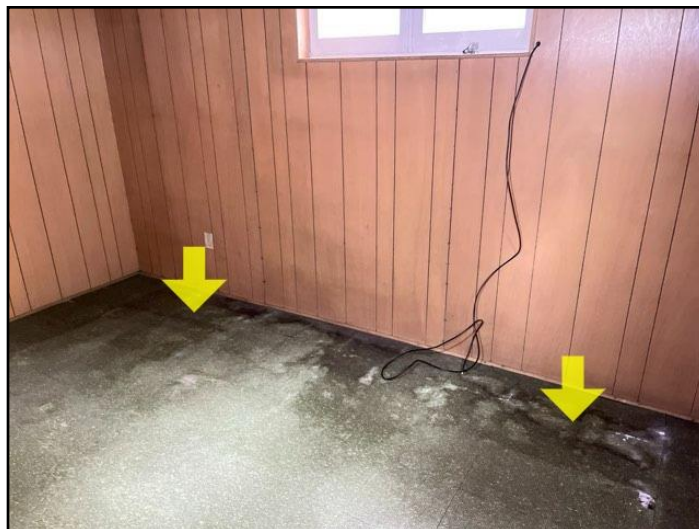
Condition: • Stains

Stains

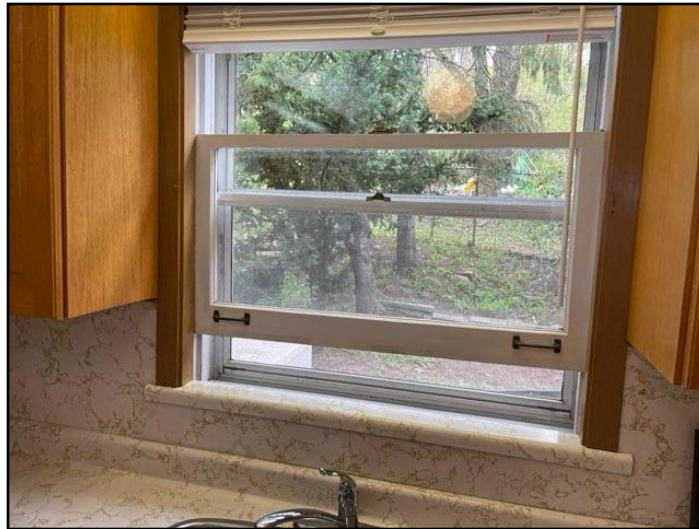
Condition: • Some windows are old but generally serviceable. At some point they should be replaced for cosmetics, ease-of-operation, or improved energy efficiency. Replacement windows are roughly \$50 to \$100/sq. ft. for moderate quality units, installed. Although more energy-efficient, new windows will typically not pay for themselves quickly in energy savings.

Old but serviceable

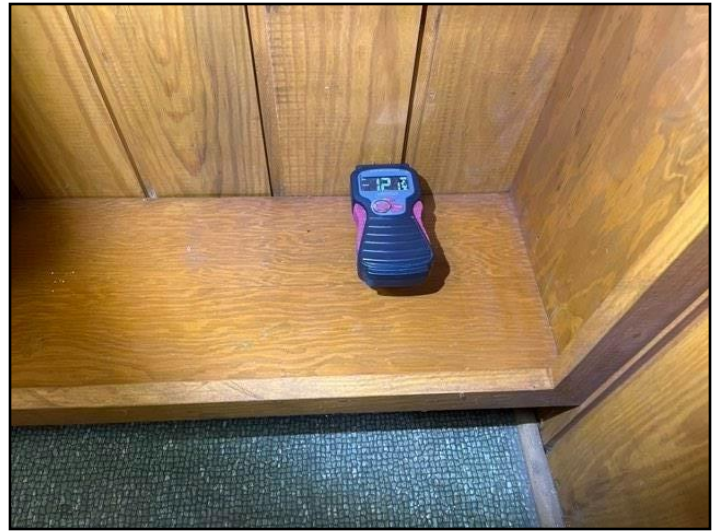
Condition: • Evidence of moisture noted
Slightly elevated moisture meter readings.

Ex., Left Wall by Bar

Task: Ensure gutters and downspouts are working properly and exterior grade slopes down away from the home. Monitor the area for evidence of moisture, particularly in the spring when snow melts or after heavy or persistent rains.

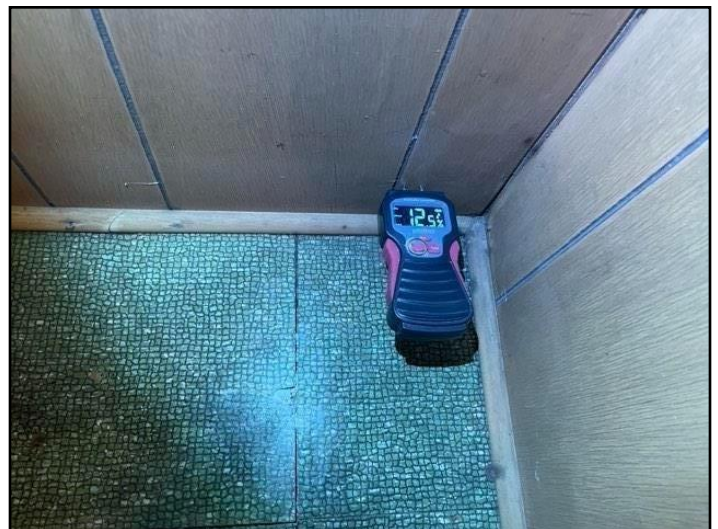
Ex., Rear Right

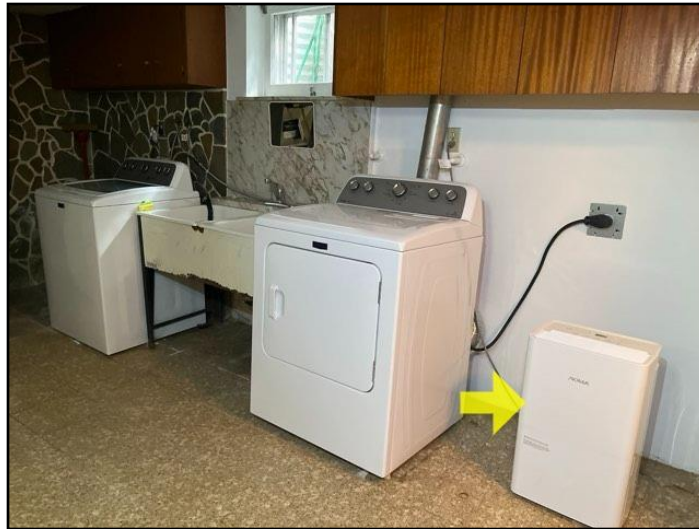
Condition: • [Dehumidifier in basement](#)

Dehumidifier in basement

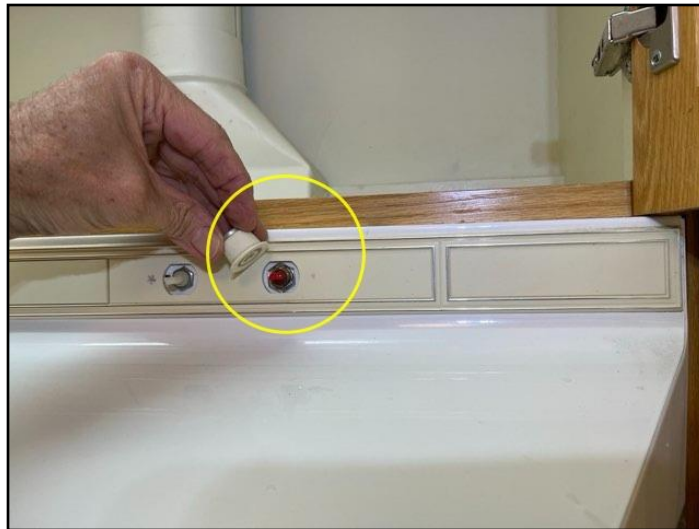
Condition: • Control damaged

Control damaged

Task: Replace
