Your Inspection Report

179 Glendonwyne Rd
Toronto, ON M6P 3E8

INSPECTION DATE:
Thursday, March 26, 2026

RE: Report No. 96456, v.2
179 Glendonwyne Rd
Toronto, ON
M6P 3E8

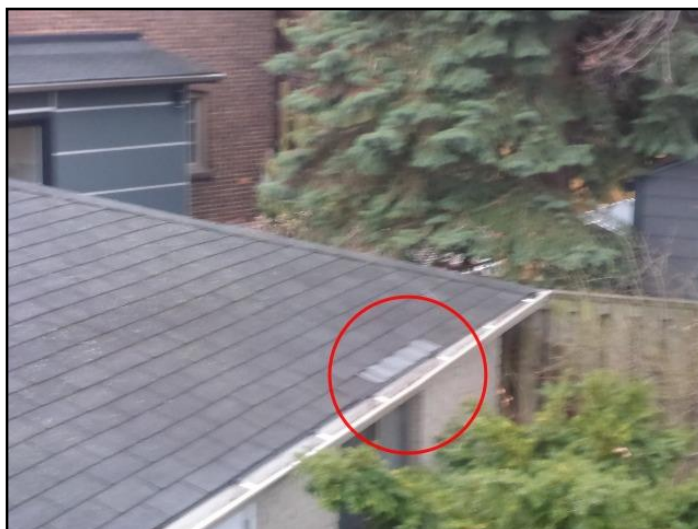
Condition: • Repair

Shingle has been replaced at the eaves edge.

Repair

Task: Monitor

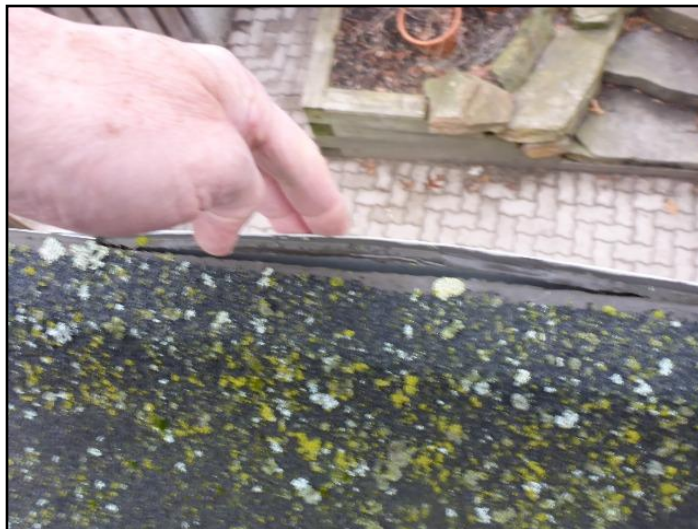
Condition: • Edges, seams and/or flashings - loose, open

Sealant has dried and cracked in areas around the perimeter. Clean up is necessary

Edges, seams and/or flashings - loose, open

Task: Repair / seal

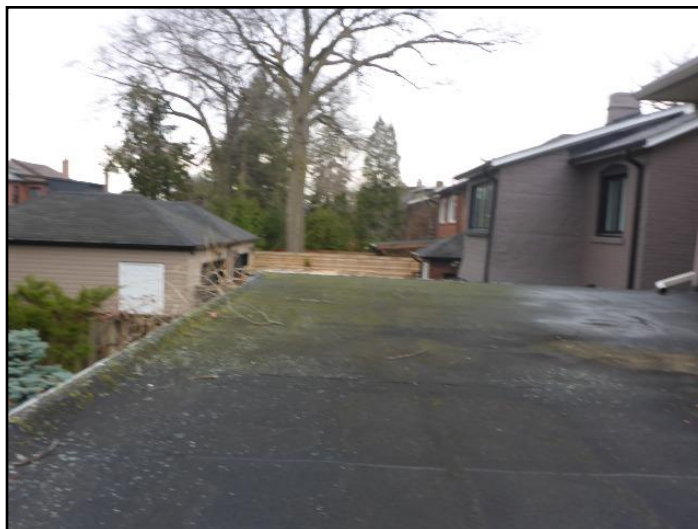
Condition: • Debris on roof

Mossy build up noted towards the rear part of the flat roof. Monitor drainage here and trim back all branches as necessary to give the roof a chance to dry out.

Moss on flat roof

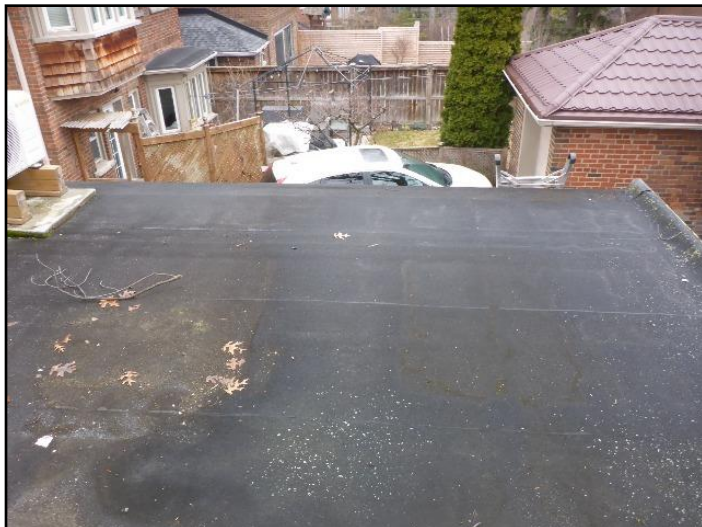
Condition: • Aging

The flat roof membrane is aging. Cracks were noted at the tar seams as well as in some parts of the roof membrane. Have a good look at this roof surface once it dries out. Some repairs may be necessary.

Suspected to be aging

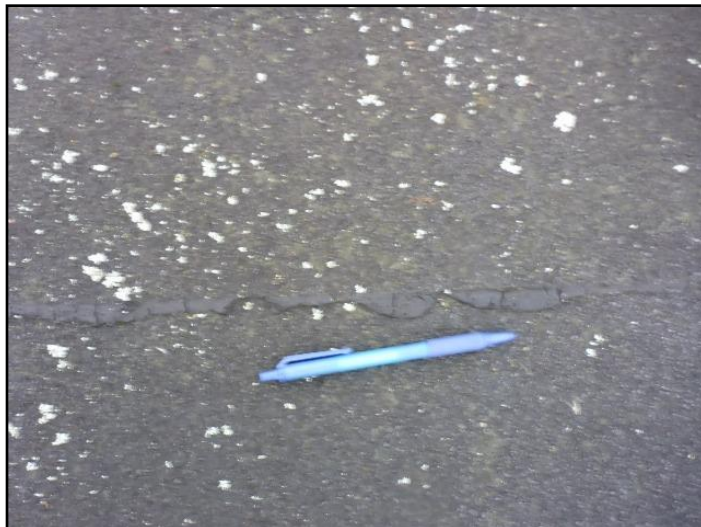
Cracks noted in tar seams

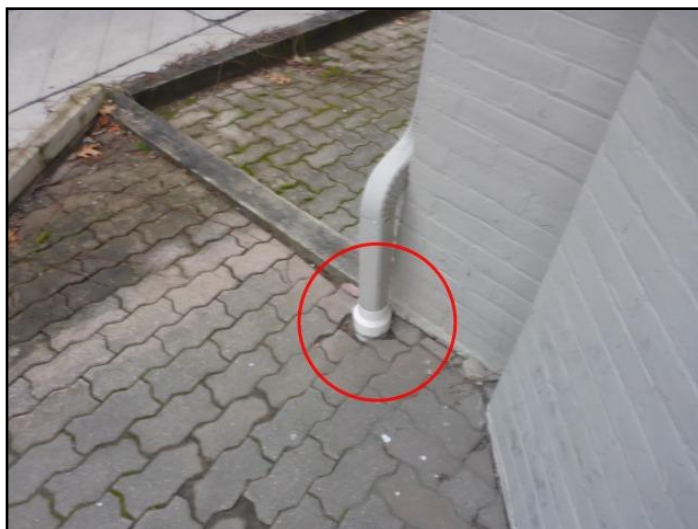
Location: Front Exterior

Condition: • Downspouts that discharge below grade may leak or be clogged, resulting in water in the basement or crawlspace.

This downspout actually discharges above grade (at front hillside)

Discharges to front yard

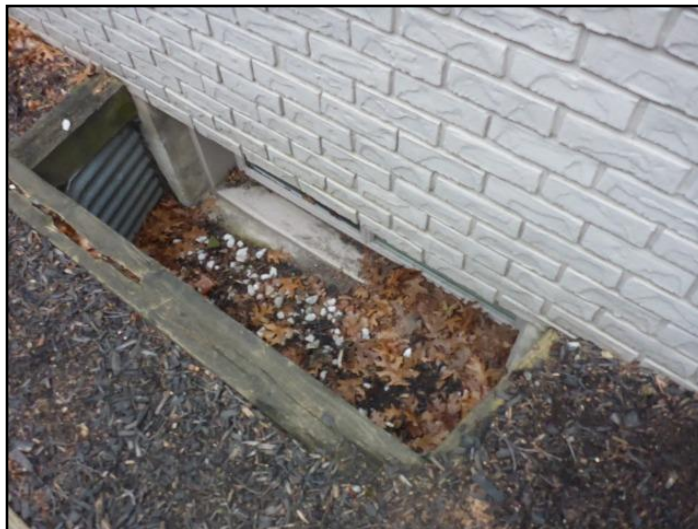
Condition: • Window close to grade in well

Window close to grade in well

Task: Improve

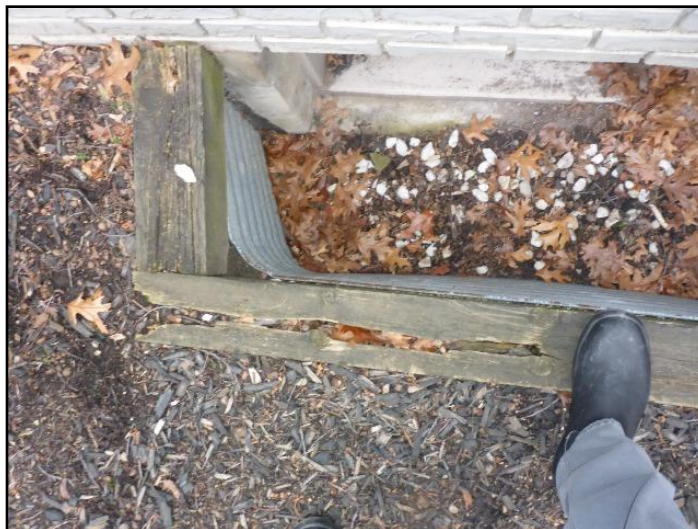
Condition: • Rotted wood

Rotted/damaged wood at the top of one window well will eventually need to be replaced.

Rotted wood

Task: Repair

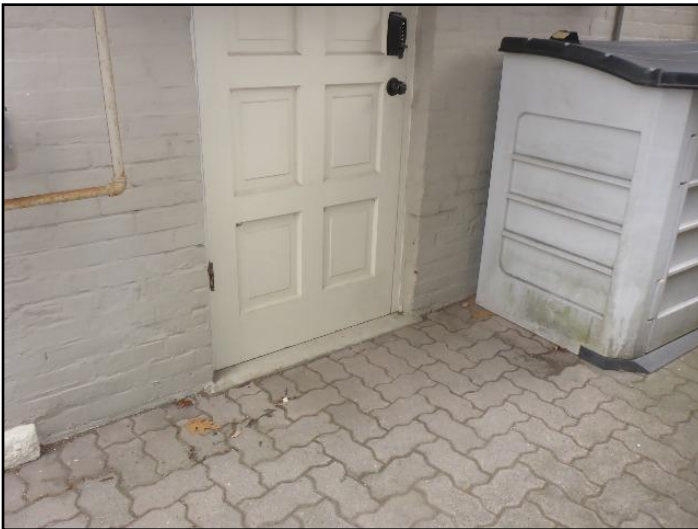
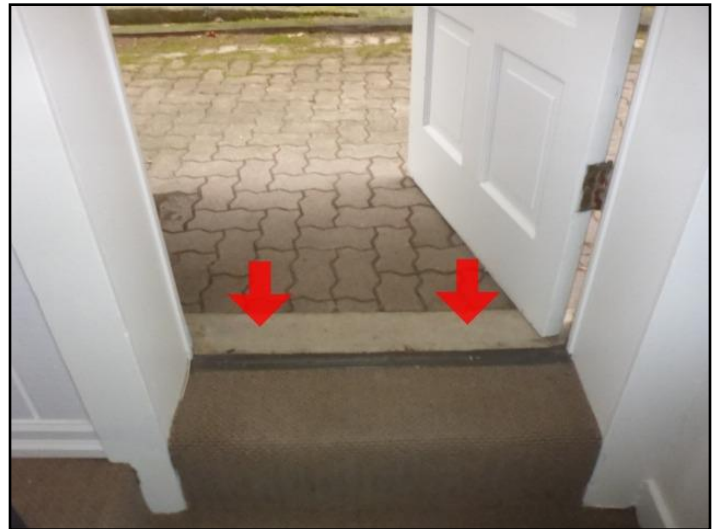
Condition: • Threshold - ineffective

Threshold - ineffective

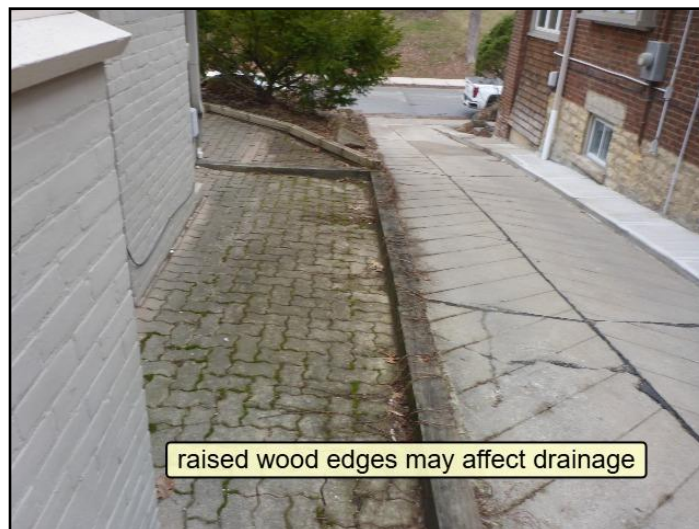
Condition: • Improper slope or drainage

Wood elements that separate sections of the walkway are taller than the bricks, which may slow drainage. This can hold water against the foundation or create ice which can be a slip hazard. Ensure that the walkways are kept clear and that water can drain properly.

Improper slope or drainage

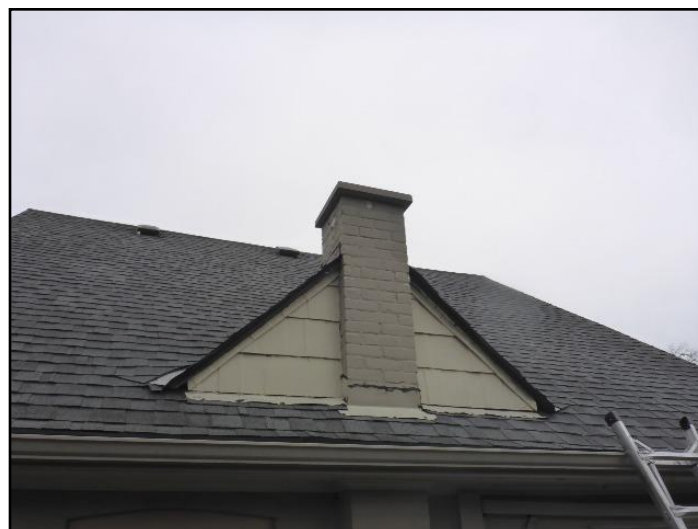
Location: Rear Roof

Condition: • Abandoned chimney

The chimney appears to be in fairly good condition (limited visibility) but is no longer in use. At a minimum, make sure that flashings remain well sealed at the base of the chimney.

Abandoned chimney

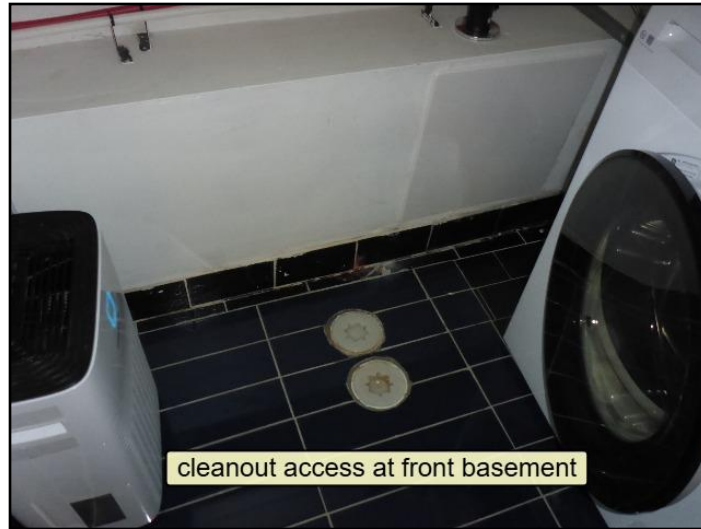
Condition: • Repairs/upgrades noted

Newer cleanouts at the front basement indicate excavation to perform drain repairs. Ask seller for details regarding any drain upgrades / repairs that have been done.

Repairs/upgrades noted

Task: Request Information

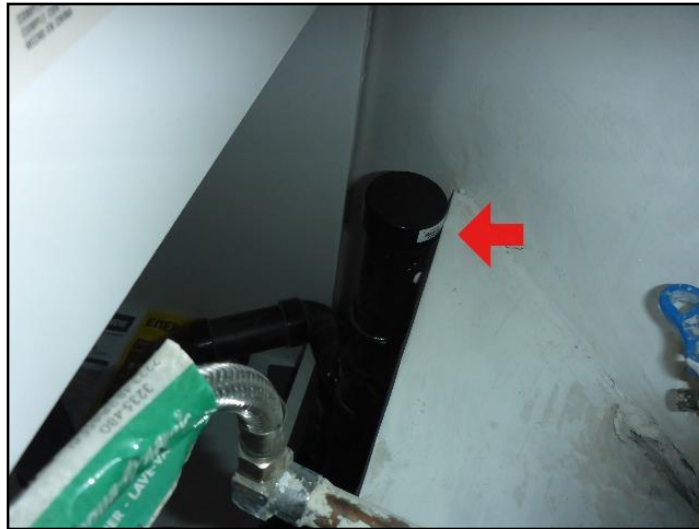
Location: Laundry Area

Condition: • Automatic air vents

Auto vent noted beside the sink at this location. A failed auto vent can allow sewer gases into the home.

Automatic air vent

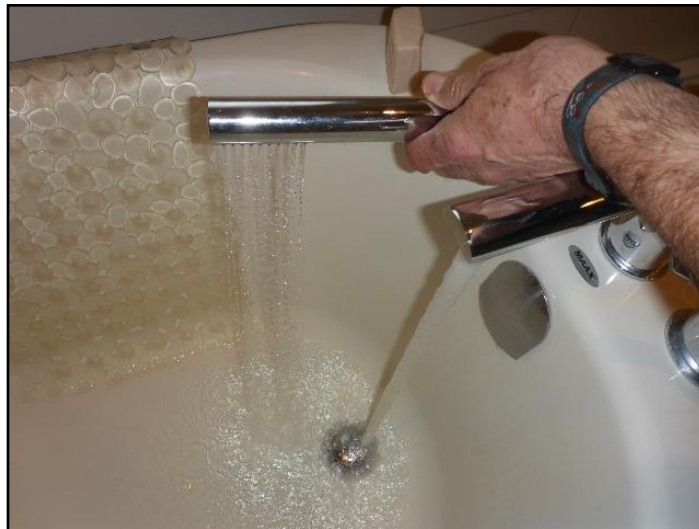
Condition: • Shower diverter inoperative or defective

Shower diverter inoperative / ineffective

Task: Correct

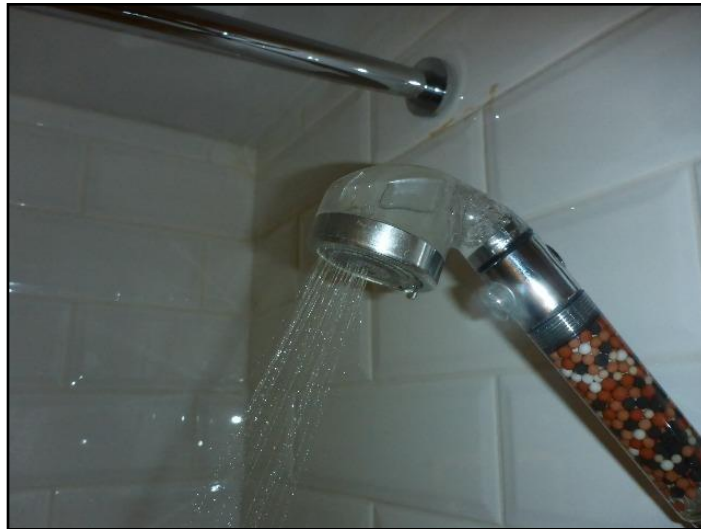
Condition: • Hand shower clogged

Hand shower clogged

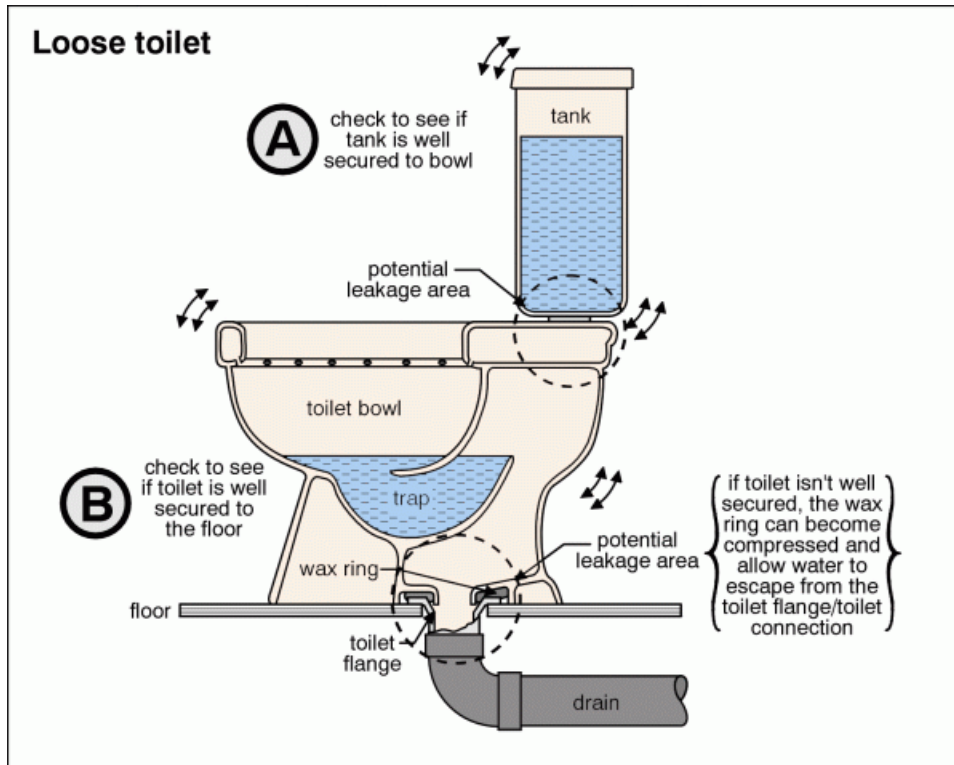
Condition: • Loose

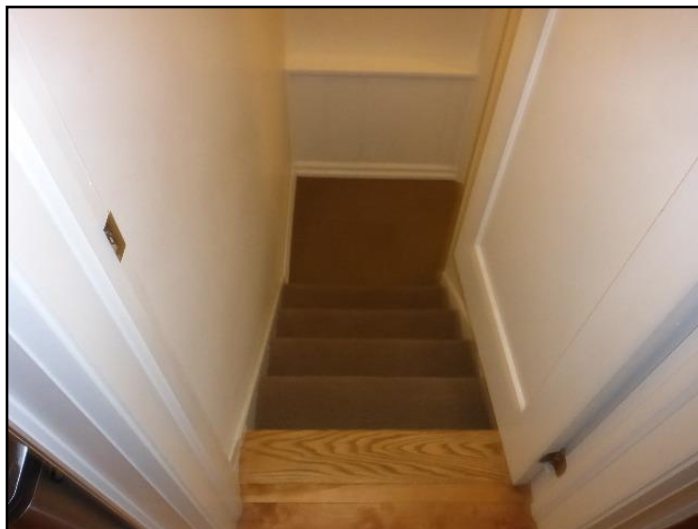
Condition: • Incomplete or not continuous railing

Incomplete or not continuous railing

Task: Improve
