# INSPECTION REPORT

For the Property at:  
**1112 DAKOTA STREET SOUTH**  
SHAKOPEE, MN 55379

Prepared for: BEN BOOKER  
Inspection Date: Wednesday, May 28, 2025  
Prepared by: Anthony Benincasa

Report No. 3280, v.6

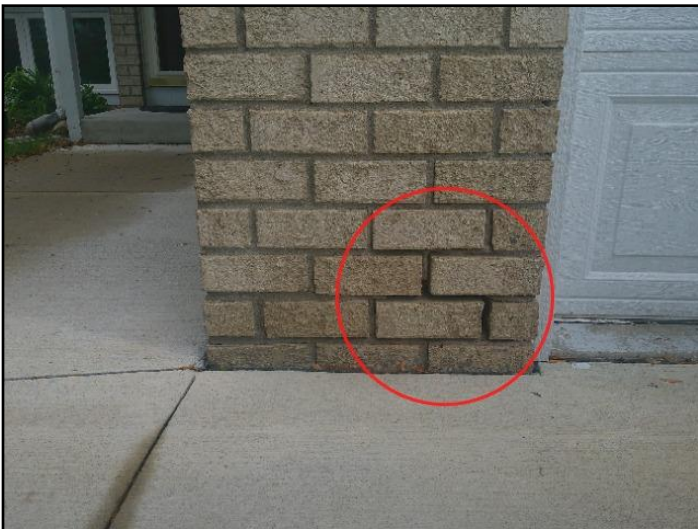
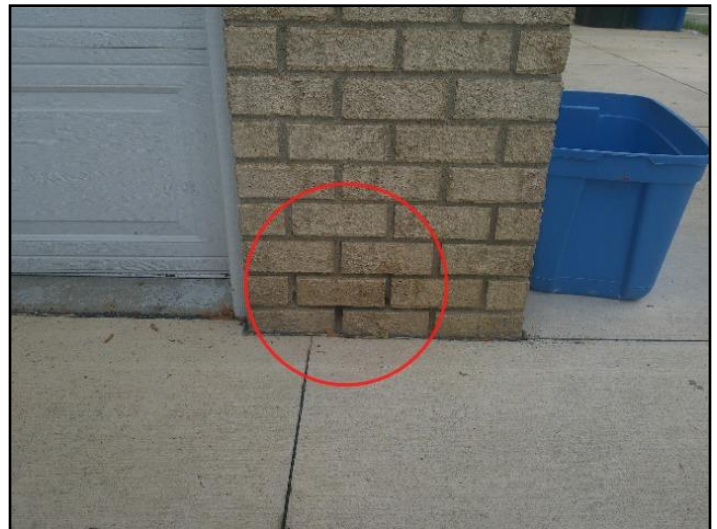
**1. Condition:** • [Mortar deterioration](#)

**Implication(s):** Chance of water entering building | Weakened structure | Chance of structural movement

**Location:** Front garage veneer

10. Mortar deterioration

11. Mortar deterioration

**Task:** Repair

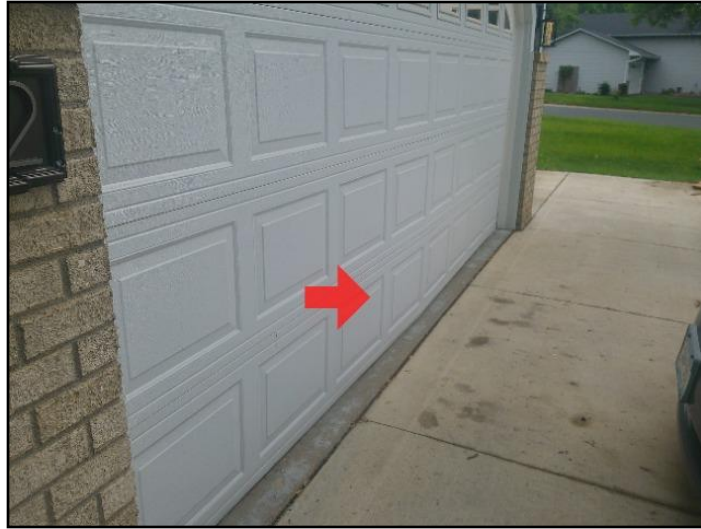
2. Condition: • Dented

Implication(s): Damage to equipment

**12.** *Dented / Bulging garage door*

Task: Repair or replace

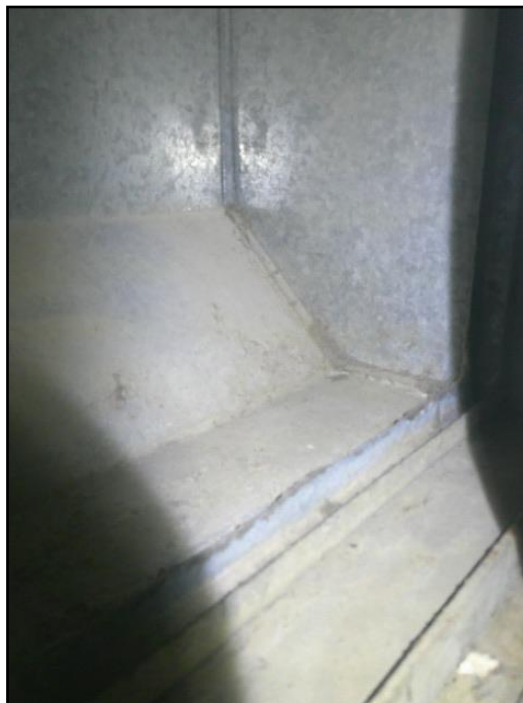
**3. Condition:** • Air duct cleaning is recommended every 3-5 years.

*25. Ductwork due for cleaning*

**Task:** Service Clean

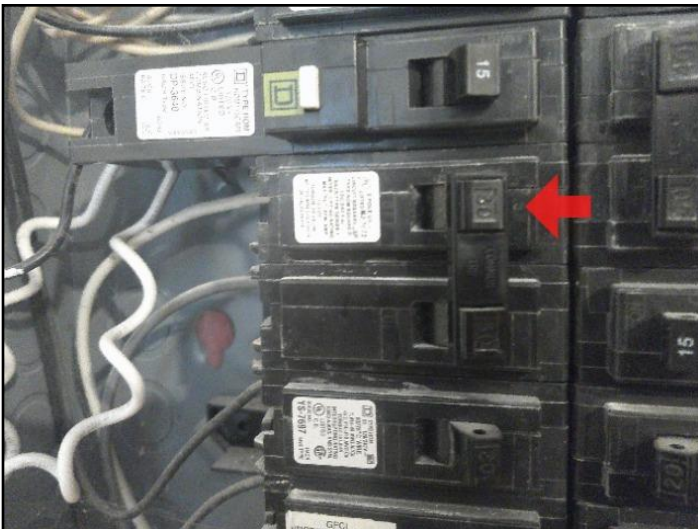
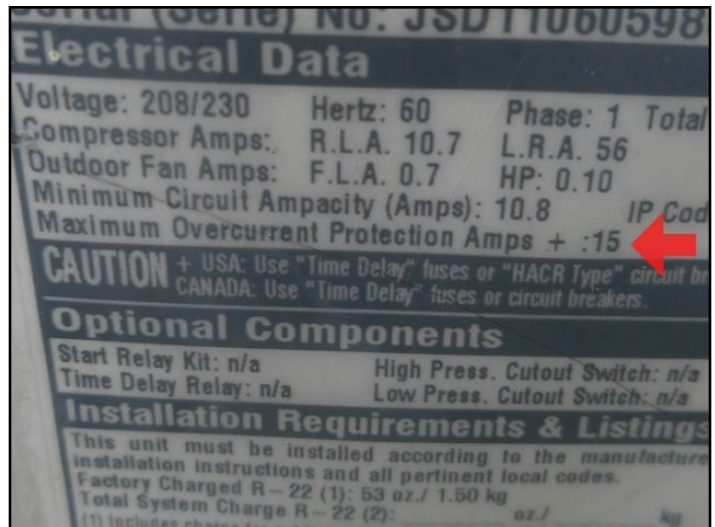
#### 5. Condition: • [Wrong fuse or breaker size](#)

AC data plate call for a 15 amp max breaker size, the panel has a 30 amp breaker installed.

**Implication(s):** Equipment overheating | Damage to equipment | System inoperative or difficult to operate

29. 30 amp AC breaker

30. Data plate calls for 15 amp max breaker

\*\*\* UPDATE \*\*\* 6/2/2025 - 30 amp breaker has been replaced with a properly sized 15 amp breaker.

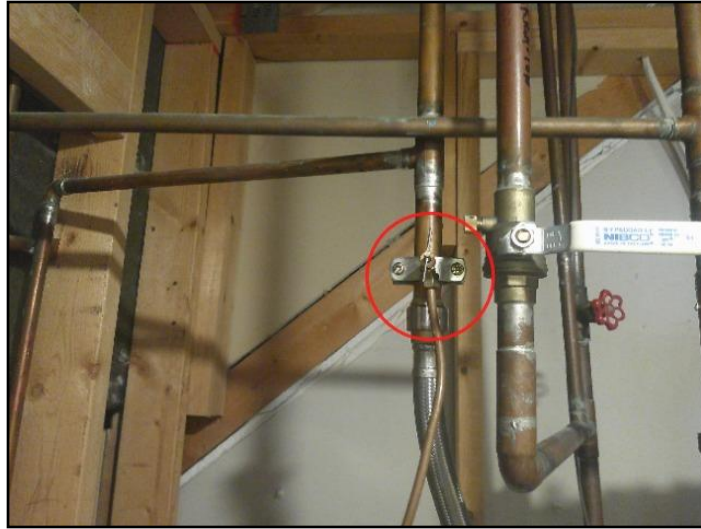
**6. Condition:** • Self tapping saddle valve used in lieu of an IRC approved water shutoff.

46. Self tapping saddle valve used in lieu of a...

**Task:** Replace

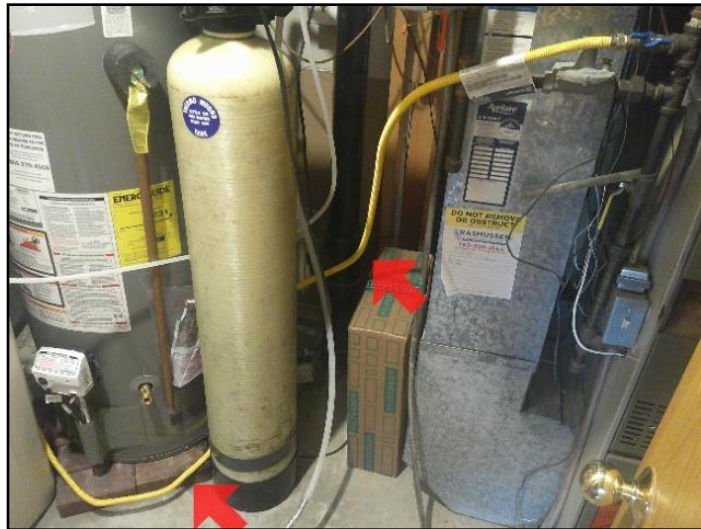
### 7. Condition: • [Inadequate support](#)

It is recommended to secure the CSST pipe and properly bond it to a nearby water pipe.

**Implication(s):** Equipment not operating properly | Fire or explosion

47. Inadequate support

\* \*\* UPDATE \*\* \* 5/31/2025 - The flexible gas line has been secured and bonded to a nearby copper water pipe.

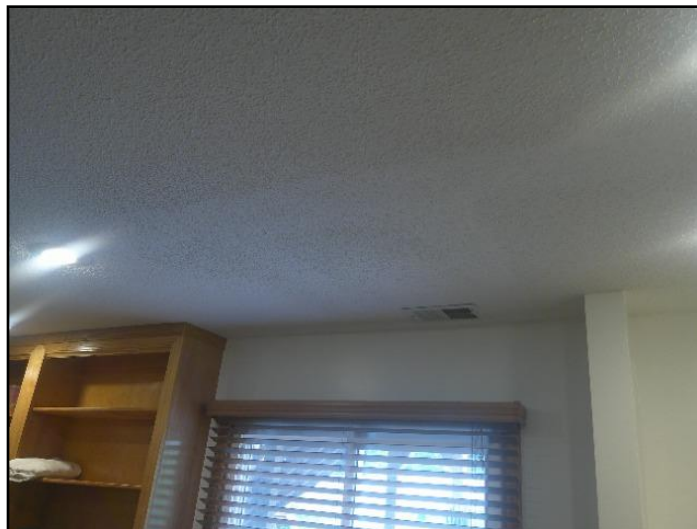
**8. Condition:** • Patched

**Implication(s):** Chance of damage to contents, finishes and/or structure

61. Patched ceiling below kitchen sink

**Task:** Request disclosure

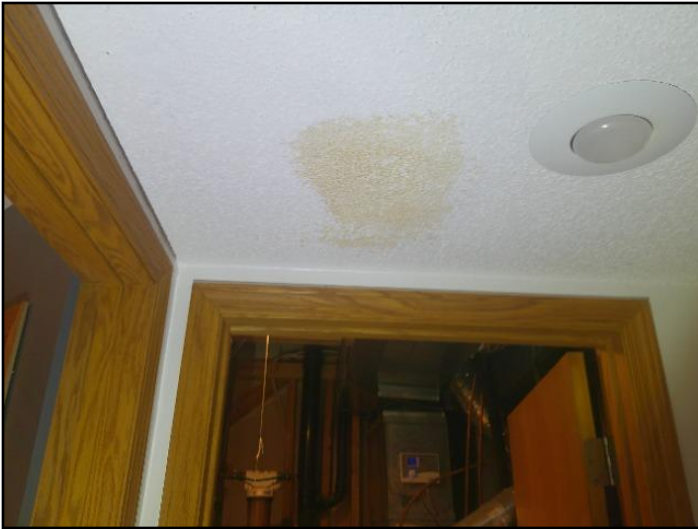
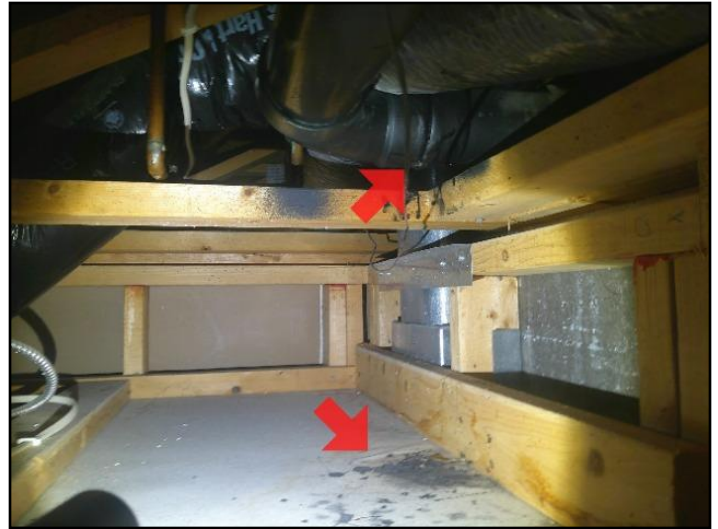
**9. Condition:** • Water stains

The affected area was tested for moisture and determined no recent moisture.

**Implication(s):** Chance of water damage to structure, finishes and contents

62. Water stains on ceiling

63. Previous leak from toilet drain

**Task:** Monitor

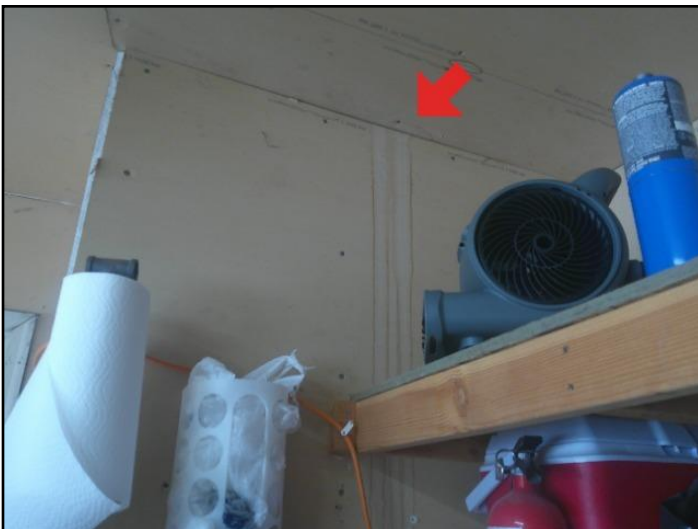
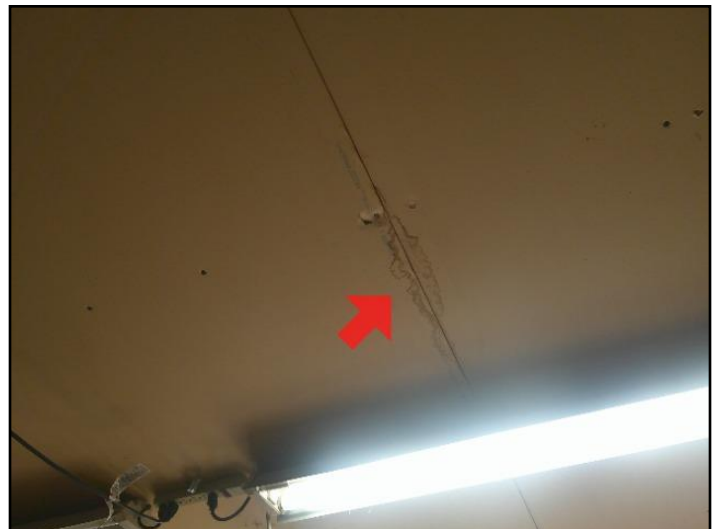
**10. Condition:** • Water stains

Water stains on the garage ceiling indicates previous leaks from valley / sidewall flashings. New roof has been installed. The affected area was tested for moisture and determined NO recent moisture.

**Implication(s):** Chance of water damage to structure, finishes and contents

64. Water stains

65. Water stains

**Task:** Monitor

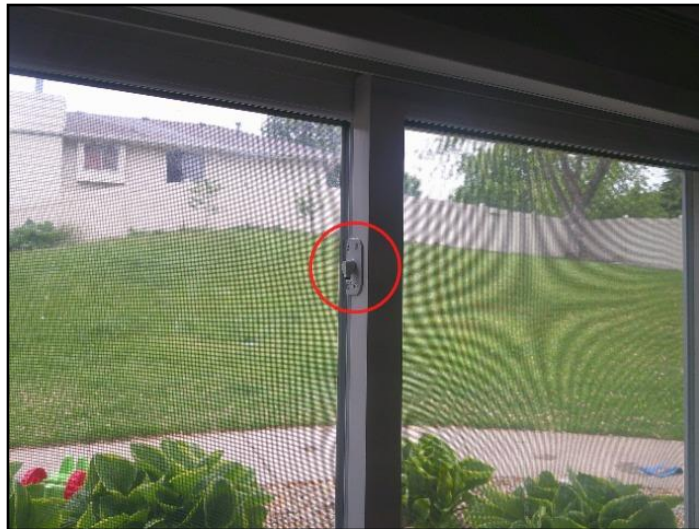
**11. Condition:** • [Broken](#)

**66.** *Broken lock lever*

**Task:** Repair
