YOUR INSPECTION REPORT

266 Delaware Avenue
Toronto, ON M6H 2T6

Tuesday, January 27, 2026

RE: Report No. 8994, v.4
266 Delaware Avenue
Toronto, ON
M6H 2T6

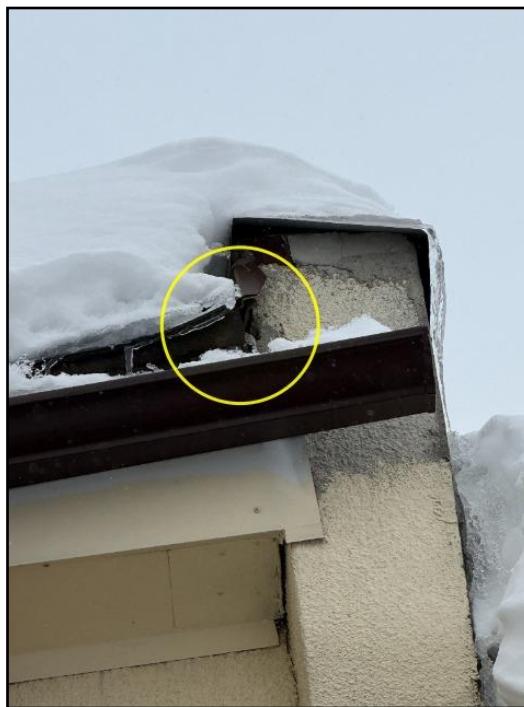
Condition: • [Open at seams or ends](#)

1. Open at seams or ends

Task: Improve

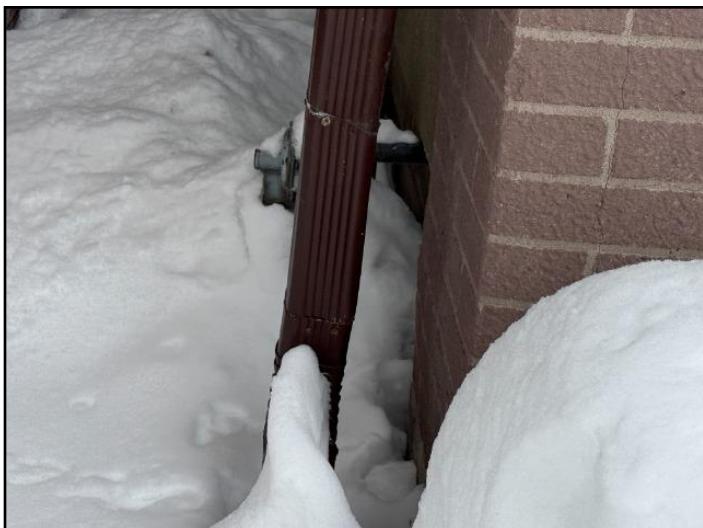
Condition: • [Not well secured](#)

2. Not well secured

Task: Improve

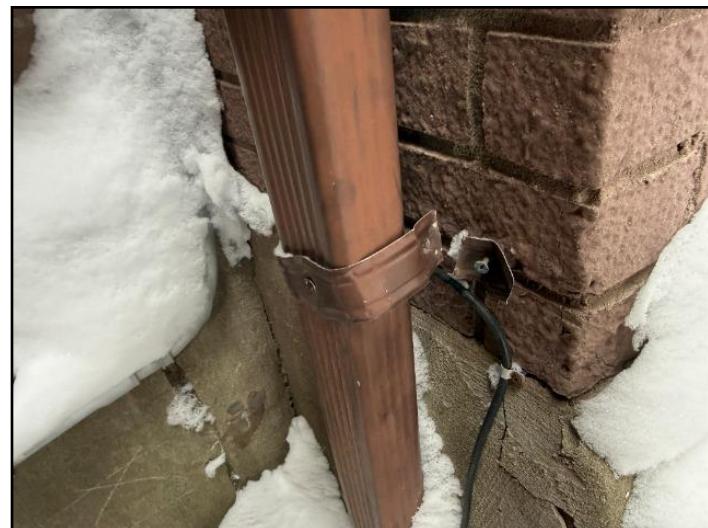
3. Not well secured

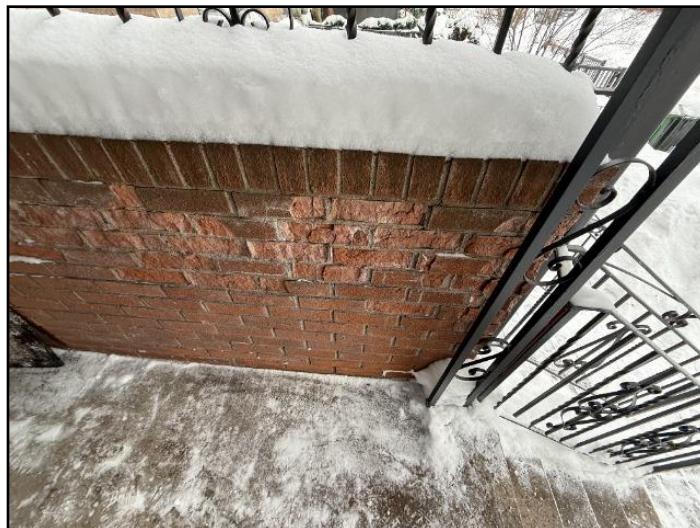
4. one example

Condition: • Masonry and/or mortar deterioration

Tuckpoint / Repoint mortar and patch/repair spalled masonry. This is typical maintenance for a home of this age.

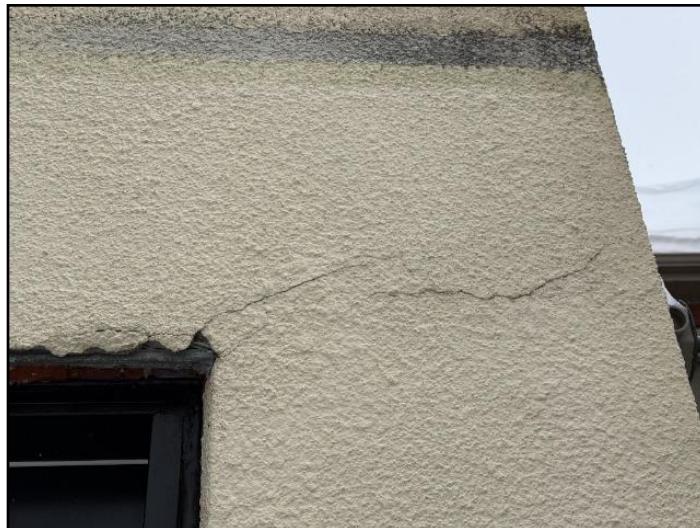
Condition: • [Minor cracks](#)

5. Minor cracks example

Task: Patch

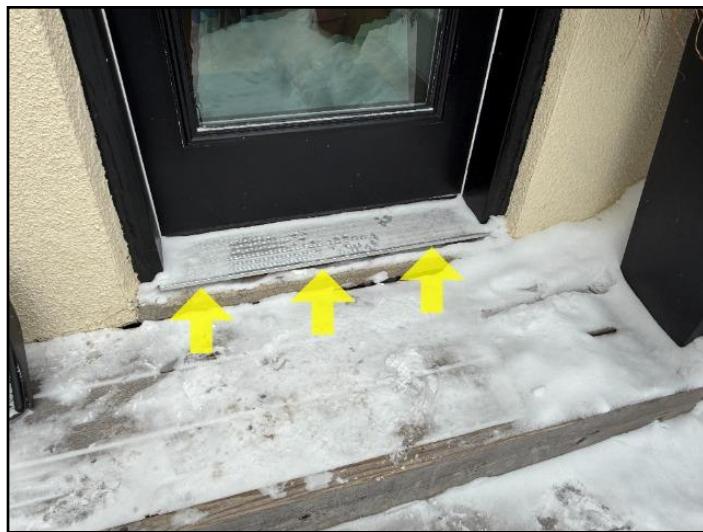
Condition: • [Caulking missing, deteriorated or loose](#)

6. Caulking missing, deteriorated or loose

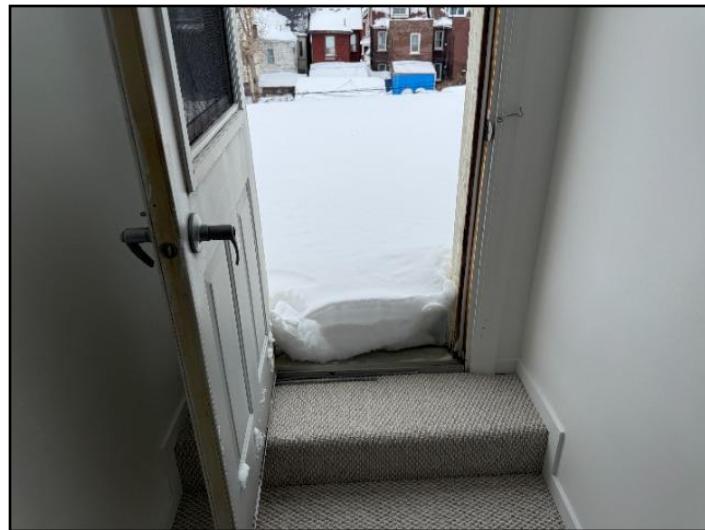
A door opens directly onto a flat roof with no guardrails or protective barriers. To reduce the fall hazard, either:

Implication(s): Fall hazard

7. Missing

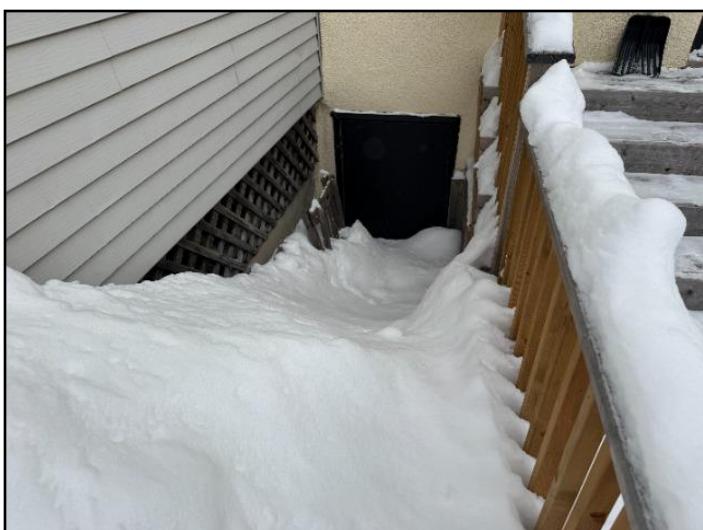
8. Rear walkout

Condition: • Basement walk-out areas snow covered at time of inspection.

Implication(s): Conditions related to drainage, moisture entry, material deterioration, or safety cannot be confirmed when areas are snow covered.

Task: Re-evaluate once snow has cleared

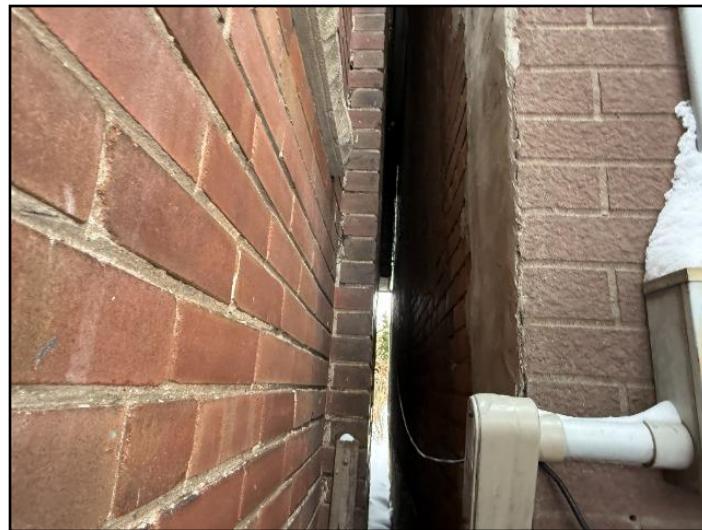
10. Space between buildings

- Space between buildings

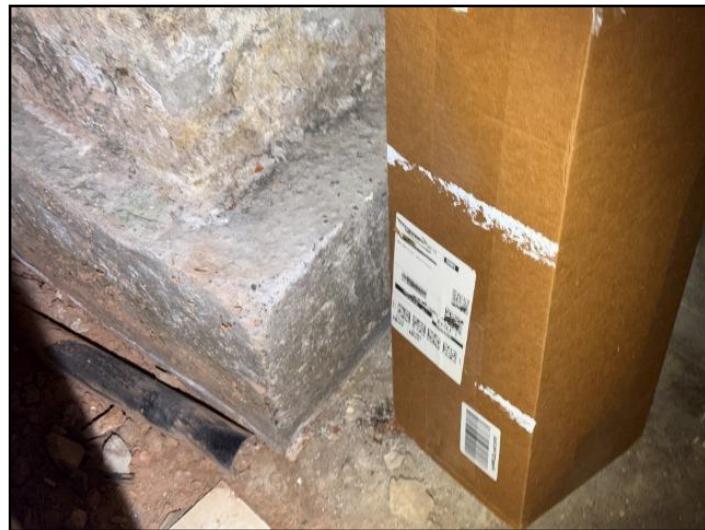
Condition: • [Basement lowered](#)

11. Basement lowered

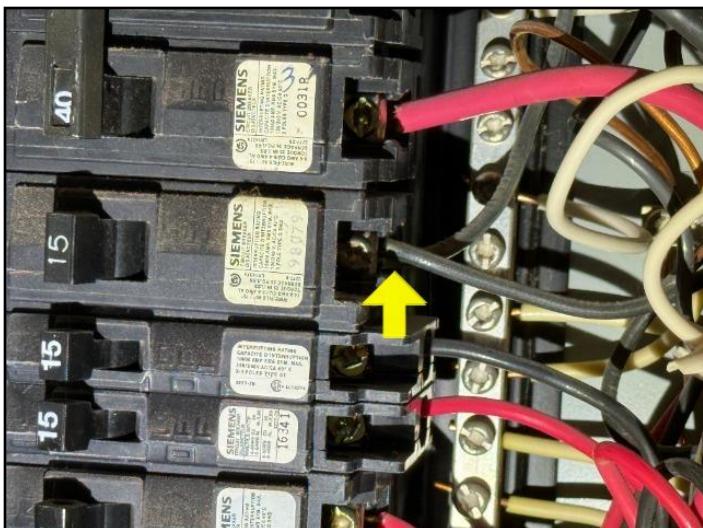
- Opening at panel - Distribution panel - Provide knockout seal
- White wire connected to breaker not identified as hot wire - Electrical panel - Correct with proper marking
- Handle tie missing at multi-wire branch circuit- Electrical panel - Have electrician verify and provide handle tie if necessary.
- Double tap (lugging) wiring at breaker - Electrical panel - Correct

13. Double taps

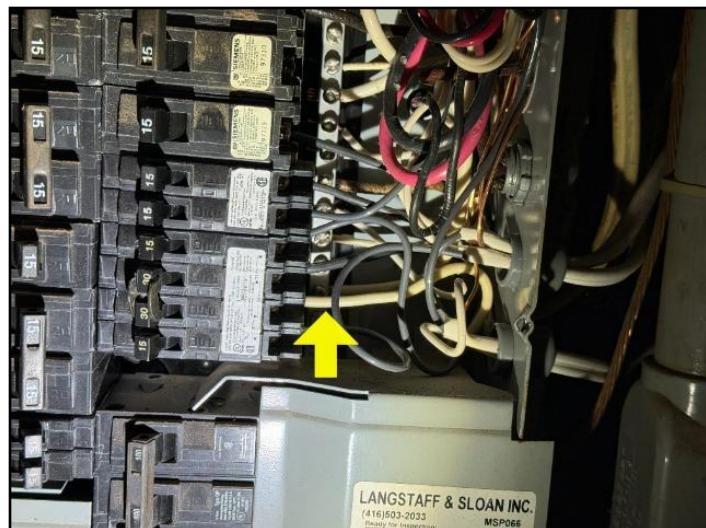
14. White wires connected to breakers not...

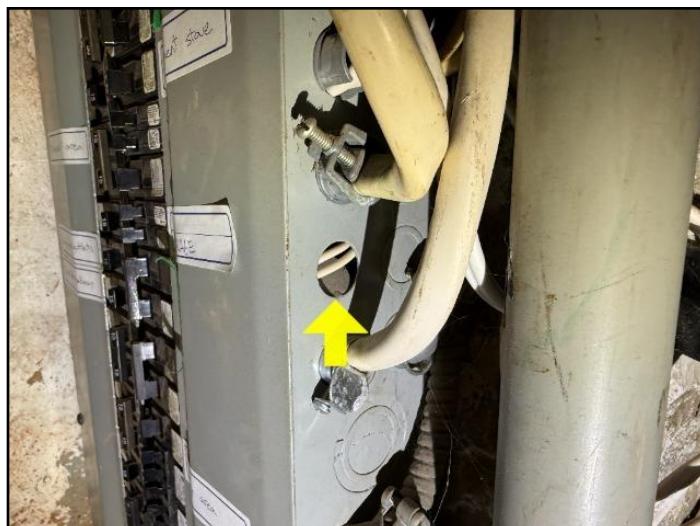
15. Opening in panel

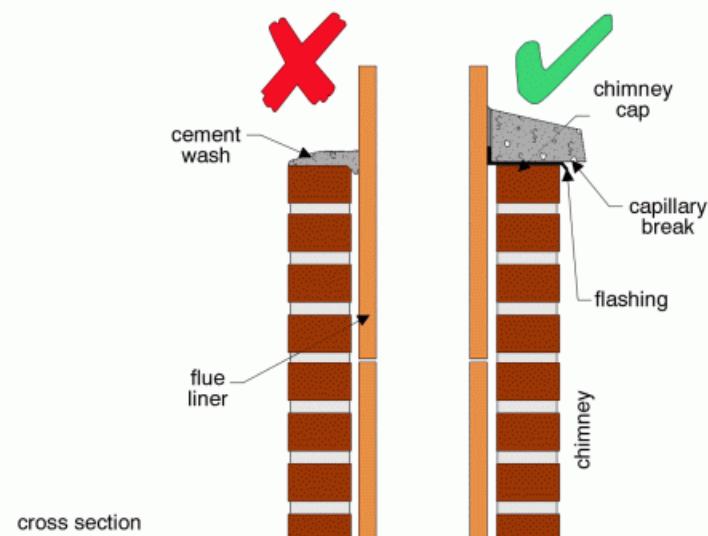
Condition: • [No drip edge on cap \(crown\)](#)

Cost: \$800 - and up

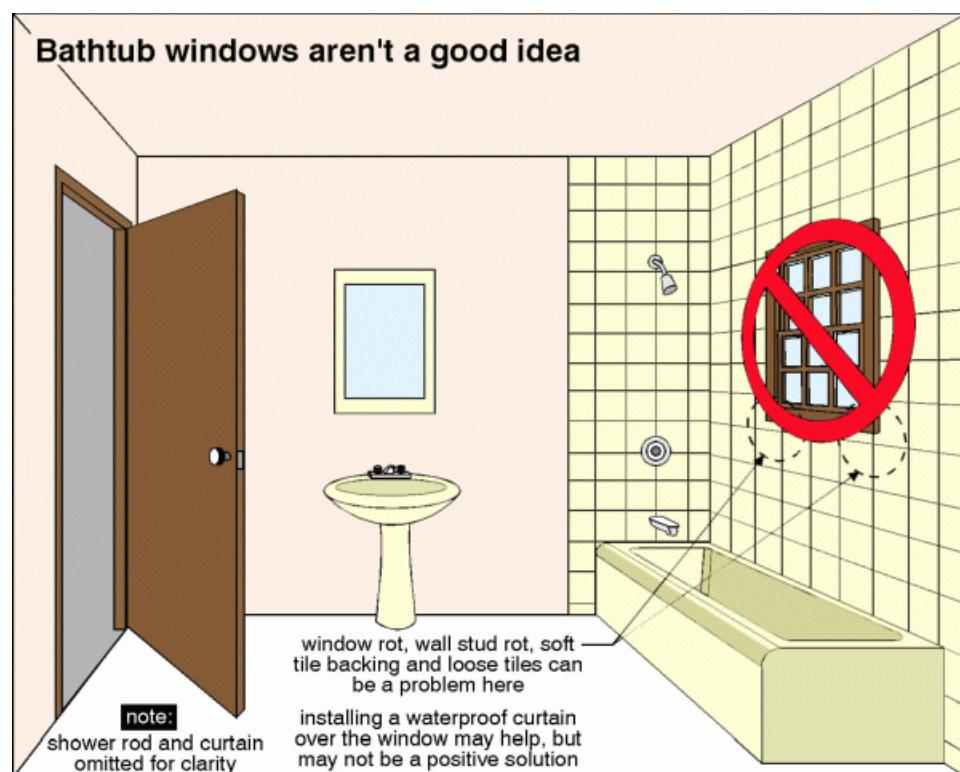
Condition: • Unprotected window

Windows in bathtub area were common when this house was originally built. These windows are vulnerable to water damage. Shower Curtain can provide temporary protection. Ensure grout and caulking are maintained regularly

Task: Protect

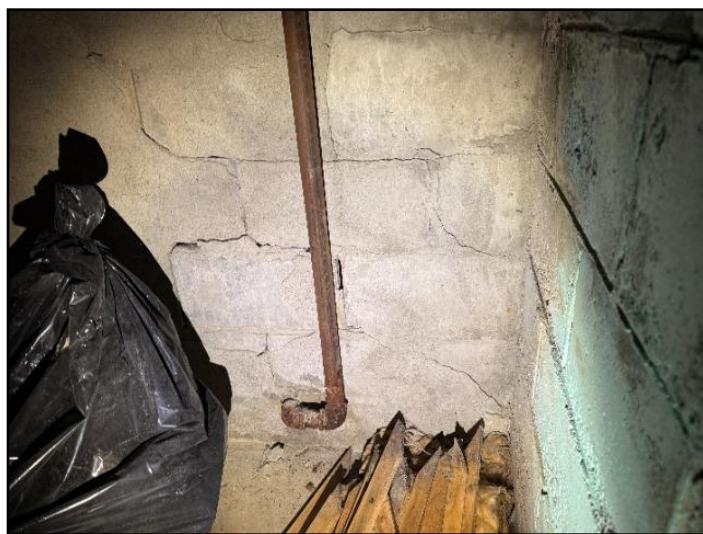
17. one example

Condition: • [Damage](#)

Cracks at parging and concrete block. Some minor displacement noted. Patch all gaps and repair parging. Monitor for movement/activity.

Task: Repair / Patch

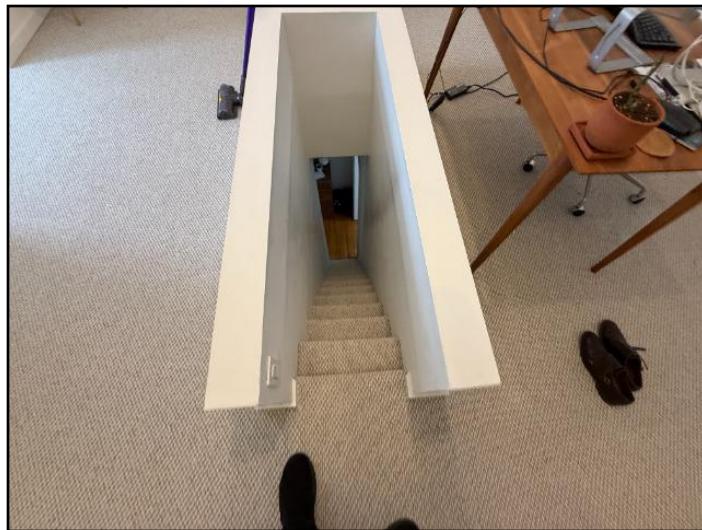
Treads are very narrow. Additionally, handrail is missing.

Implication(s): Trip or fall hazard

18. Width too small

Task: Take precaution when using staircase / Provide handrail

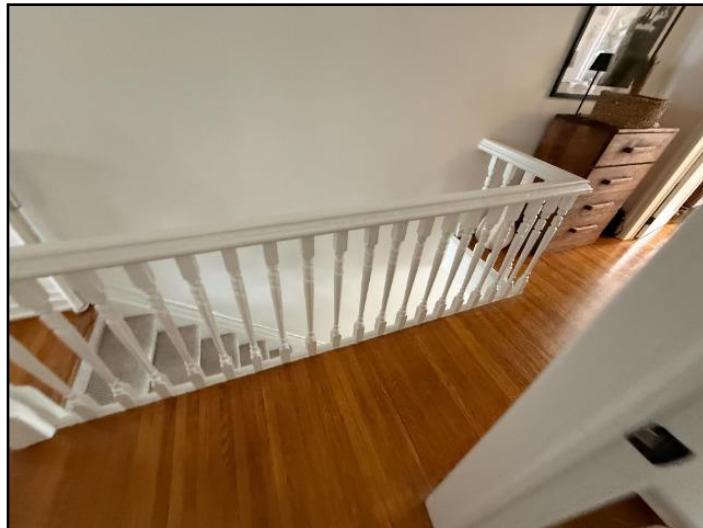
**19. Too low****Condition:** • Missing**Implication(s):** Fall hazard**Location:** Third Floor

Task: Provide guardrails around entire opening
