Your Inspection Report

1152 Concession Road 1
Brechin, ON L0K 1B0

Monday, August 18, 2025

RE: Report No. 3117
1152 Concession Road 1
Brechin, ON
L0K 1B0

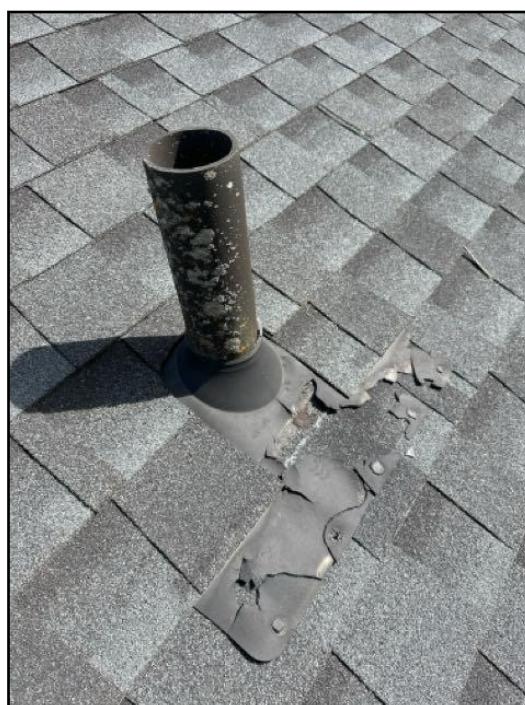
5. Damage

Waste vent pipe flashing is damaged, recommend replacing the waste vent pipe flashing to ensure no leaks. No leaks noted during inspection. Recommend replacing prior to the winter season.

Implication(s): Chance of water damage to structure, finishes and contents

Task: Replace

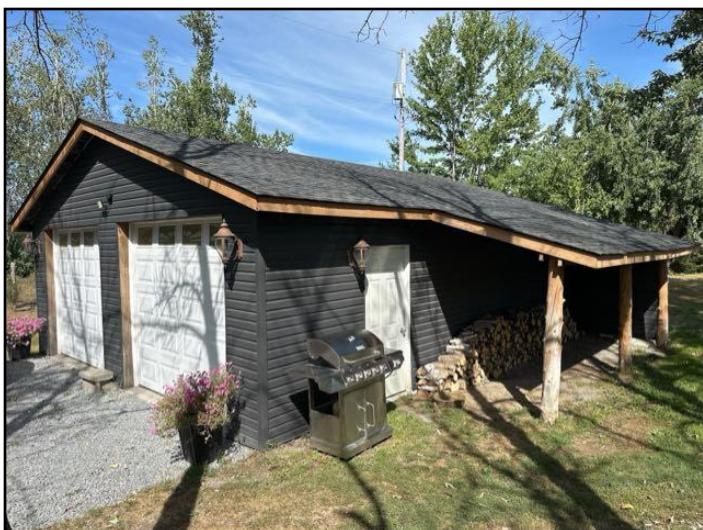
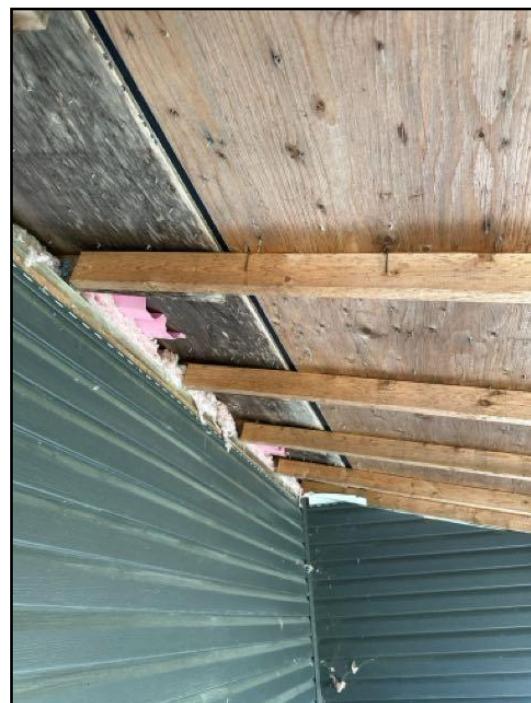
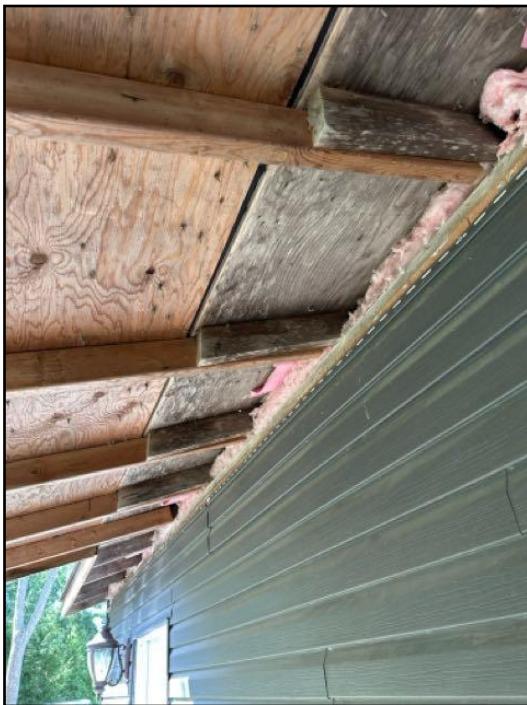
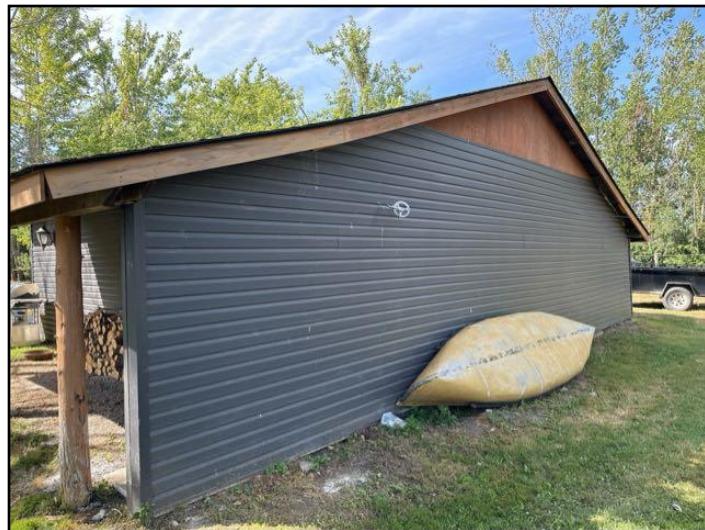
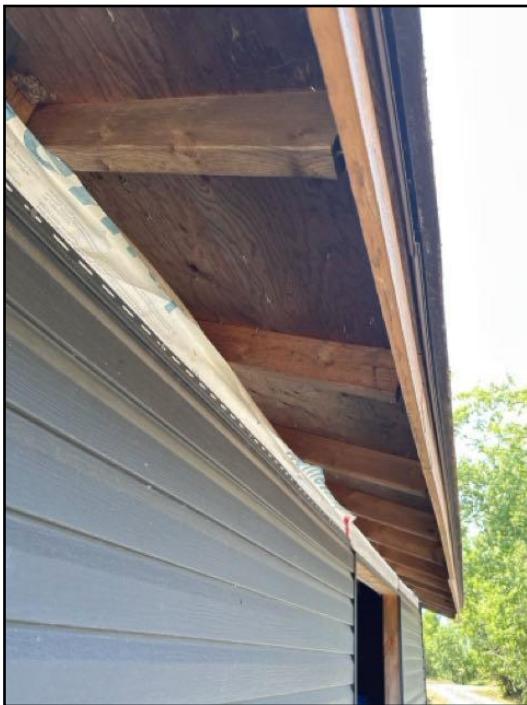
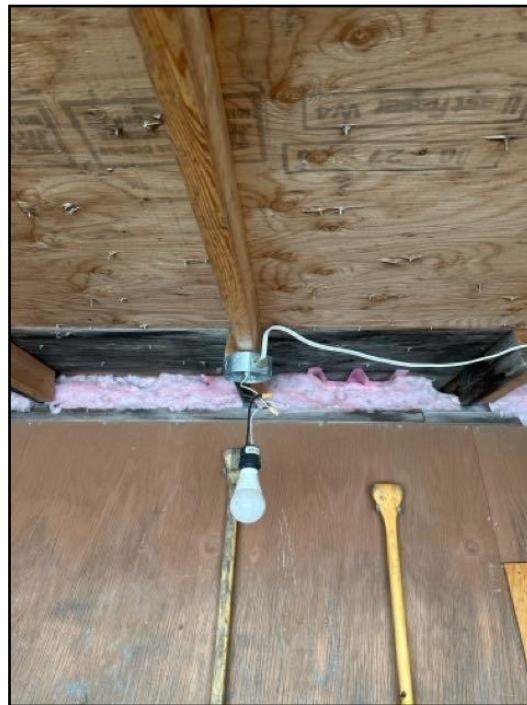
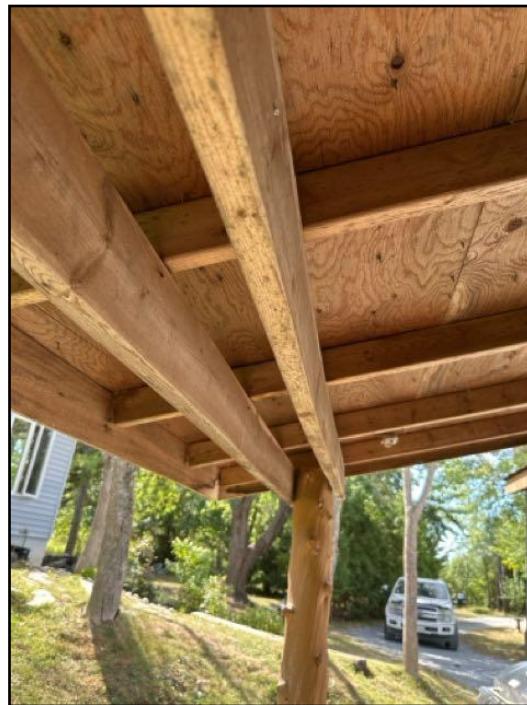
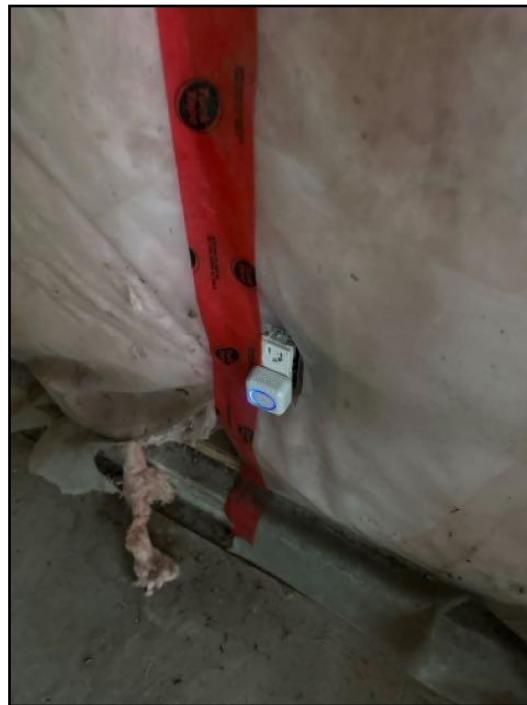
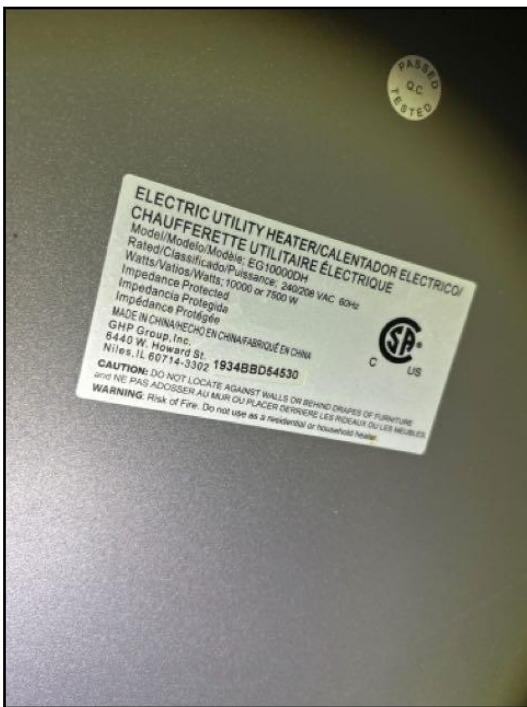
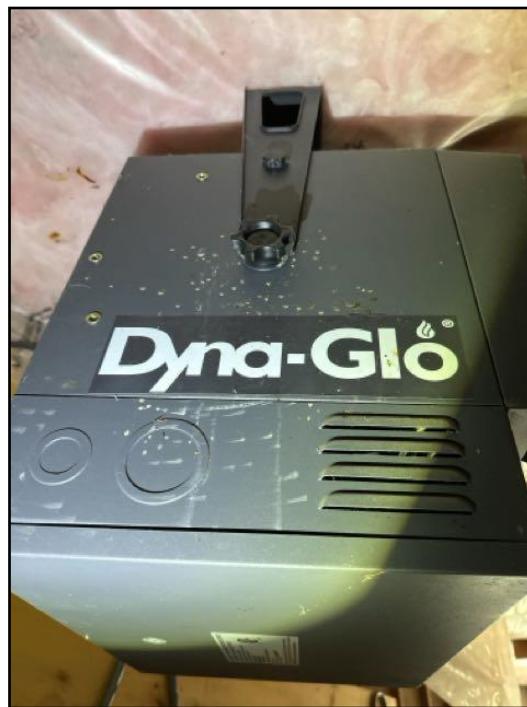
1. Both side roof additions require improvements for adequate support. Rafters should be resting on the garage wall and left side of the garage is missing a top plate for rafters to sit on.
2. Cracked concrete floor is cosmetic and not a structural concern, patch when necessary.
3. Missing vinyl siding on the back and left side. Consider installing a metal soffit.
4. Outlet missing a cover plate.

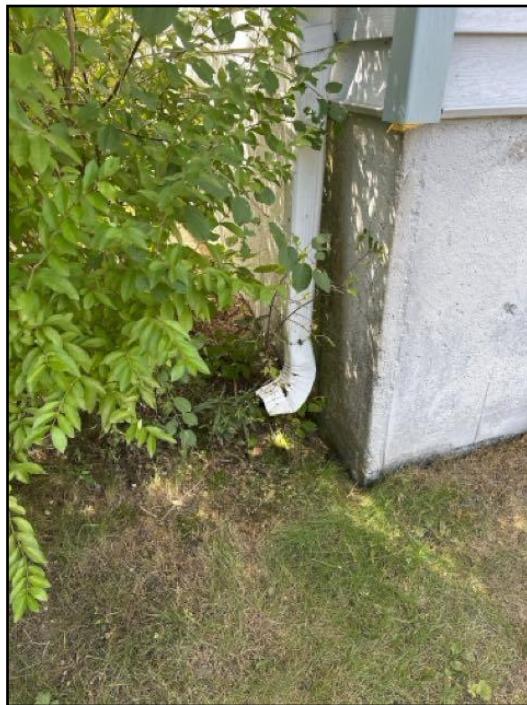
30. Discharge too close to building

Downspout ends too close to building, recommend adding an extension to ensure water drains far enough from foundation wall.

Implication(s): Chance of water damage to structure, finishes and contents

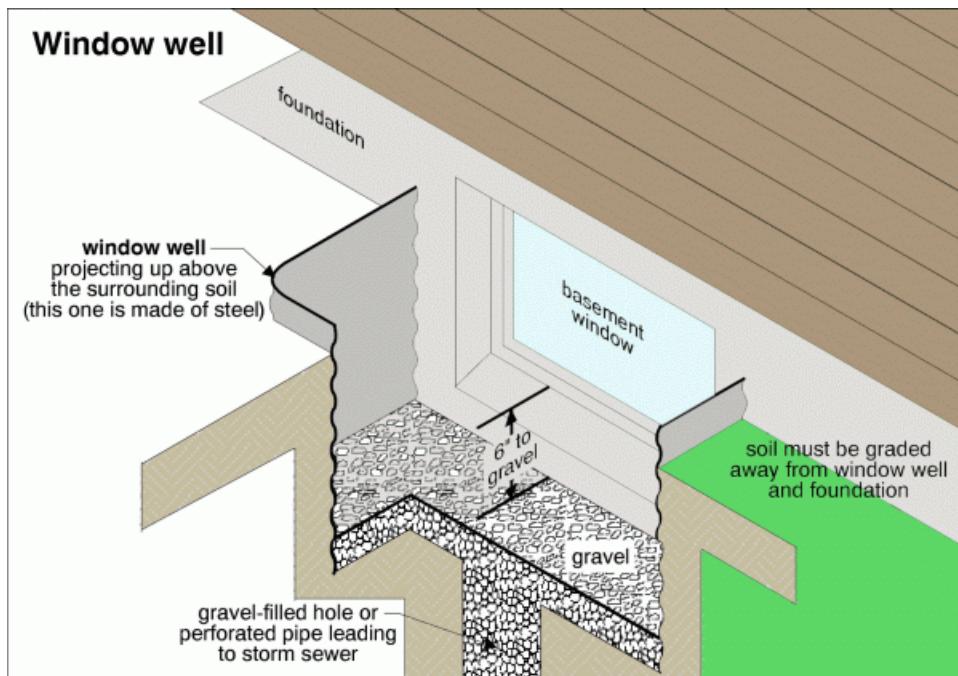
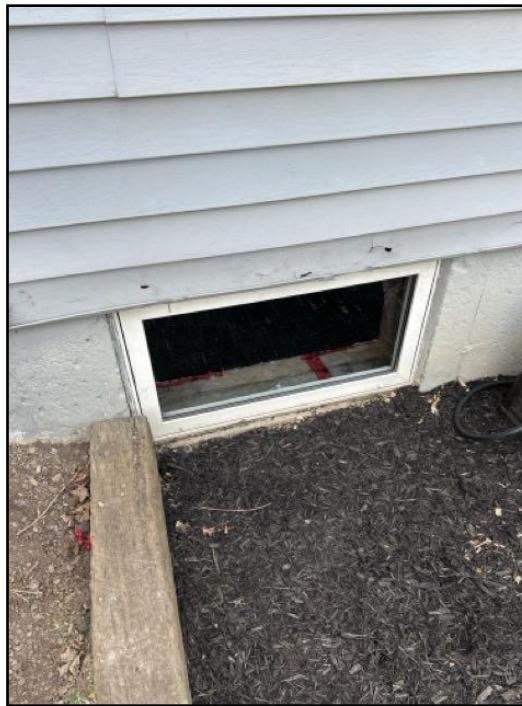
31. Missing

Missing window well on basement window, recommend providing to ensure melting snow does not enter basement. At the very least install a window well cover to prevent snow from building up near window. Left side of house.

Implication(s): Chance of water damage to structure, finishes and contents | Material deterioration

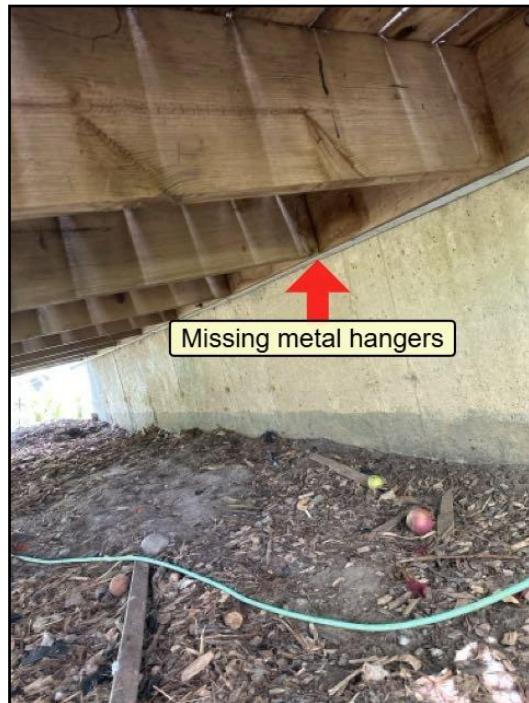
33.

4. Condition: • Front porch not built to todays standards, recommend improving by adding a beam across all floor joist and adding metal hangers on each floor joist attached to the house.

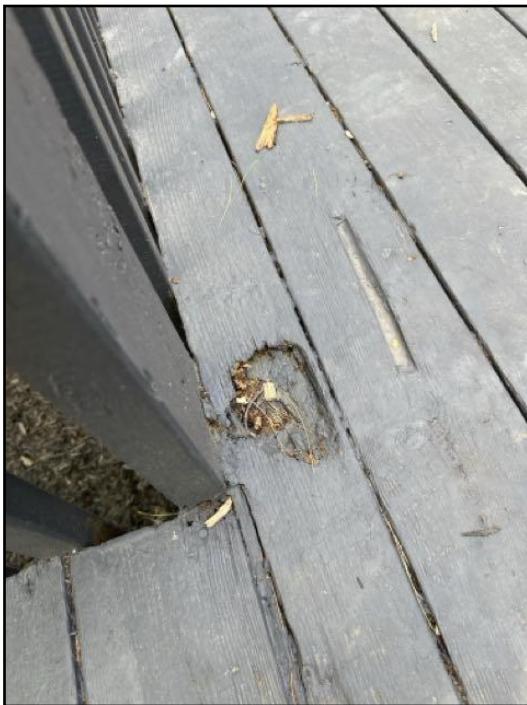
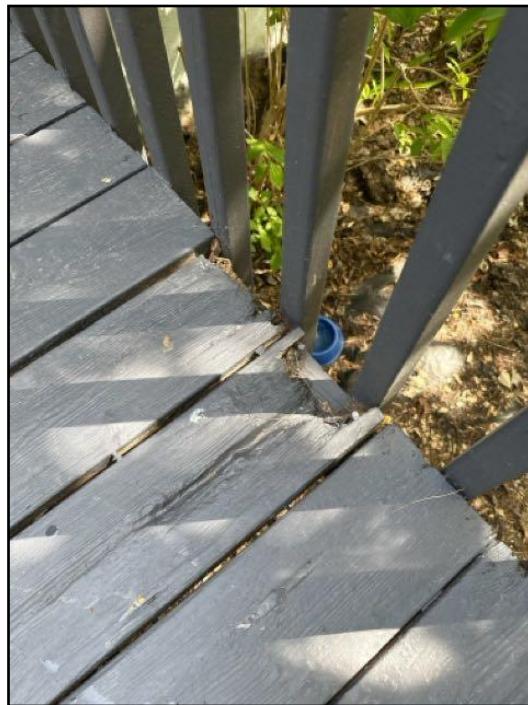
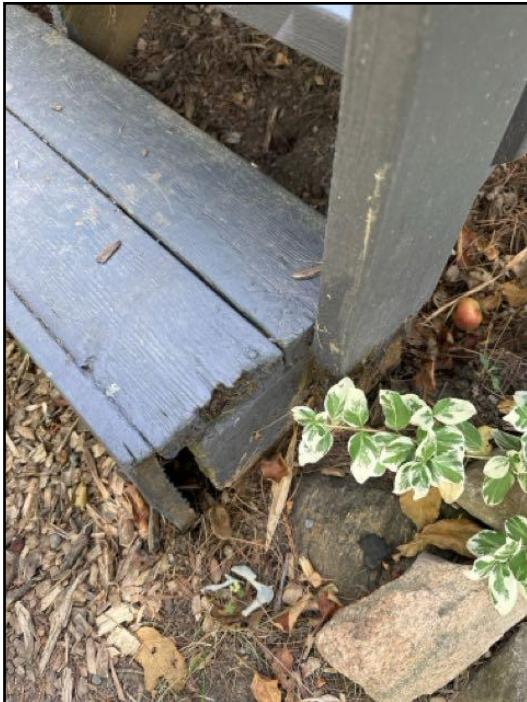
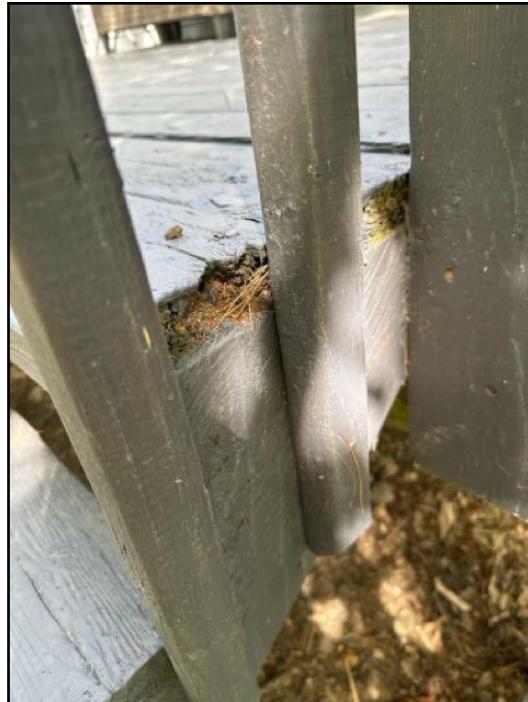
Front porch floor boards are starting to rot, recommend monitoring and replacing when necessary.

Implication(s): Weakened structure | Chance of movement | Material deterioration

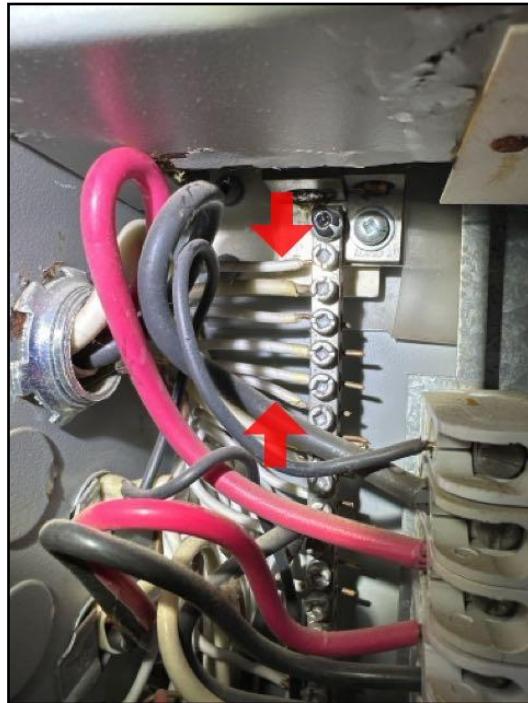
43. Stab Lok - Stab Lok breakers have had a...

7. Condition: • Stab Lok - Stab Lok breakers have had a history of not tripping during over loaded circuits which caused wires to over heat and fires. No evidence of any wires over heating in this panel, consider having a licensed electrician evaluate these breakers in the future to determine if the panel will need replacing.

5 circuits have evidence of over heating, recommend replacing the electrical panel.

Task: Replace

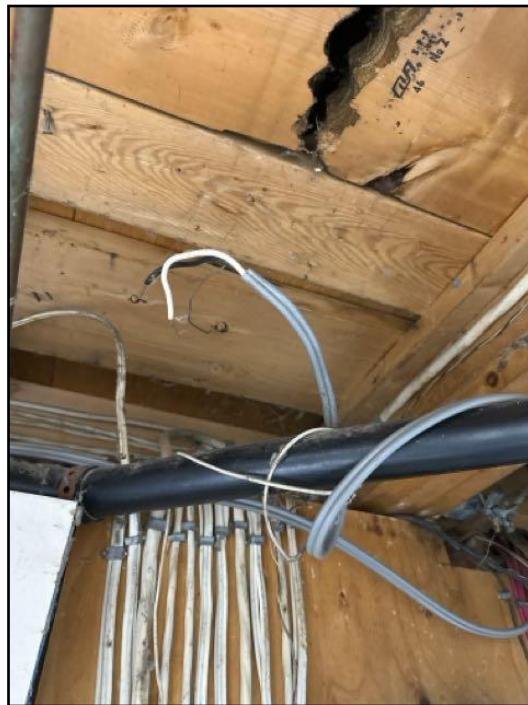
44. Abandoned wire

8. Condition: • Abandoned wire

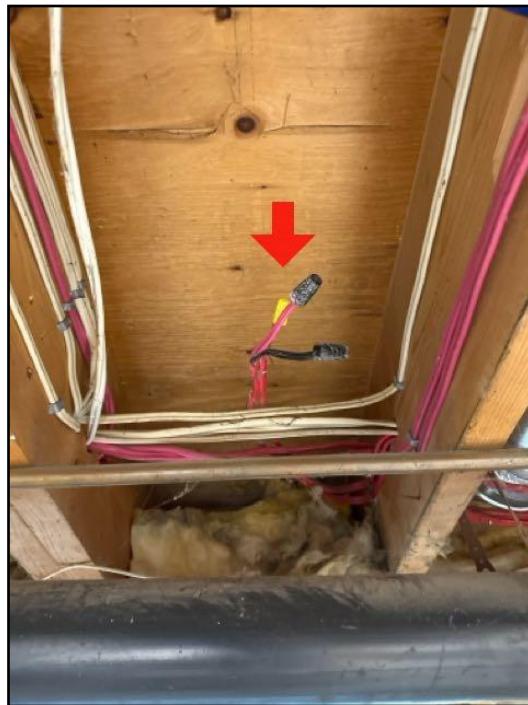
45.

9. Condition: • All wire connections must be protected in a metal junction box with a cover for safety.

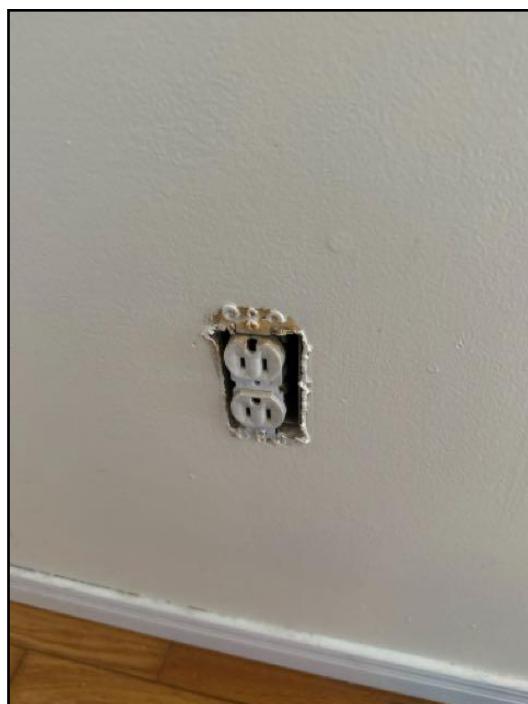
46. *Missing*

Missing cover plate, recommend providing, Bedroom

Implication(s): Electric shock

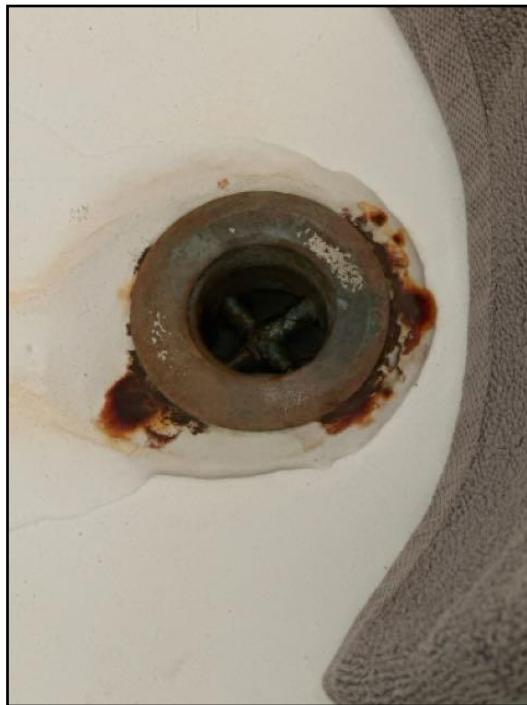
138. Rust

Bath tub drain is starting to rust, recommend monitoring and replacing when necessary.

Implication(s): Chance of water damage to structure, finishes and contents
