YOUR INSPECTION REPORT

FOR THE PROPERTY AT:
32 Ardagh Street
Toronto, ON M6S 1Y3

INSPECTION DATE:
Thursday, February 12, 2026

RE: Report No. 9046, v.2
32 Ardagh Street
Toronto, ON
M6S 1Y3

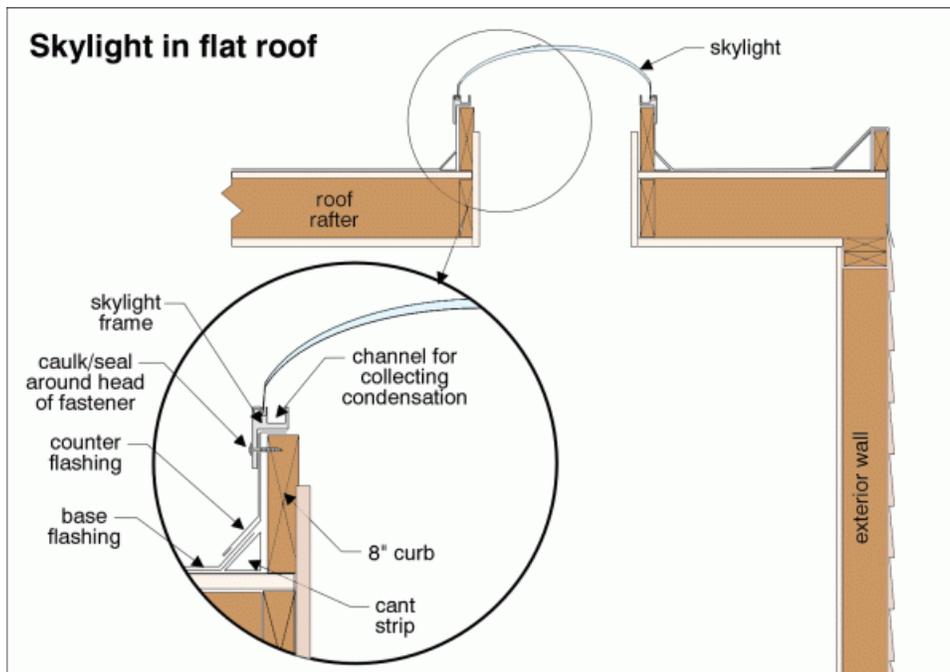
Condition: • Skylights are vulnerable areas

Task: Monitor for leakage

Time: Ongoing - especially after heavy rain

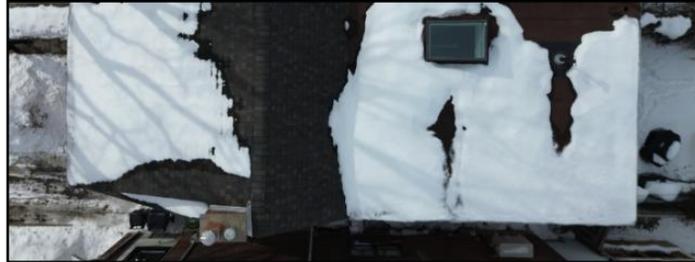
3. View of roofs

- Portions of the roof covering were snow/ice covered at the time of inspection, limiting full evaluation. Visible areas were inspected from the ground and or by drone where accessible.

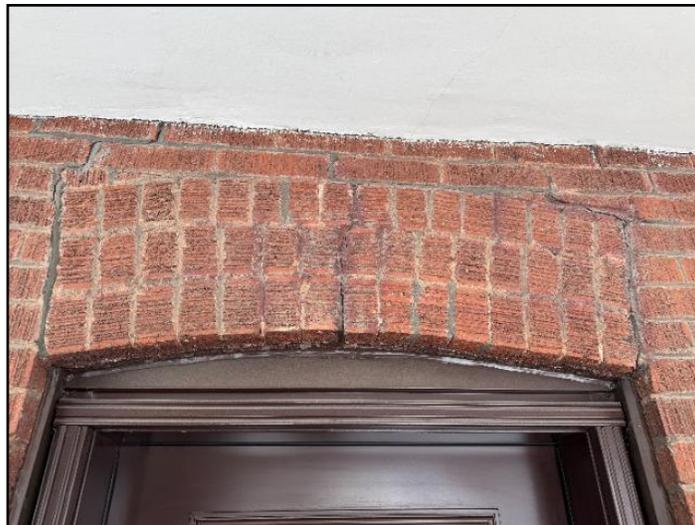
Condition: • FOR ALL HOMES - Most masonry walls have small cracks due to shrinkage or minor settlement. These will not be individually noted in the report, unless leakage, building movement or similar problems are noted

4. example of typical minor cracks

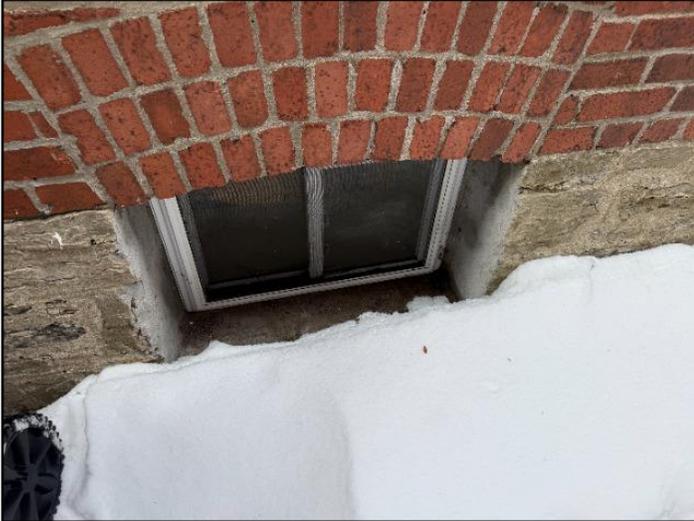
Condition: • Sill - Near or at Grade Level

Basement windows at or near grade level. Modern standards recommend that the bottom of the window be at least 6 inches above grade or have a window well installed. Consider adding window well if regrading or when necessary. In the meantime, ensure windows remain well-sealed to prevent water intrusion.

5. example at right

Task: Monitor for moisture intrusion / Improve

Cost: If/when upgrading to window wells in the future, \$2000 and up each

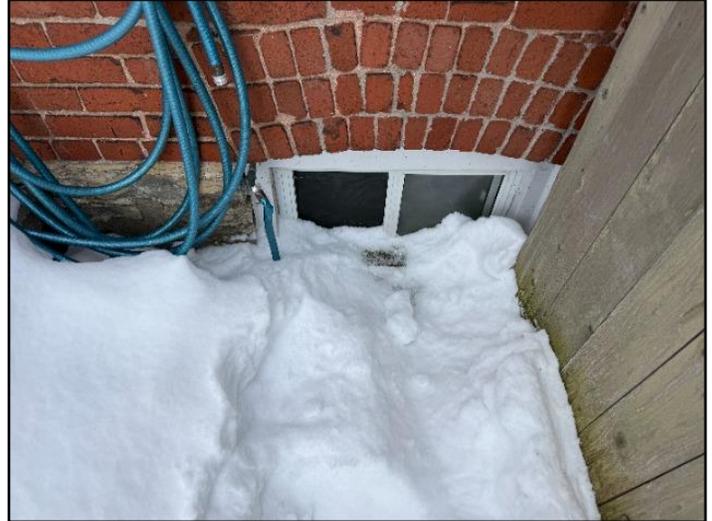
6. example at rear

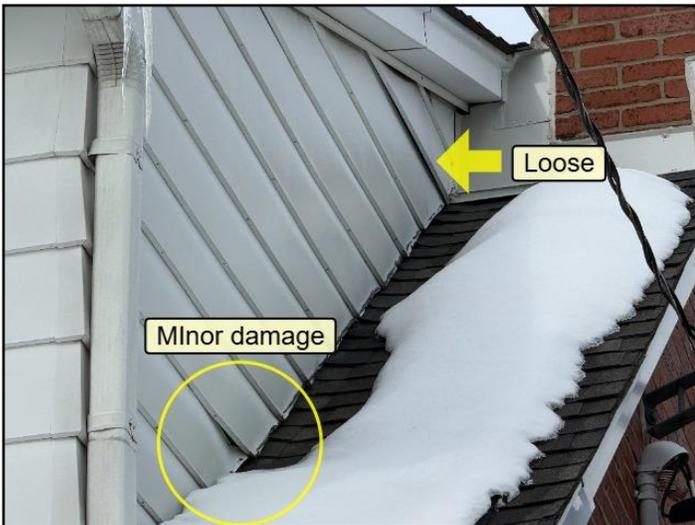
- Metal siding minor damage and one area loose - Right near front - Repair as part of routine maintenance.
- Keep tree branches trimmed back 3 feet from roof line - ongoing maintenance.
- Fence leaning - Rear left yard - Repair when practical
- Gate latch requires adjustment - Routine maintenance.

7. Metal siding

Task: Repair or Replace or Improve or Monitor

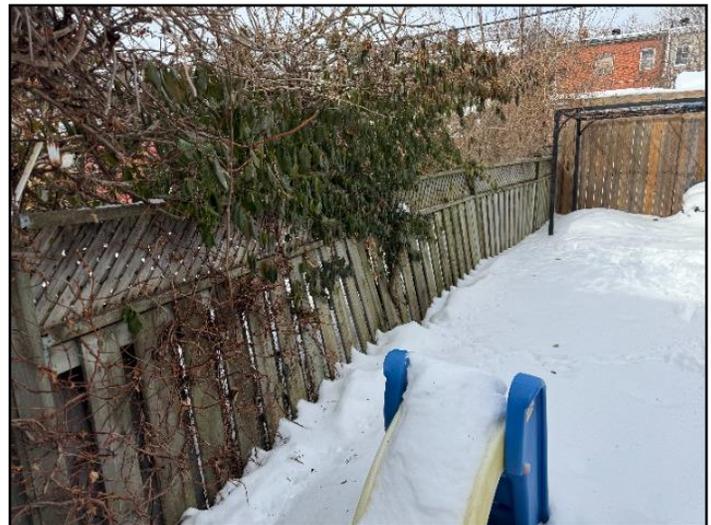
8. Fence leaning

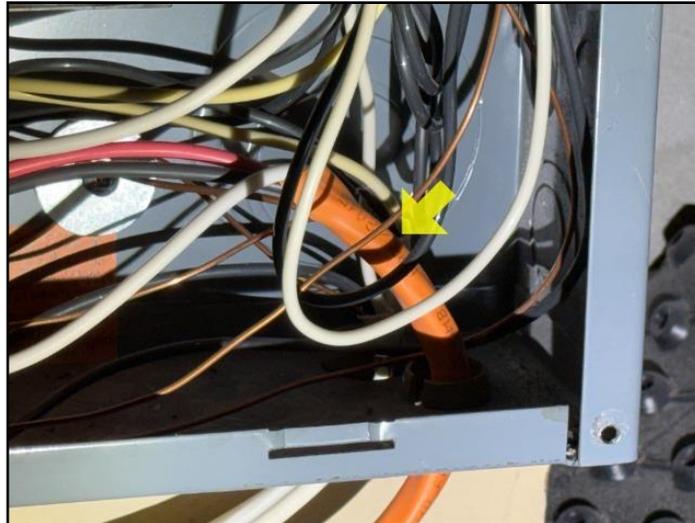
Condition: • [Sheathing not removed](#)

10. Sheathing not removed

Time: Less than 1 year

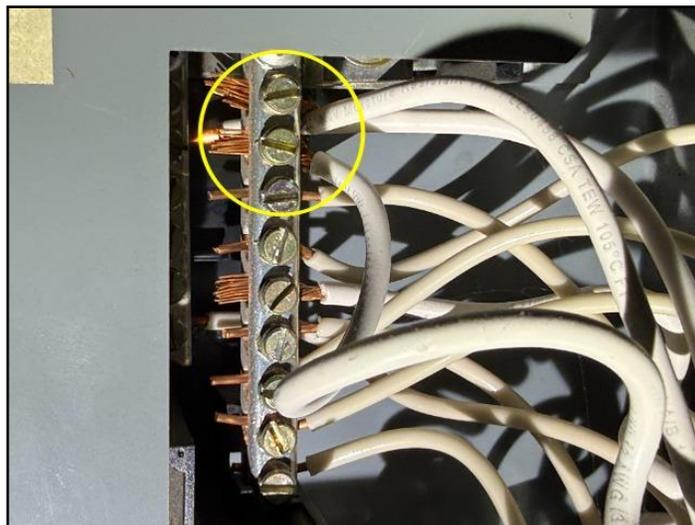
Condition: • Double taps - Neutral wire(s)

11. Double taps - Neutral wire(s)

Time: As Soon As Possible

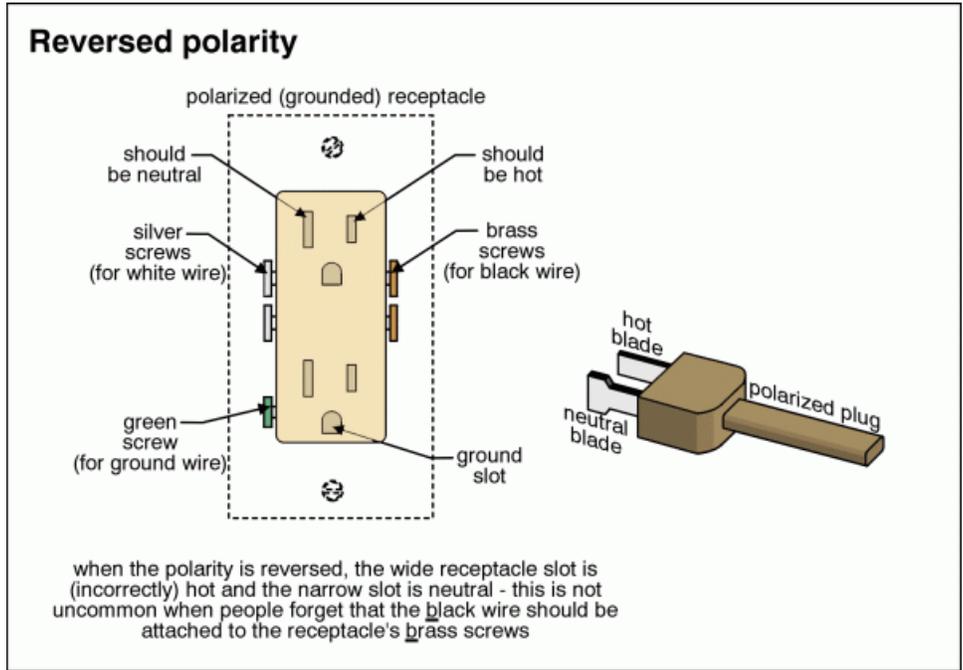
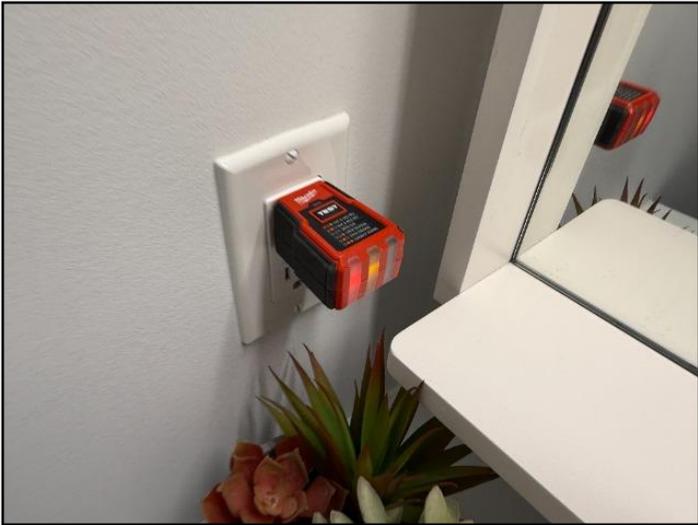
Condition: • [Reversed polarity](#)

12. Reversed polarity

Time: As Soon As Possible

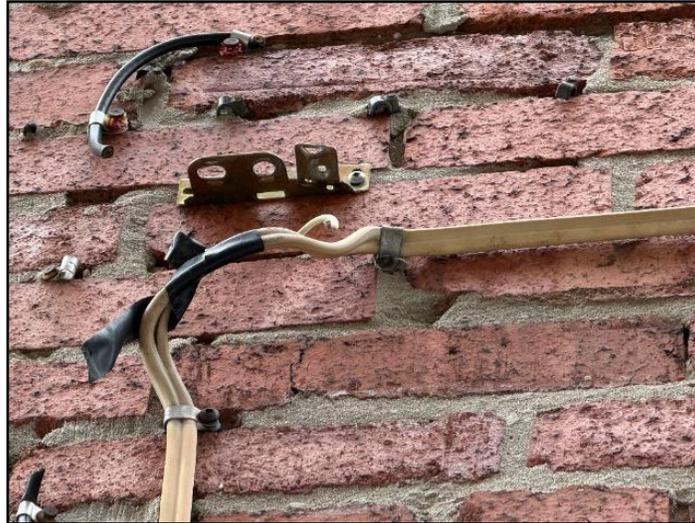
13.

- Damaged/exposed wiring - exterior right side. Unable to determine whether wiring is active - Repair if active or remove if inactive.

Implication(s): Fire and/or shock hazards

Time: As soon as possible

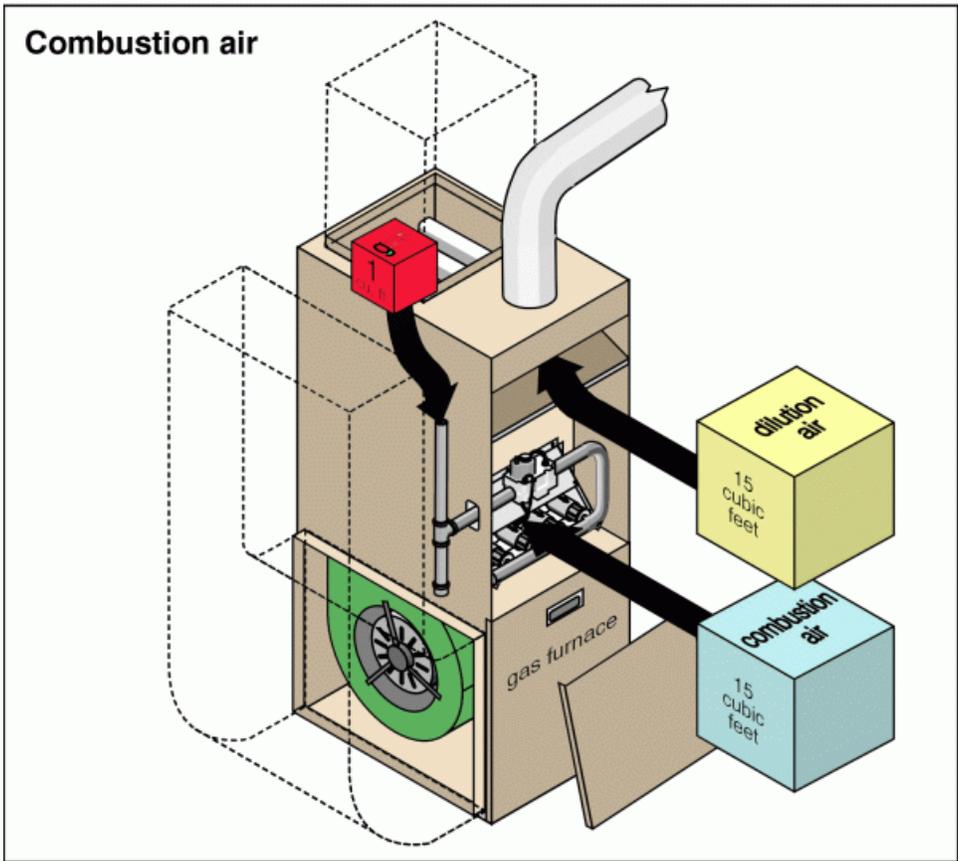
Condition: • [Inadequate combustion air](#)

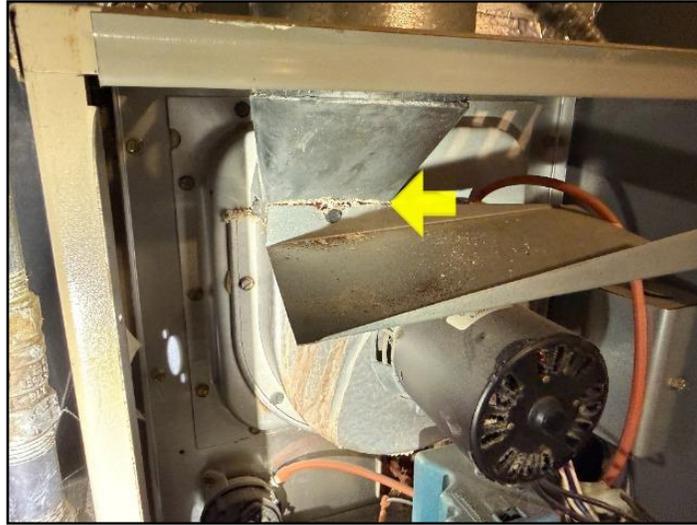
Condition: • [Rust, dirty, obstructed](#)

Implication(s): Equipment not operating properly | Hazardous combustion products entering home

14. Rust

Task: Service

Time: Less than 1 year

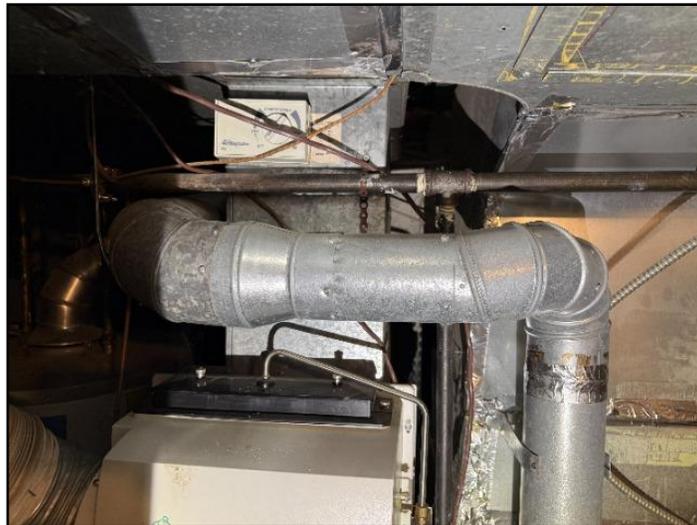
15.

Condition: • Vent connector includes a short horizontal section. Recommend confirming proper upward slope toward the chimney at next annual service.

Task: Confirm proper slope

Time: At next annual servicing

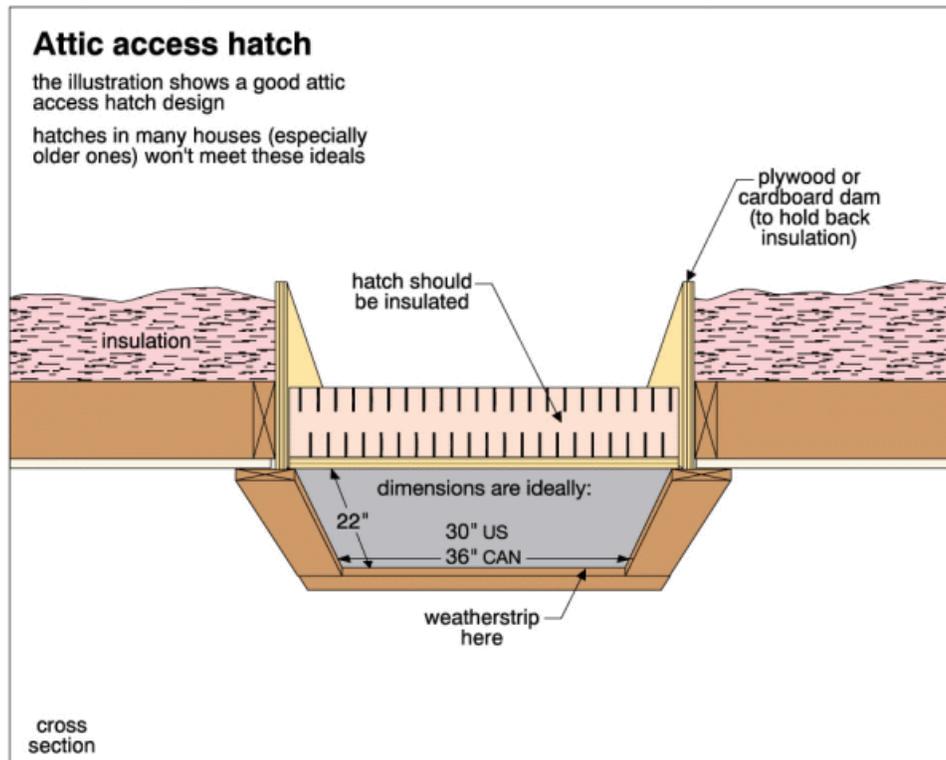
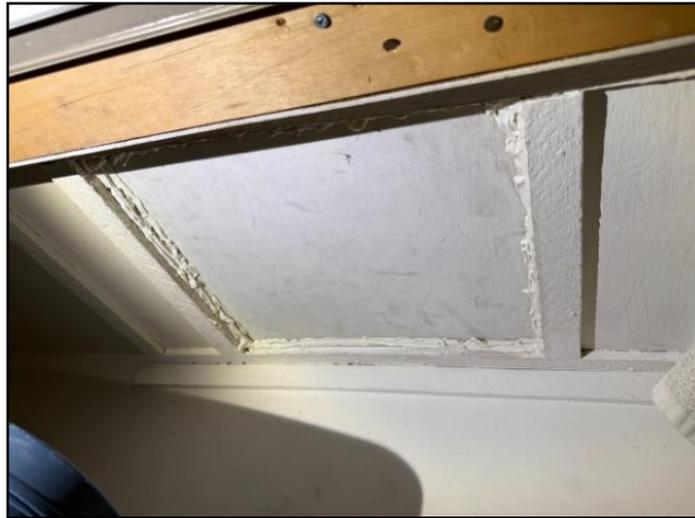
Condition: • [Inaccessible](#)

Small attic located below front sloped roof. Hatch was sealed/fastened. Inspecting the attic is recommended to assess structure, insulation, ventilation, mold, stains, asbestos, and other potential issues.

16. *Inaccessible*

Task: Provide access and inspect

Time: As soon as practical

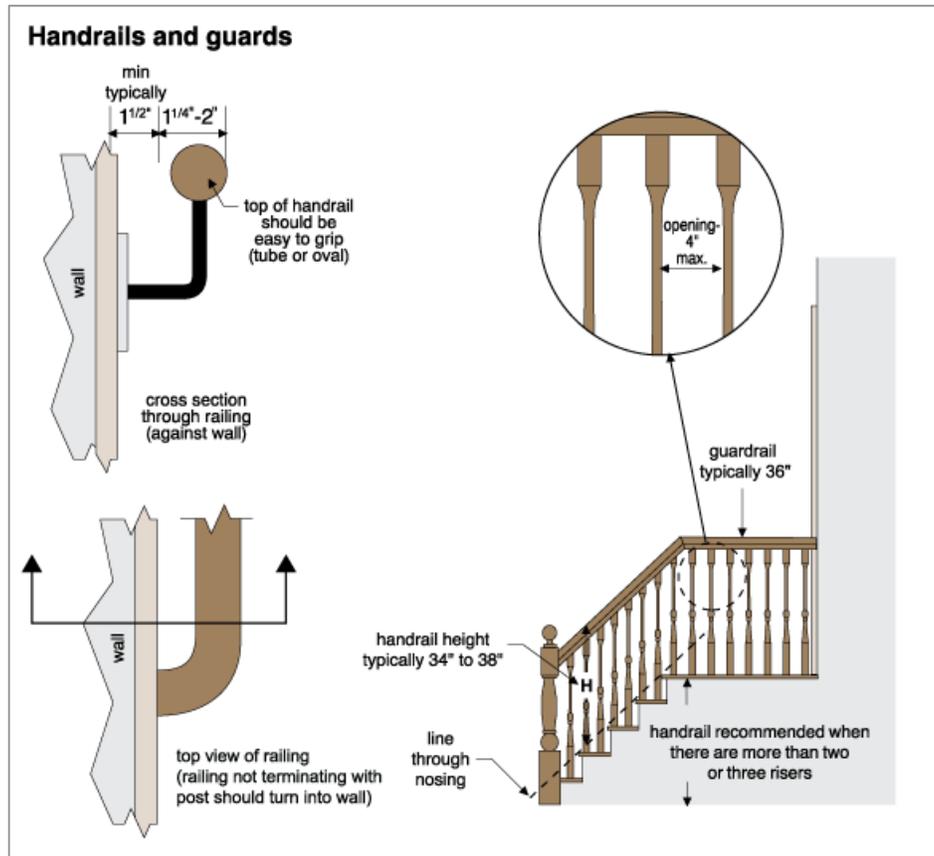
Condition: • [Missing](#)

Implication(s): Fall hazard

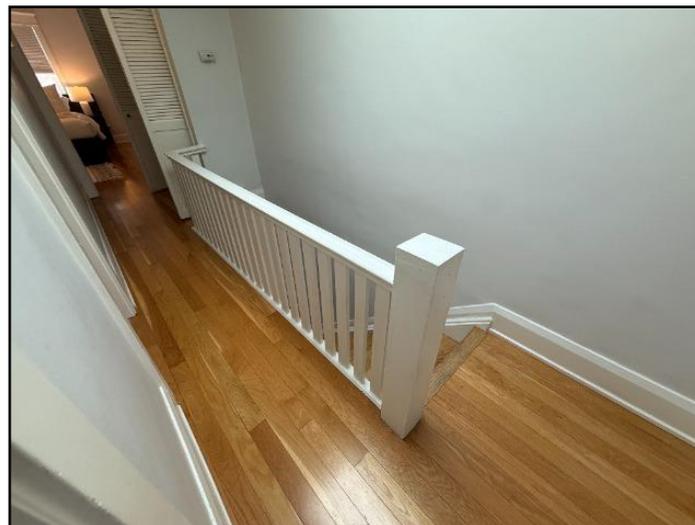
Condition: • [Too low](#)

Implication(s): Fall hazard

17. Too low

Time: As soon as practical

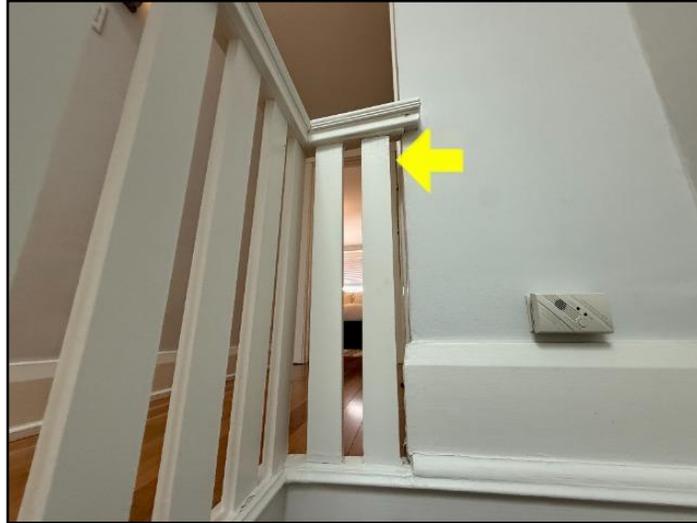
Condition: • [Damage](#)

Implication(s): Fall hazard

18. Damage

Task: Repair

Time: As Soon As Possible

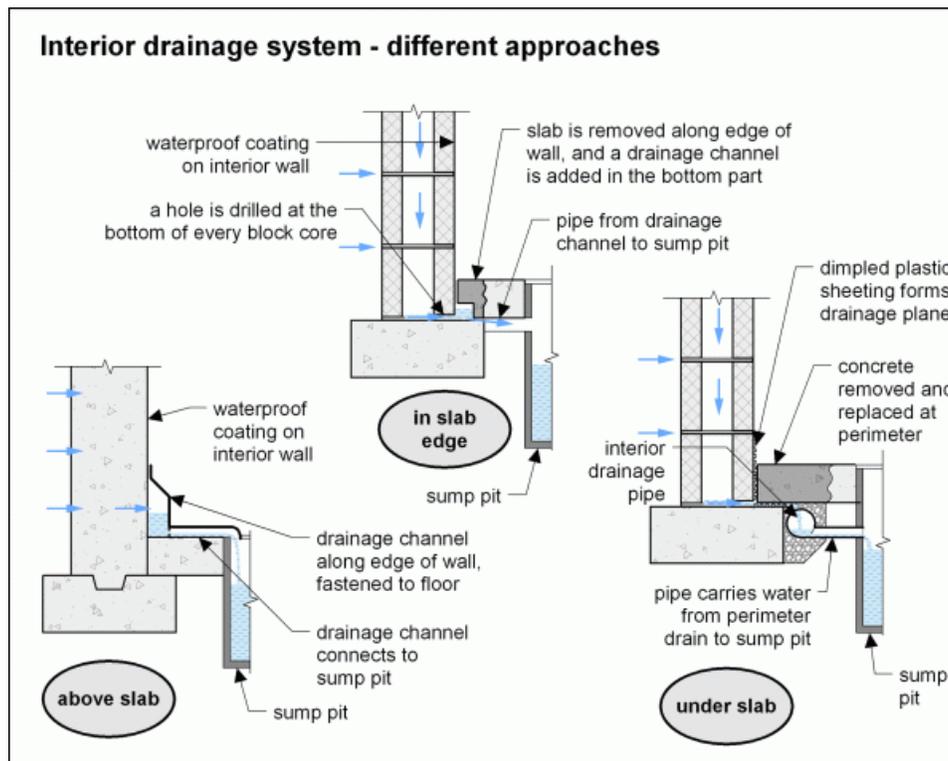
Condition: • [Interior drainage system](#)

A dimple membrane was observed at exposed areas in the furnace room, indicating an interior drainage system has been installed in portions of the basement. No sump pump or discharge piping was observed in accessible areas at the time of inspection. The discharge method for this system could not be confirmed.

Task: For Your Information / Verify discharge method
