# INSPECTION REPORT

For the Property at:  
**41 HERTLE AVENUE**  
TORONTO, ON M4M 2L3

Prepared for: CHRIS OLSEN FORD THURSTON  
Inspection Date: Saturday, May 3, 2025  
Prepared by: Joe Marino

RE: Report No. 4039, v.2  
41 Hertle Avenue  
Toronto, ON  
M4M 2L3

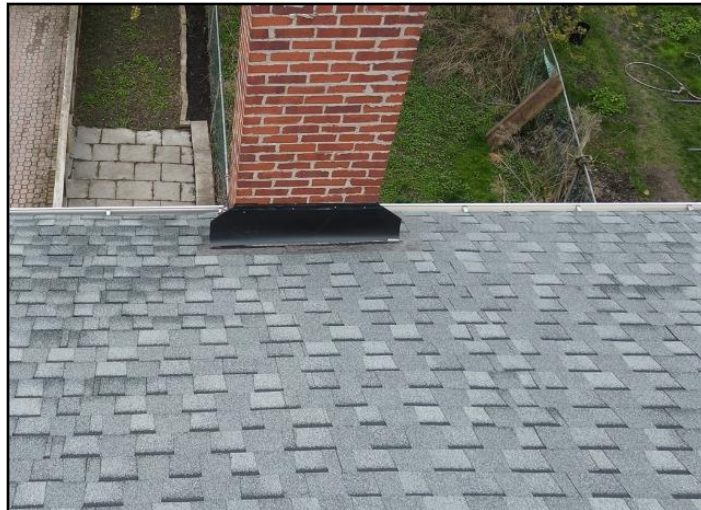
1. **Condition:** • [Cricket \(Saddle\) missing, loose, damaged](#)

**Location:** Rear Exterior Roof

1. Cricket (Saddle) missing, loose, damaged

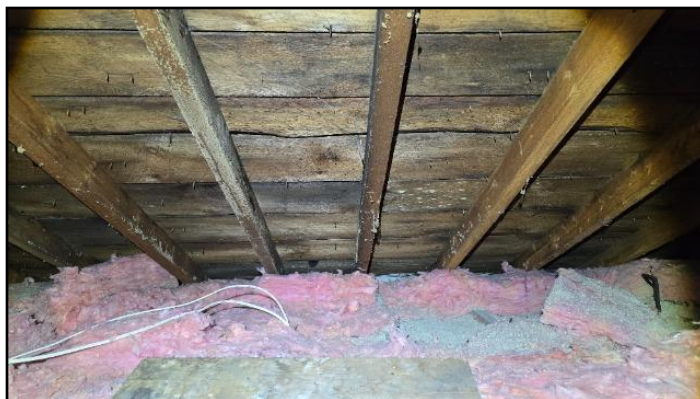
#### 2. Condition: • [Vents - ineffective / missing](#)

Common to add more ventilation with homes of this age. Improve by adding baffles

**Location:** Throughout Exterior Roof

5. Vents - ineffective / missing

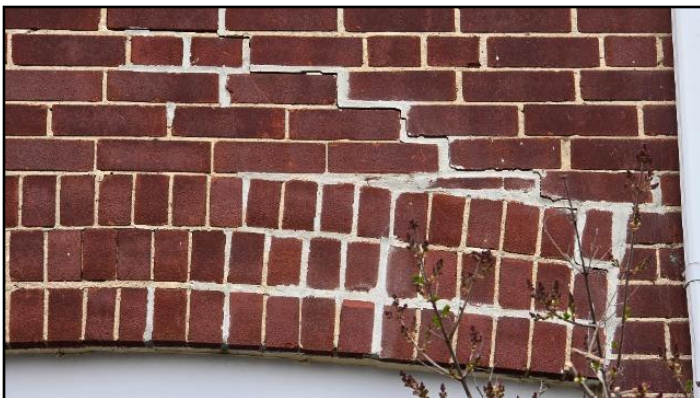
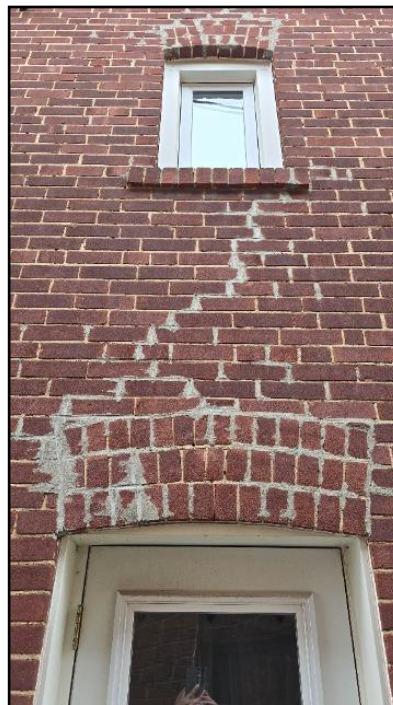
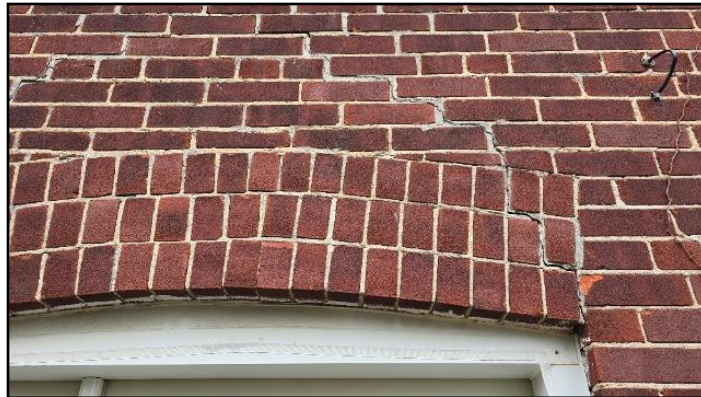
#### 3. Condition: • [Mortar deterioration](#)

**Location:** Various Exterior Wall

6. Mortar deterioration

7. Mortar deterioration

8. Mortar deterioration

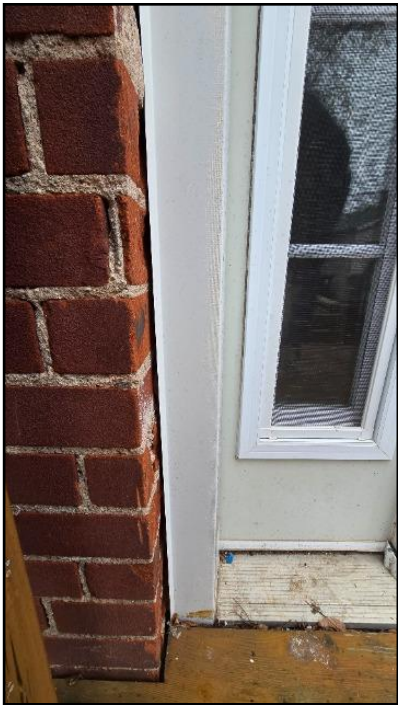
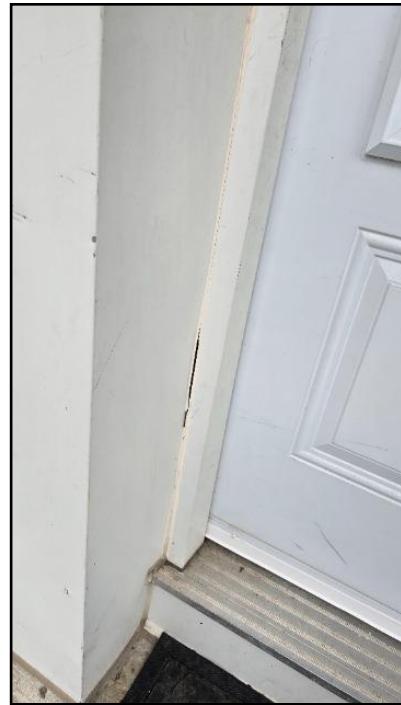
6. Condition: • [Caulking missing, deteriorated or loose](#)

Location: Various Front Rear First Floor Exterior

13. Caulking missing, deteriorated or loose

14. Caulking missing, deteriorated or loose

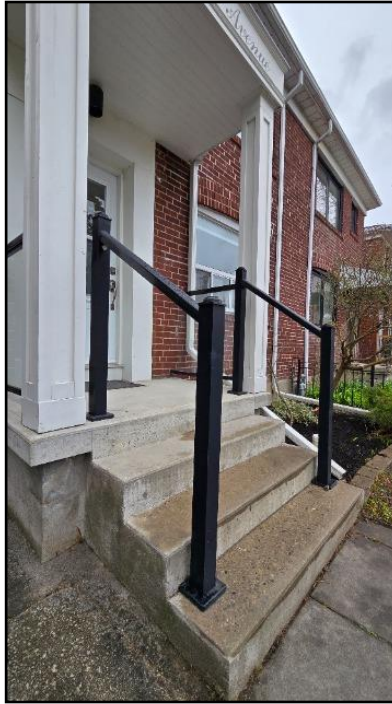
**7. Condition:** • [Missing](#)

**Location:** Front Exterior Porch

15. Missing

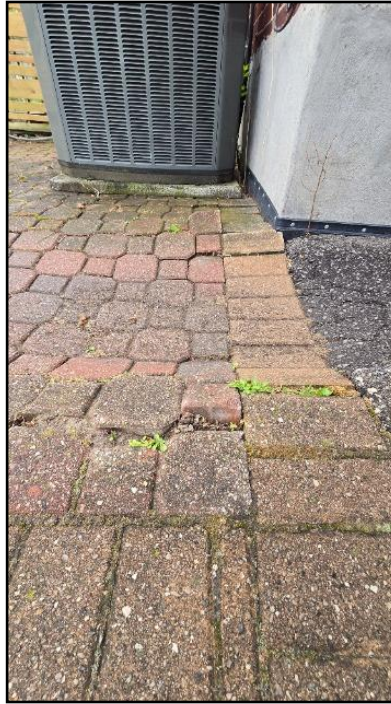
8. Condition: • [Uneven \(trip hazard\)](#)

Location: Various Rear Exterior

16. Uneven (trip hazard)

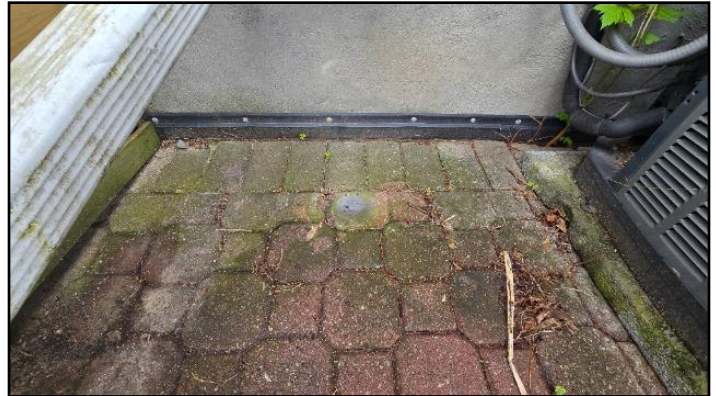
**9. Condition:** • Water proofing was added to the homes foundation. Follow up with listing agent

**Location:** Various Basement

32. Water proofing was added to the homes...

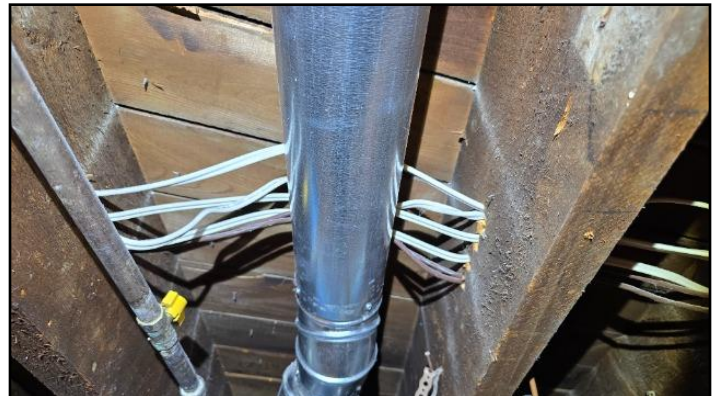
**10. Condition:** • [Too close to/touching ducts, pipe, chimneys, etc.](#)

**Location:** Various Basement

42. Too close to/touching ducts, pipe, chimneys...

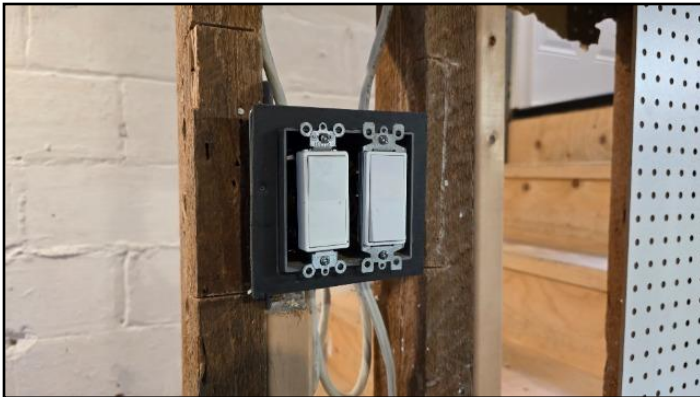
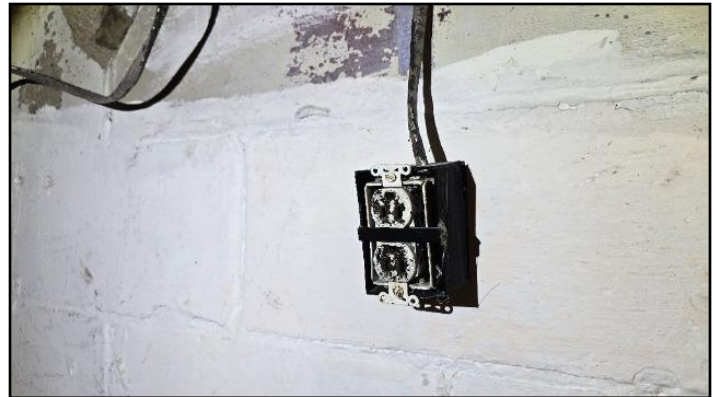
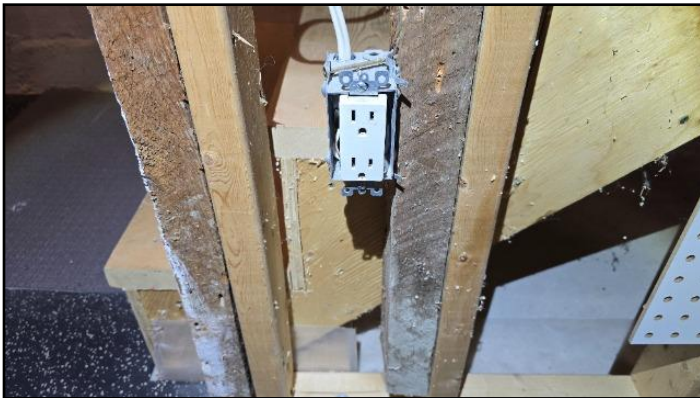
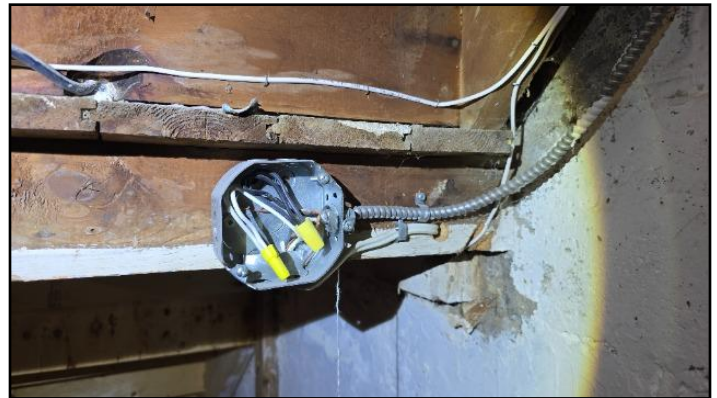
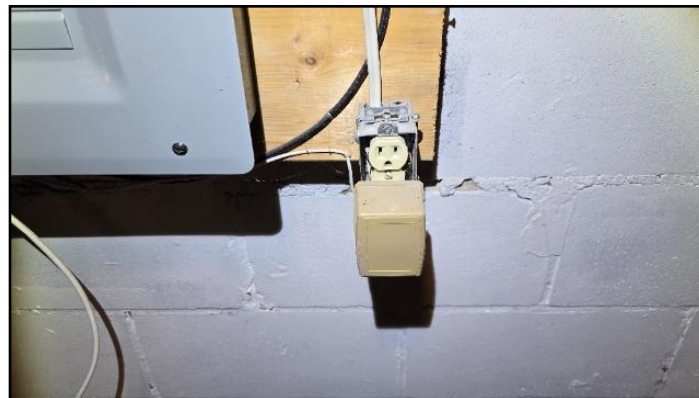
**11. Condition:** • Damaged, loose or missing

**Location:** Various

44. Damaged, loose or missing

45. Damaged, loose or missing

46. Damaged, loose or missing

47. Damaged, loose or missing

48. Damaged, loose or missing

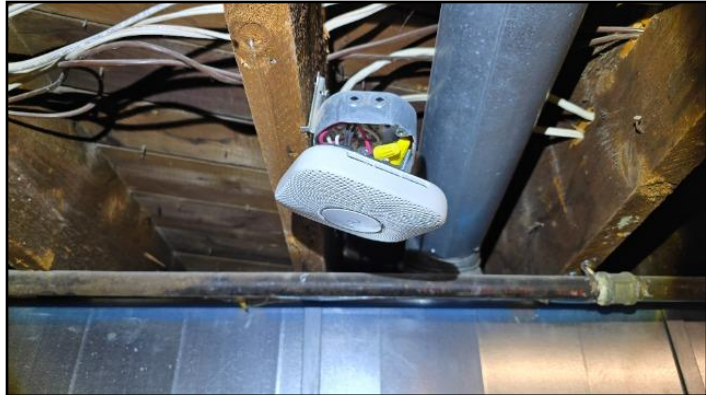
**12. Condition:** • Recommend securing smoke detector

**Location:** Basement

49. Recommend securing smoke detector

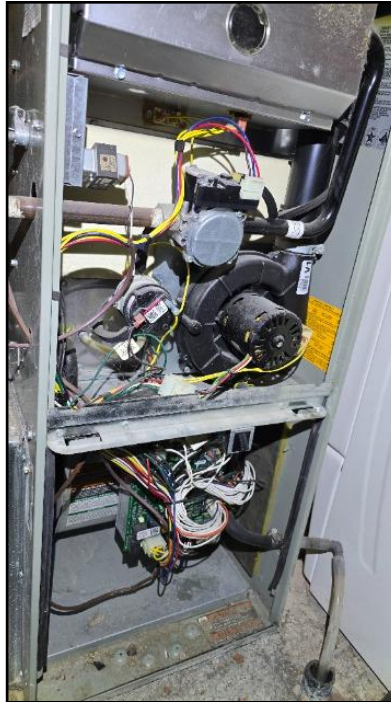
**13. Condition:** • Recommend a service plan for proper efficiency  
Annual service recommend. Operated on day of inspection.

**Location:** Basement Furnace Room

60. Recommend a service plan for proper...

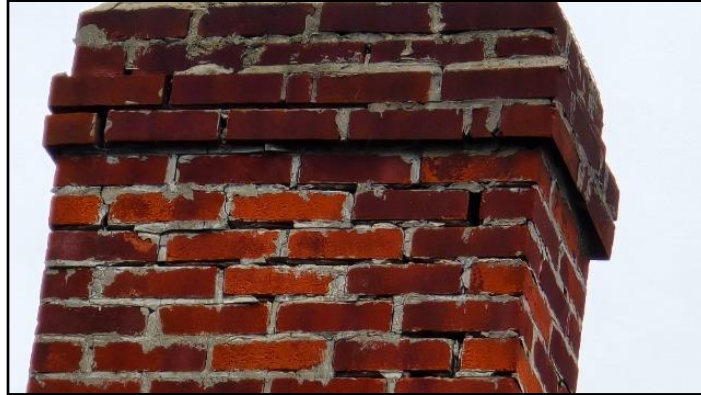
15. Condition: • [Loose, missing or deteriorated mortar](#)

Location: Rear Exterior Roof

62. Loose, missing or deteriorated mortar

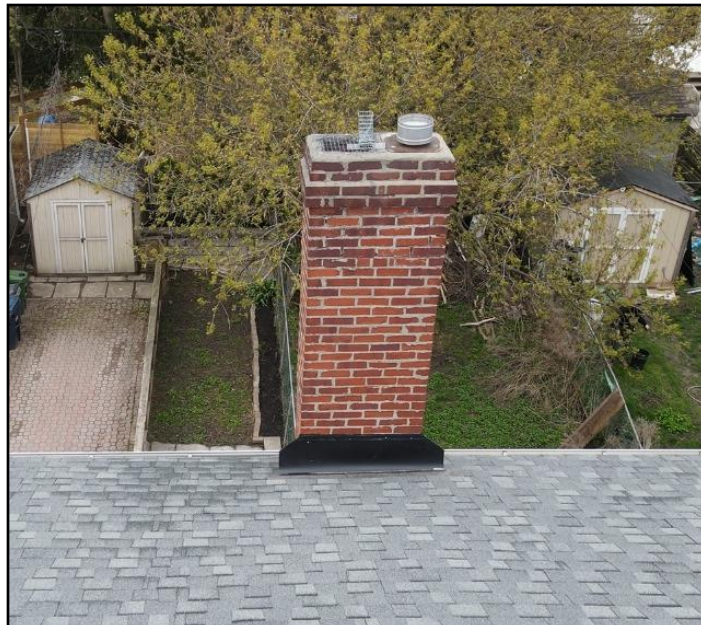
- Heat loss calculations
  - Interiors of vent systems, flues, and chimneys
- Chimney on left side. Not in use. Cap and seal if not needed

77. Interiors of vent systems, flues, and...

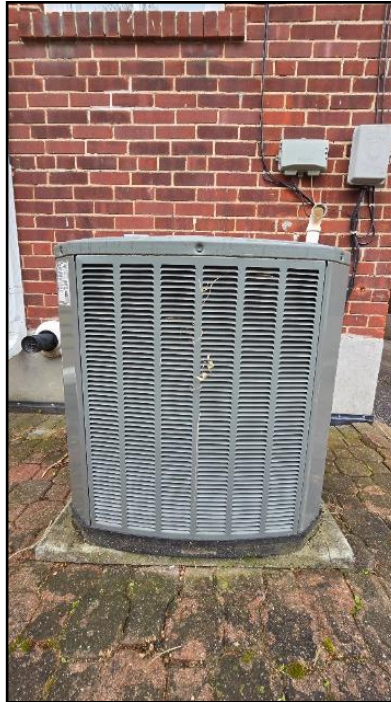
**16. Condition:** • Standard service and maintenance recommended with A/C unit  
Recommend a yearly service plan. Keep unit clean for proper operation. Operated on day of inspection.

*78. Standard service and maintenance recommende...*

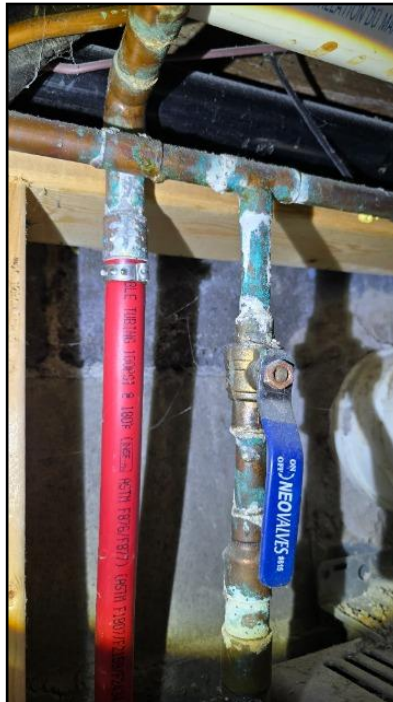
**19. Condition:** • Corrosion Noted

**89. Corrosion Noted**

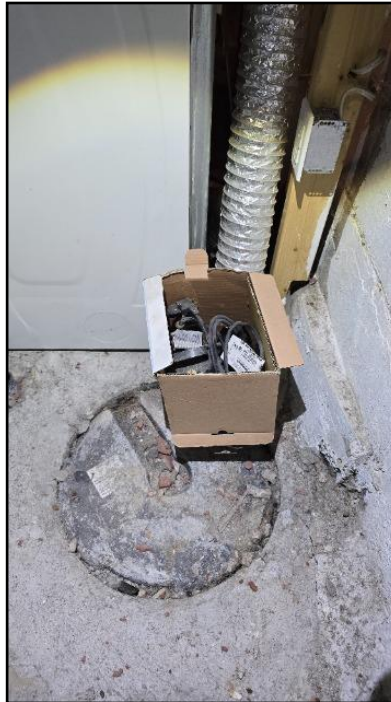
99.

**Pumps:** • Noted in the basement. Follow up with sellers

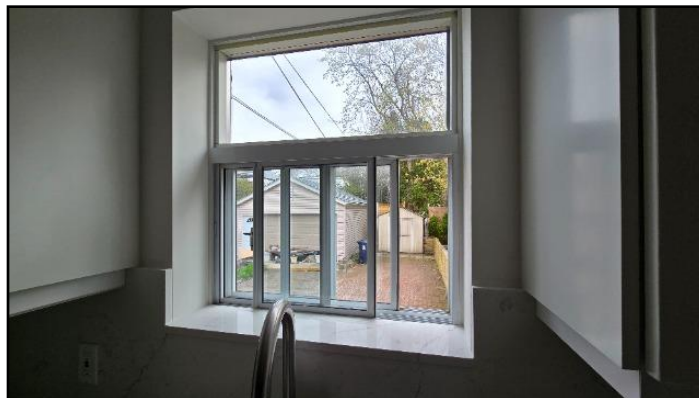
**21. Condition:** • [Missing](#)

**Location:** First Floor Kitchen

102. Missing

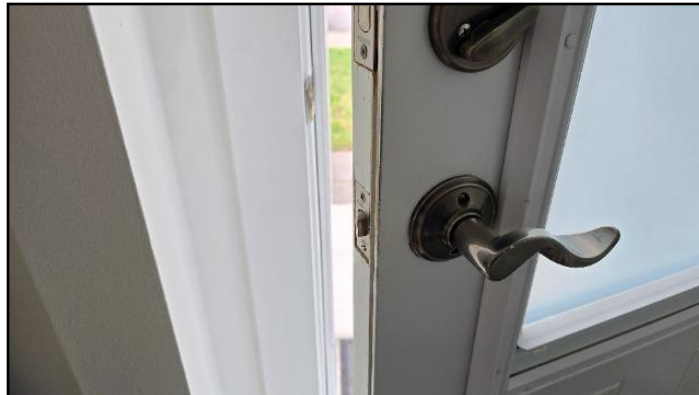
**22. Condition:** • Latch not effective on exterior door

**Location:** Front First Floor Exterior

103. Latch not effective on exterior door

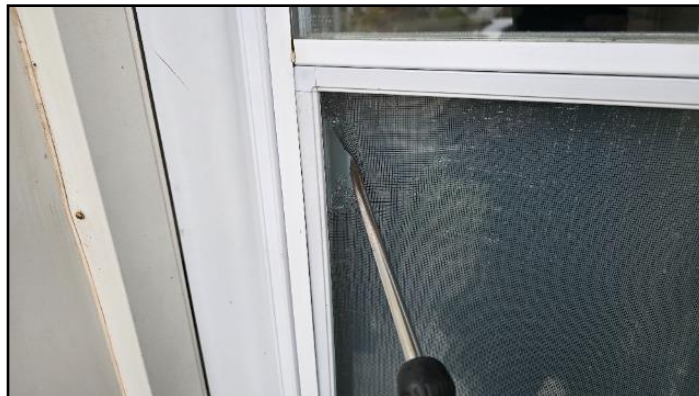
23. Condition: • [Torn](#)

Location: Front First Floor Exterior

104. Torn

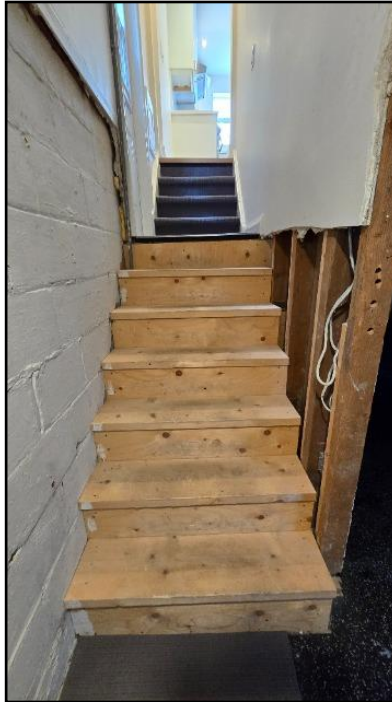
24. Condition: • [Missing](#)

Location: Basement Staircase

105. Missing
