Your Inspection Report

12 Weybourne Crescent
Toronto, ON M4N 2R3

INSPECTION DATE:
Wednesday, March 18, 2026

RE: Report No. 96377
12 Weybourne Crescent
Toronto, ON
M4N 2R3

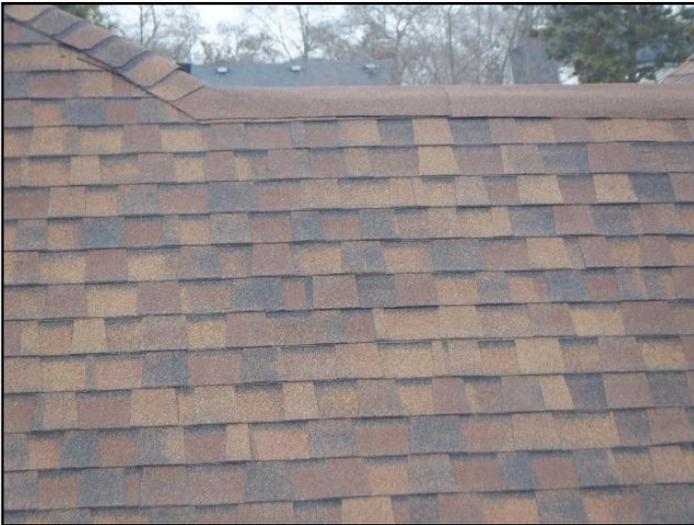
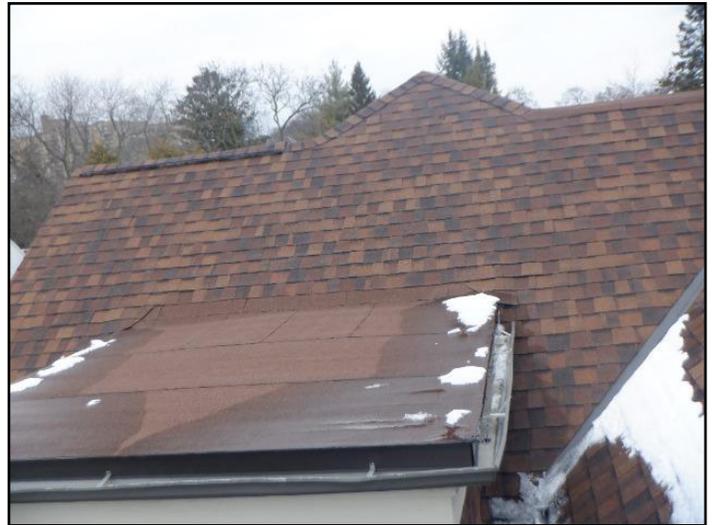
Condition: • The roof shingles are in good overall condition.

The roof shingles are in good overall...

Annual inspections are recommended (on any roof) to take care of any roof damage and/or regular maintenance items (flashings/caulking).

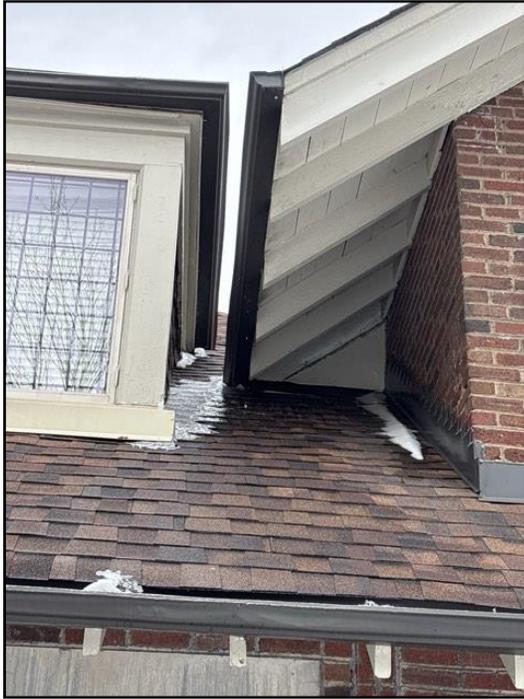
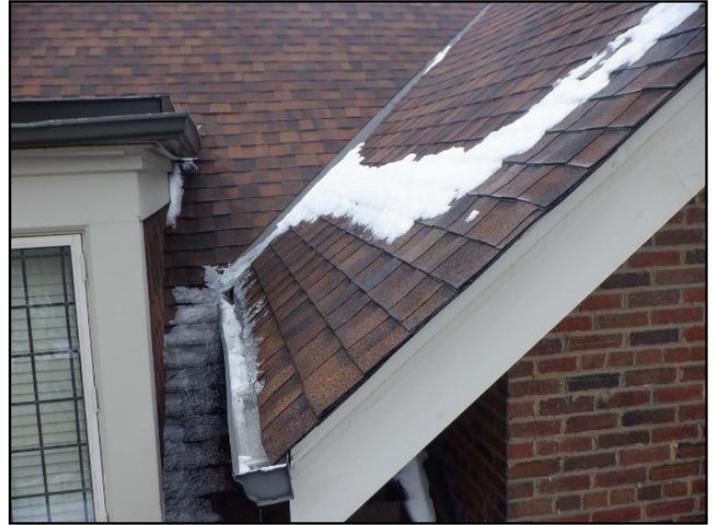
Condition: • Vulnerable areas

Location: Front

Vulnerable areas

Task: Monitor / improve

Time: Ongoing / when re-roofing

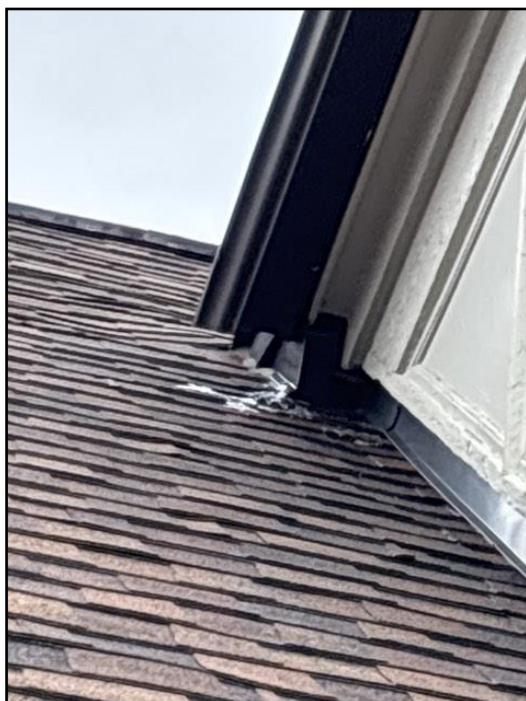
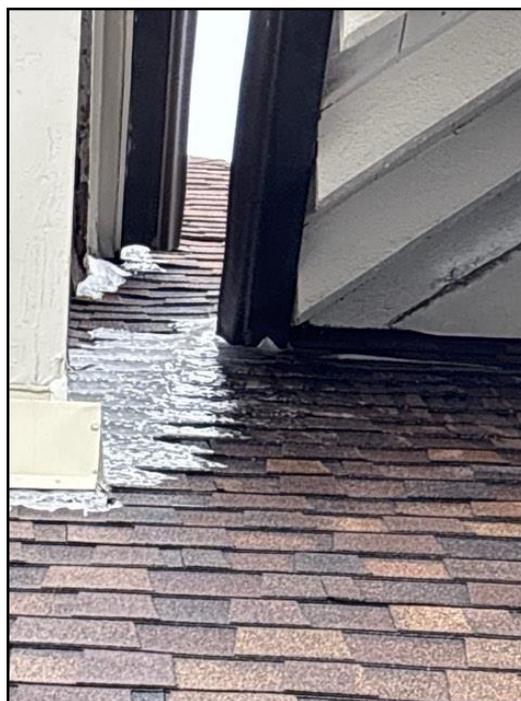
Condition: • Discharge onto roofs

Location: Front

Discharge onto roofs

Task: Improve

Time: As soon as practical

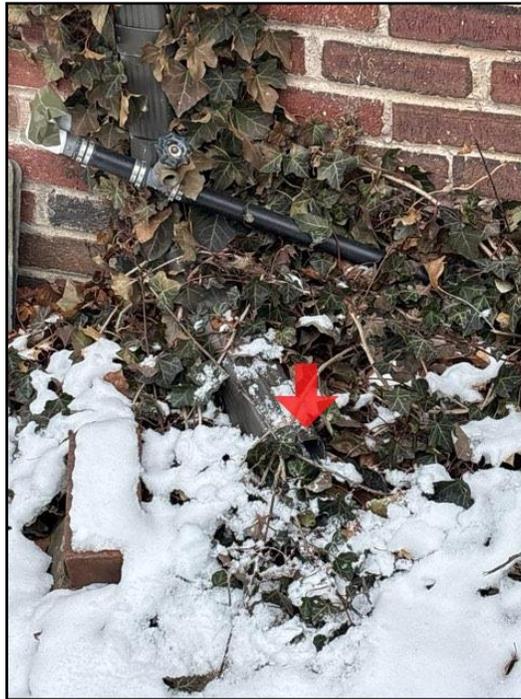
Condition: • Discharge too close to building

Discharge too close to building

Always transfer water as far away from the house as practical. However attention to erosion, tripping hazard, or creating a slippery ice surface should also be considered.

Task: Improve

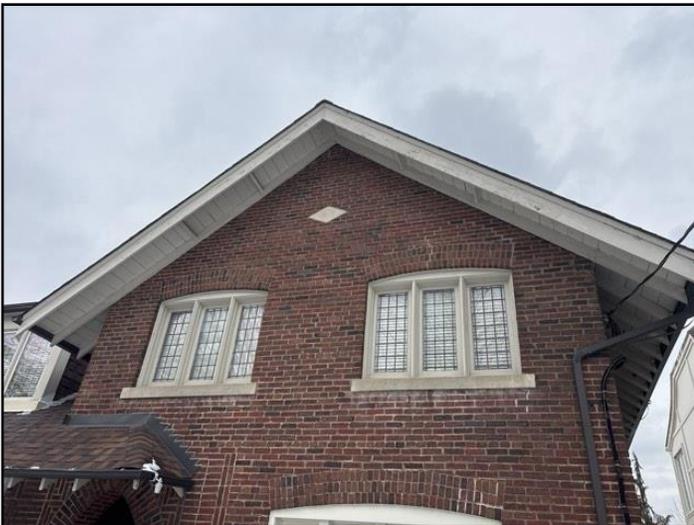
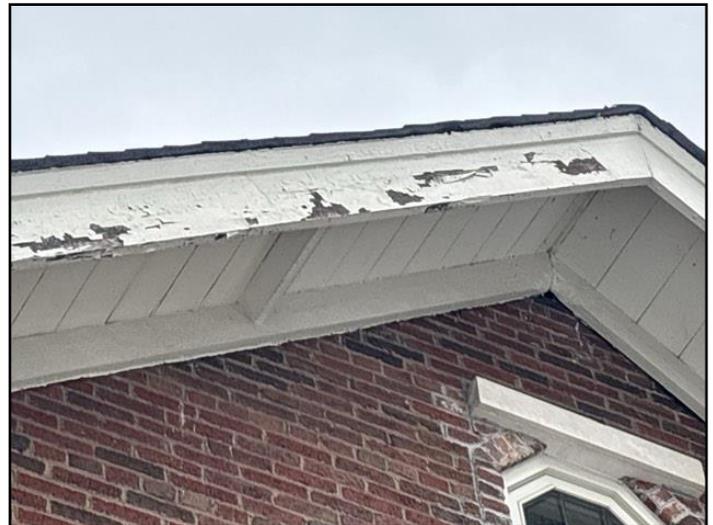
Condition: • Paint - deteriorated / missing

Location: Throughout

Paint - deteriorated / missing

Task: Improve

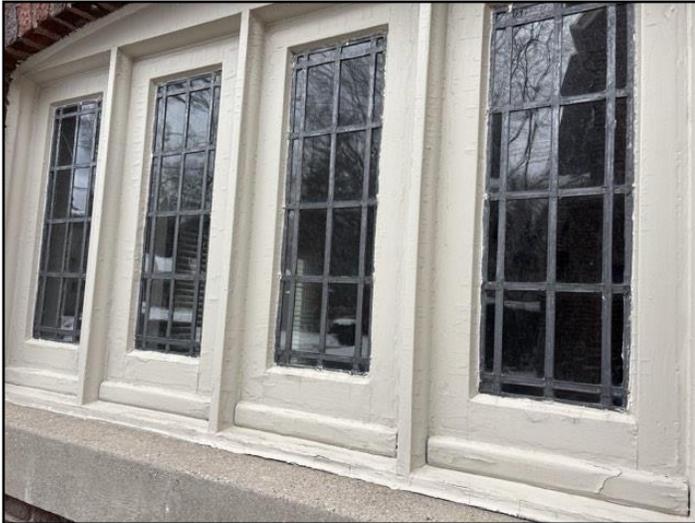
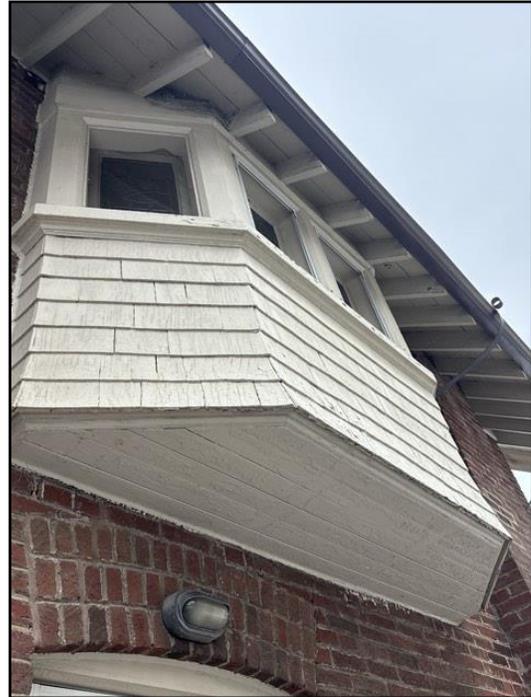
Condition: • Regular maintenance needed

Location: Various

Regular maintenance needed

Task: Improve

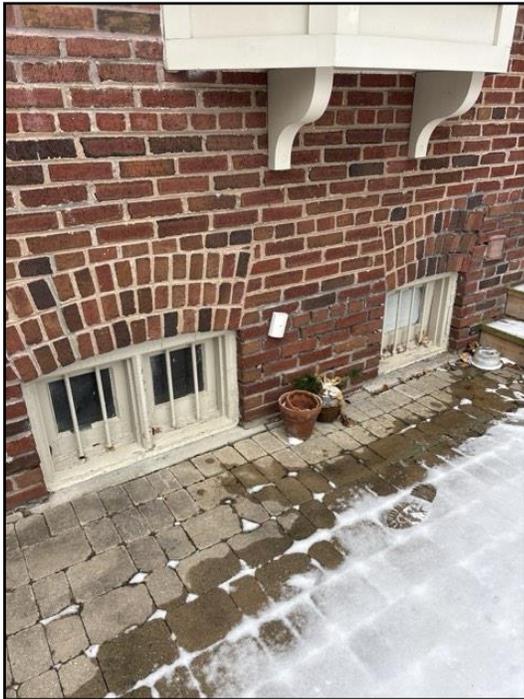
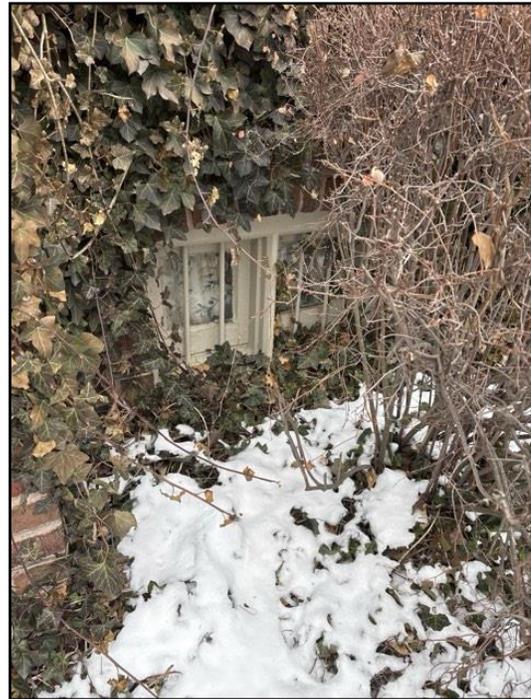
Condition: • Missing

Location: Various

Missing window wells

Task: Provide

Cost: \$250 - + / each

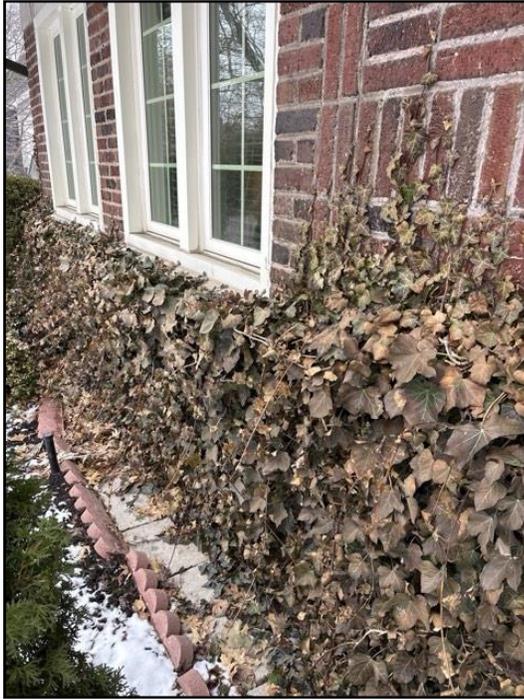
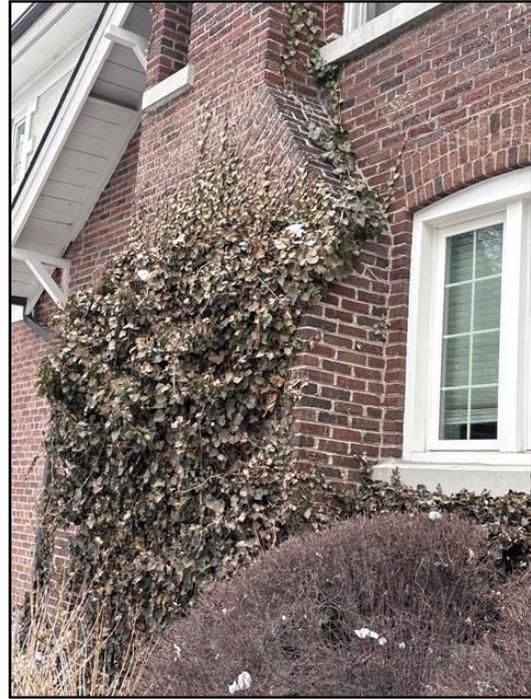
Condition: • Vines may damage the home over time. If vines are to remain, and we understand the aesthetic reasons for leaving them, we recommend controlling the growth so vines do not attach to wood surfaces or roofs, and do not clog gutters and downspouts.

Location: Left side exterior

Vines may damage the home -

Task: Monitor/Improve

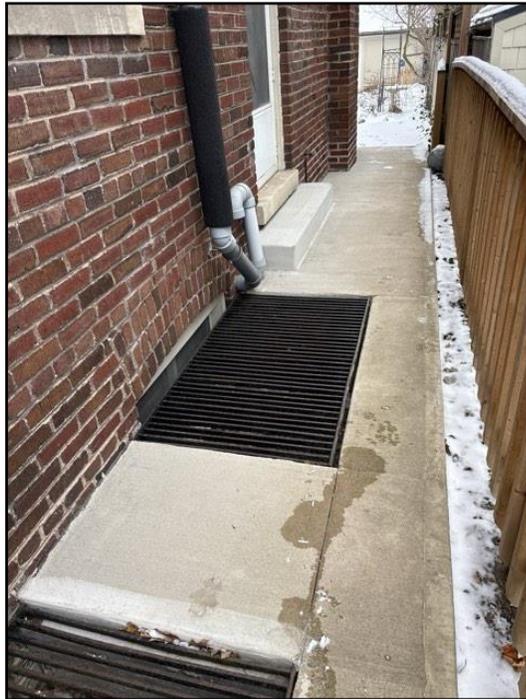
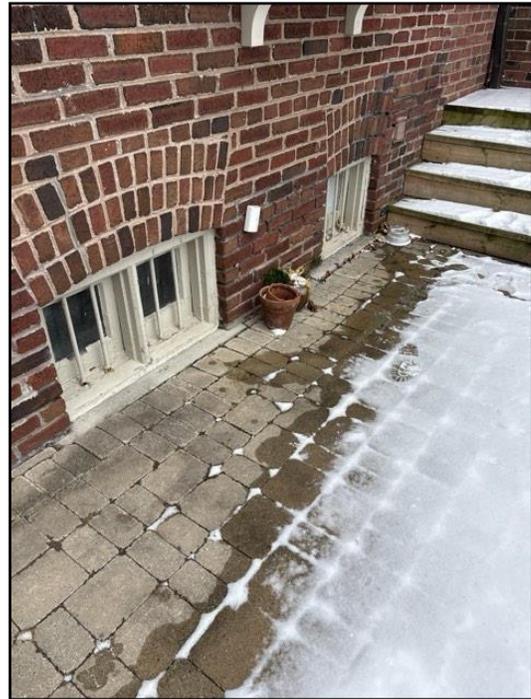
Condition: • The ground around some parts of the home does not slope to drain water away from the foundation.

Lot grading

Task: Improve grading so the ground slopes down at least 1 inch per foot for the first 6 feet away from the home. Note: Less slope is needed on hard surfaces like driveways

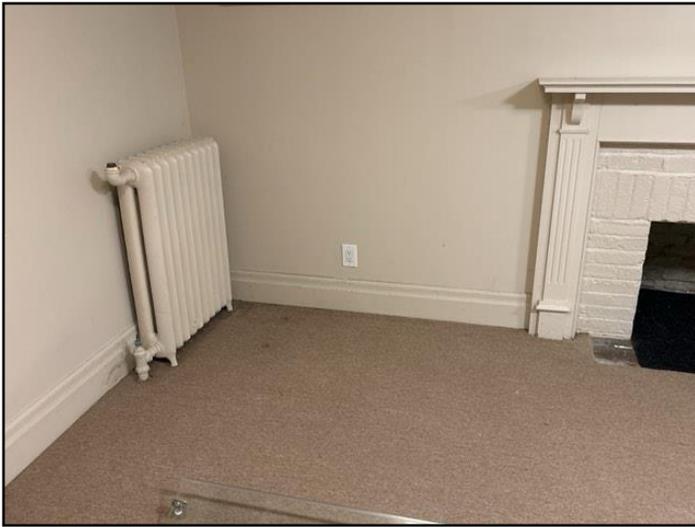
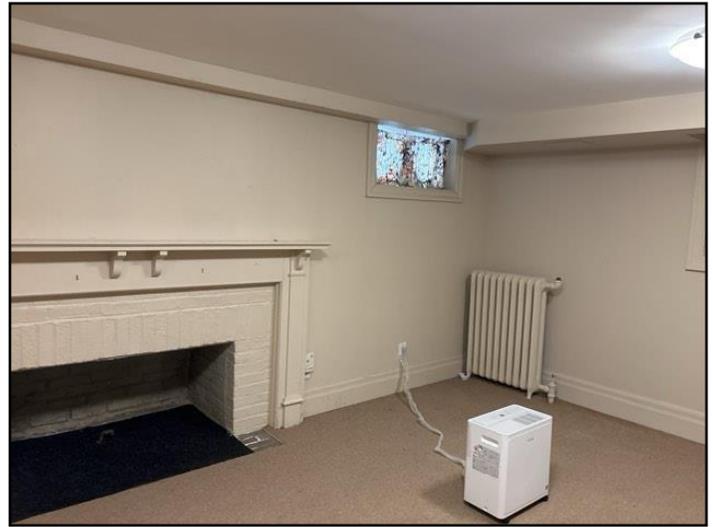
Condition: • Cold

Cold

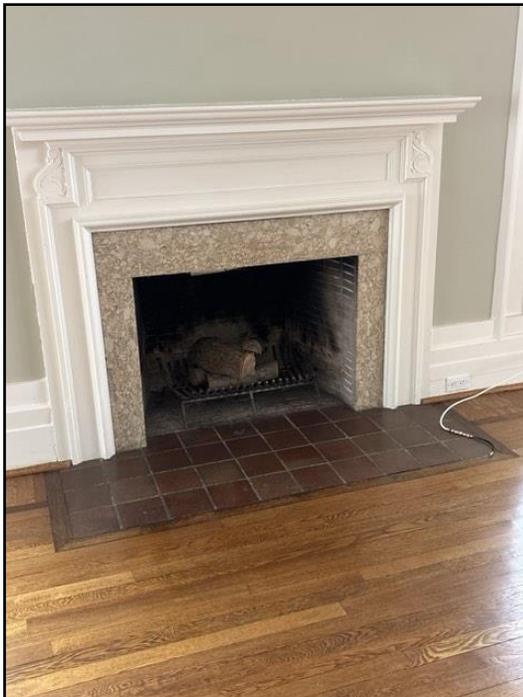
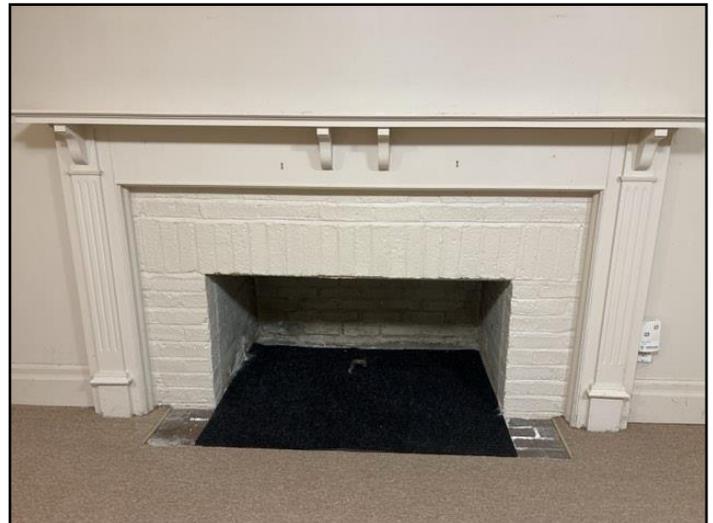
Condition: • Not functional

The chimney has been removed at the roofline and will need replacement if the fireplaces are to be used.

not operational

Not functional

Task: Improve

Time: If intending to re-activate the fireplace

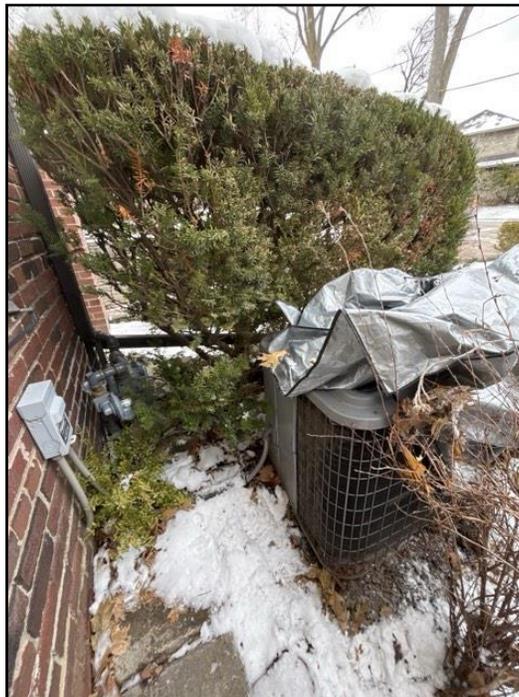
Condition: • Air conditioner past typical life expectancy

AC Past life expectancy

Be prepared to replace at any time.

Task: Replace

Cost: \$3,000 - \$6,000

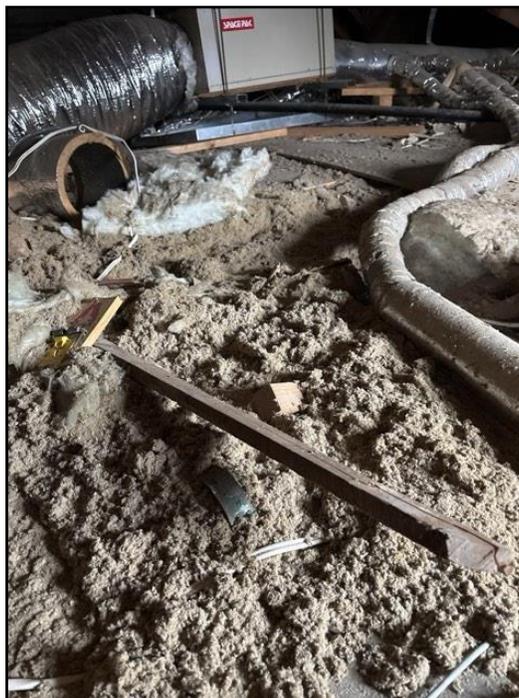
Condition: • Amount less than current standards

Insulation levels are below modern standards (R50-R60) and, in many cases, it is not practical (or cost effective) to improve it unless the opportunity presents itself (e.g. during renovations). Improvements may lead to lower heating/air conditioning costs and improved comfort.

Amount less than current standards

Cost: \$1,500 - and up

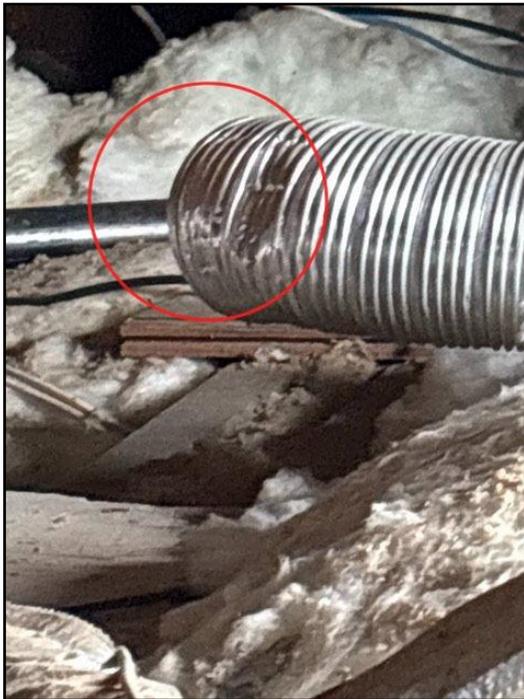
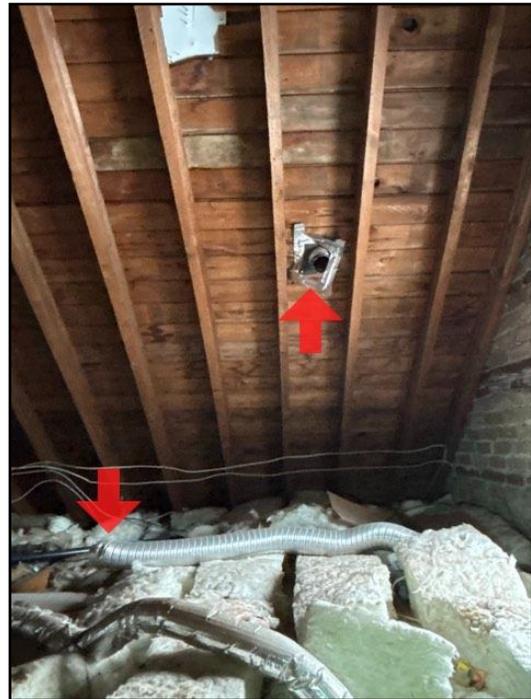
Condition: • Not vented to exterior

Not vented to exterior

Time: As soon as practical

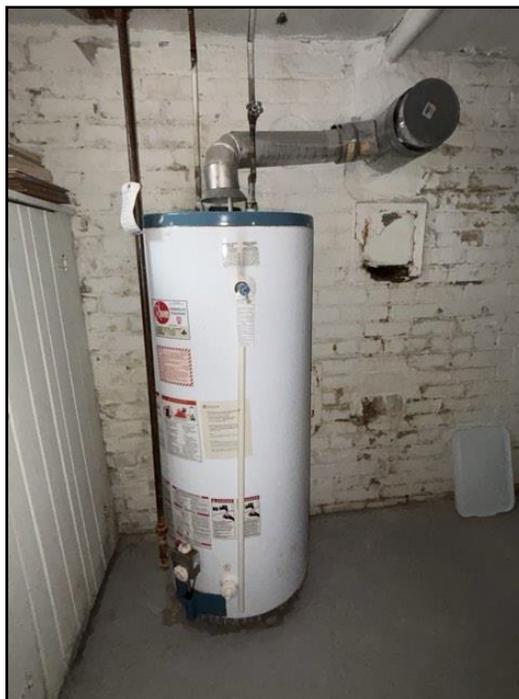
- Water heater fuel/energy source:** • Gas
- Water heater approximate age:** • 23 years
- Water heater typical life expectancy:** • 10 to 15 years
- Waste and vent piping in building:** • Plastic • Cast iron • Not visible in some areas.
- Pumps:** • None
- Floor drain location:** • Center of basement
- Backwater valve:** • None noted

Condition: • Past life expectancy
Be prepared to replace at any time.

Water Heater past life

Task: Replace

Cost: \$1,000 - \$3,000

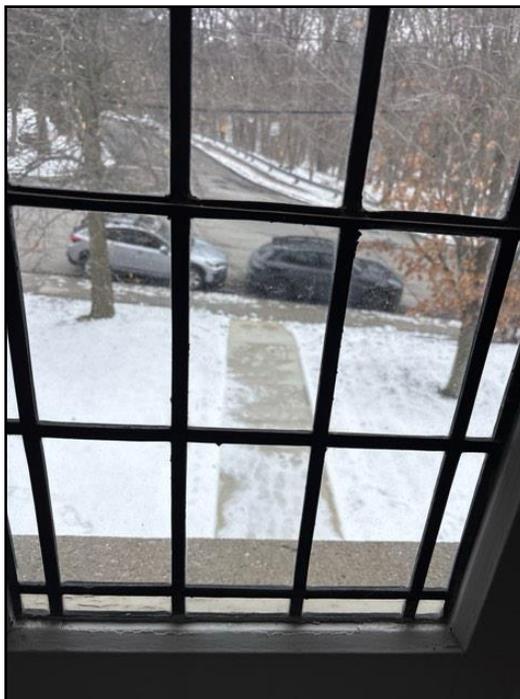
Condition: • Older windows

Older windows

Task: Repair / Replace

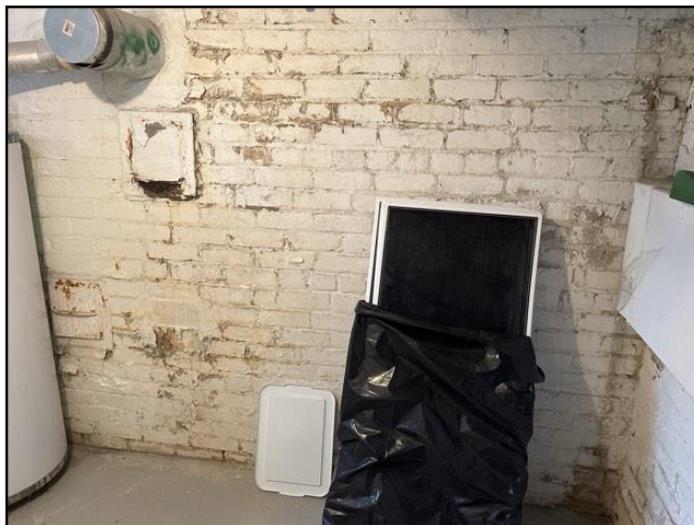
Condition: • Peeling paint

Peeling paint

See exteriors section regarding basement leakage.

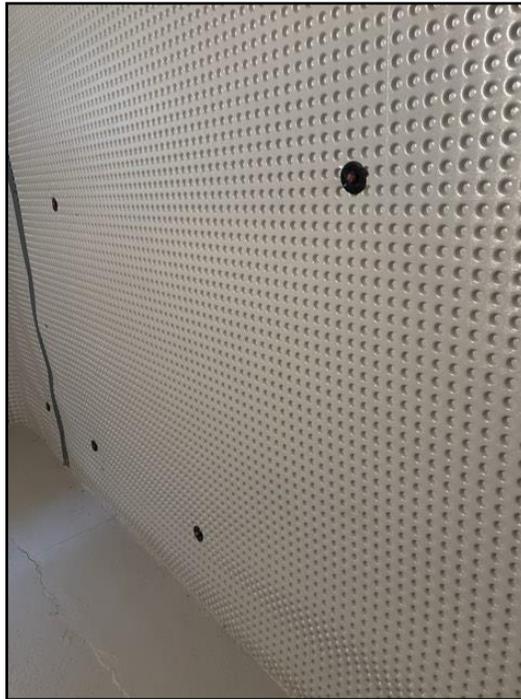
Condition: • Drainage membrane

Drainage membrane

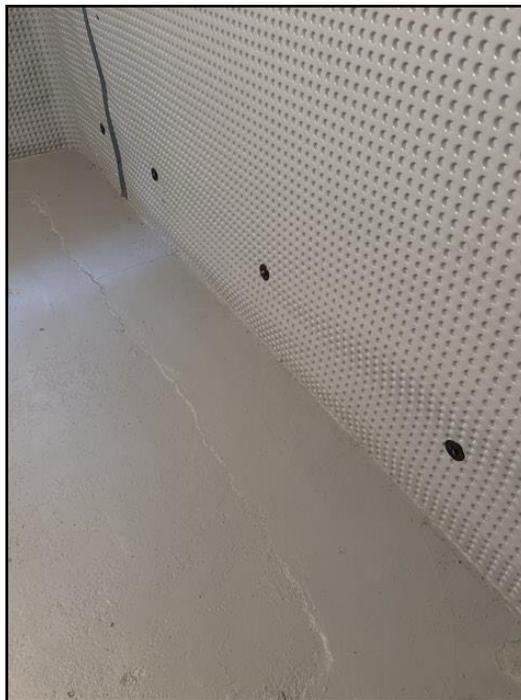
Condition: • Floor patched around perimeter

Floor patched around perimeter
