INSPECTION REPORT

For the Property at:
35 DARRELL AVENUE
TORONTO, ON M4E 2G5

RE: Report No. 4401, v.2
35 Darrell Avenue
Toronto, ON
M4E 2G5

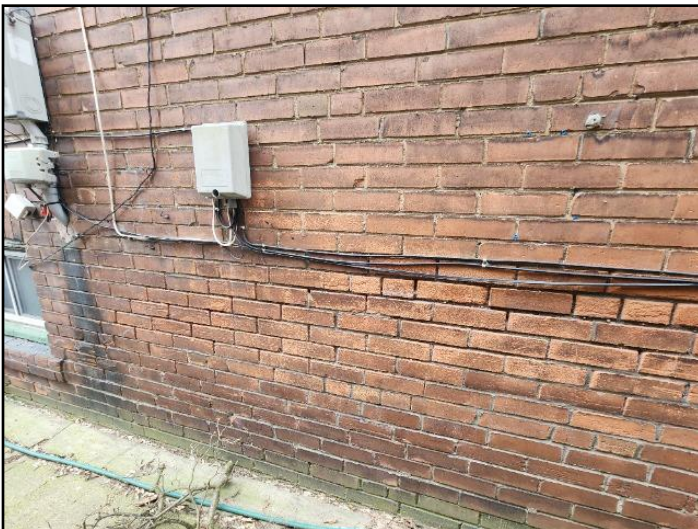
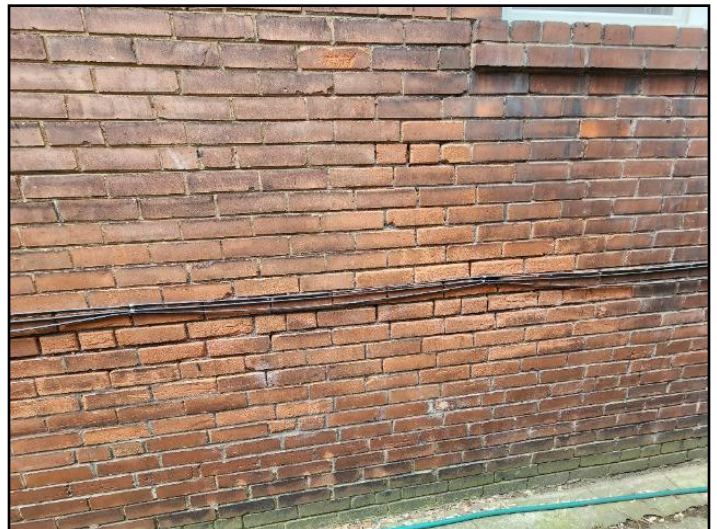
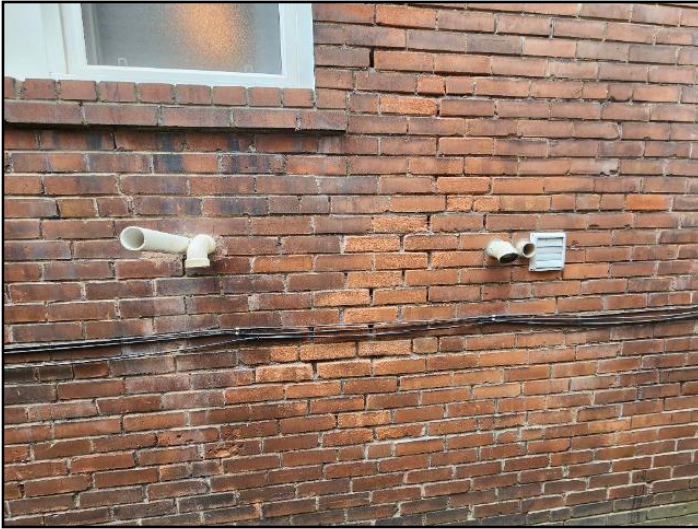
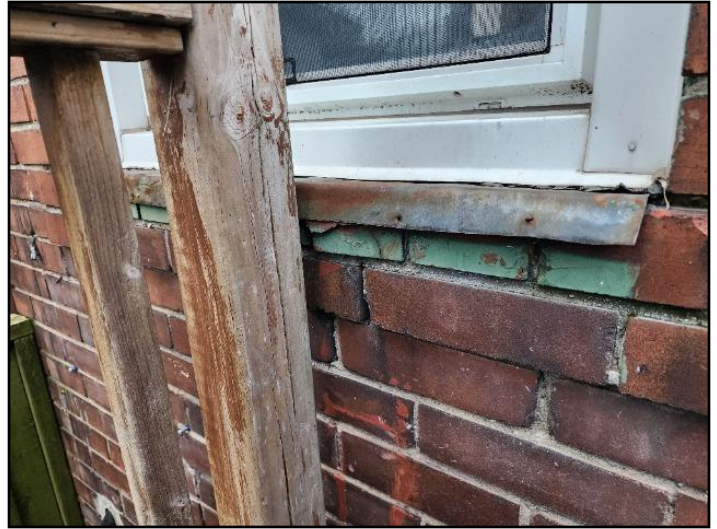
1. Condition: • Deteriorated or damaged

Clay brick will deteriorate if close to grade and absorbing moisture also we recommend using enviromentally friendly ice melter in winter seasons to avoid masonry deterioration

3. Deteriorated or damaged

4. Deteriorated or damaged

5. Deteriorated or damaged

6. Deteriorated or damaged

Task: Repair or replace

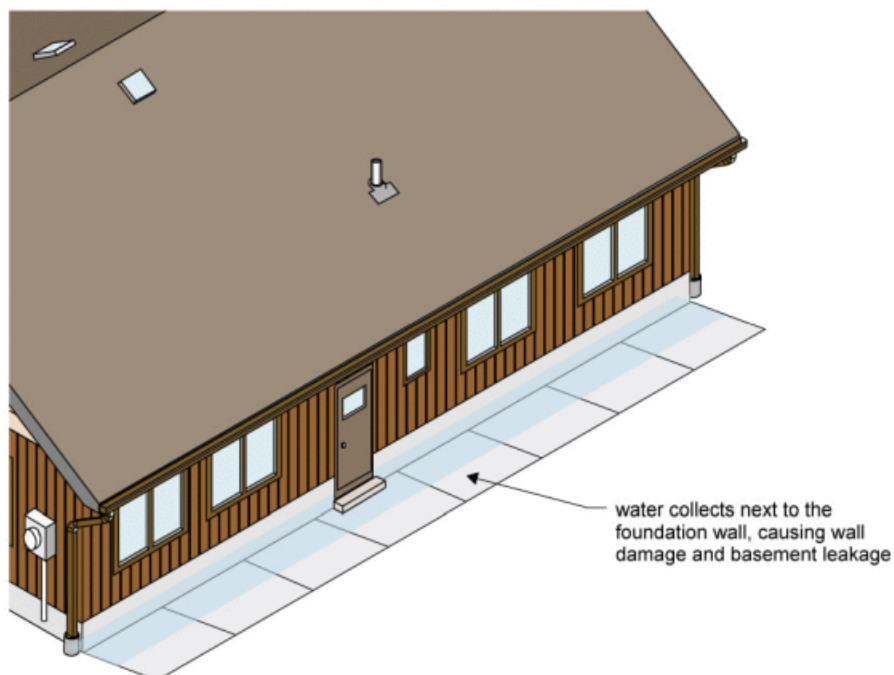
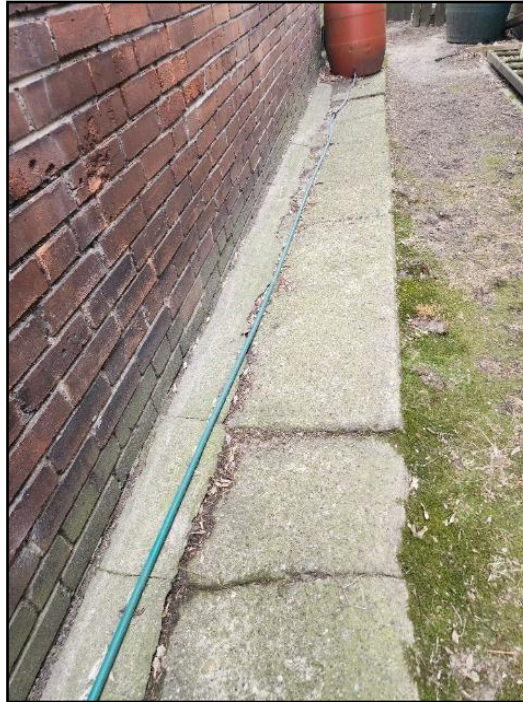
3. Condition: • [Improper slope or drainage](#)

Location: Along right side of home

Walk/patio sloping towards house

7. Improper slope or drainage

Task: Repair

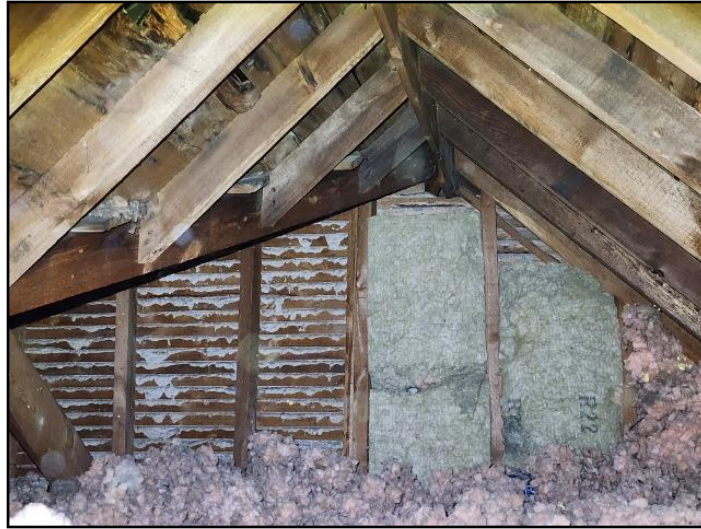
5. Condition: • Incomplete

Location: Attic common separation wall

9. Incomplete

Recommend adding proper fire separation materials & closure to the common wall

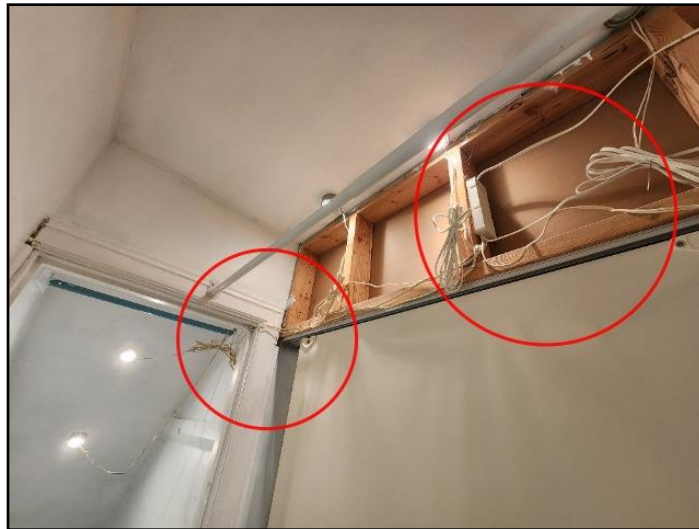
6. Condition: • [Loose](#)

Closet lighting, wiring all loose

Location: Front bedroom closet

11. Loose

Task: Repair

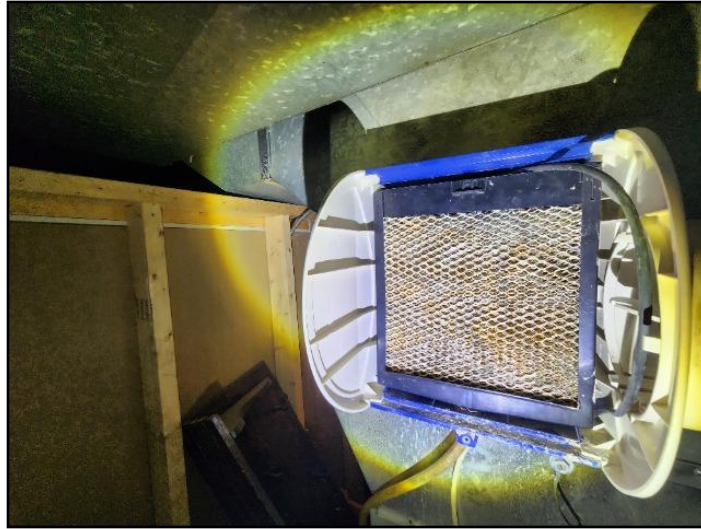
8. Condition: • Humidifier water pad requires regular cleaning or replacement

Location: Basement utility/ furnace room

14. Humidifier water pad requires regular...

Usually once a year, have cleaned before use in the winter season

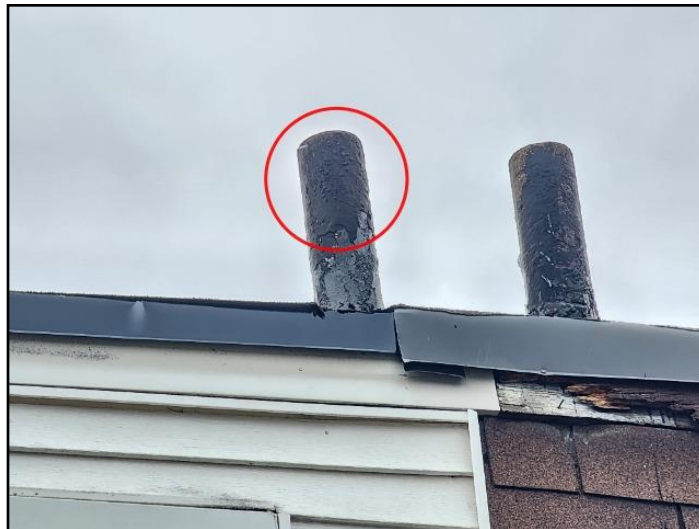
Condition: • Cast iron drain pipes. (Past its typical life expectancy) These drain pipes can be tied into clay drain pipes underground and beyond the foundation of the home.

12. Condition: • Cast iron drain pipes. (Past its typical life expectancy) These drain pipes can be tied into clay drain pipes underground and beyond the foundation of the home.

This piping issue is typical to this age bracket of home, and if only in use on the vent stack or vertical sections replacement may not be required

Location: Section(s) noted in basement or above the roof

20. Cast iron drain pipes. (Past its typical...

Recommend having piping scoped with a drain camera (all the way to the city connection) to check the condition and determine how urgent replacing or upgrading the pipes would be.

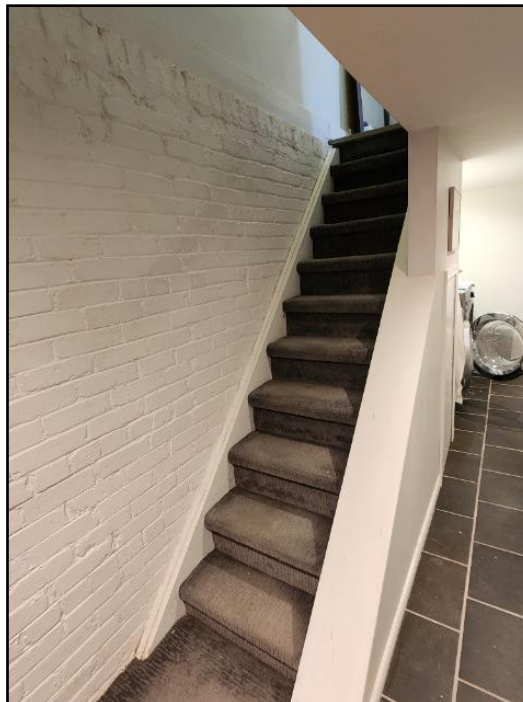
13. Condition: • [Missing](#)

27. Missing

Safety recommendation

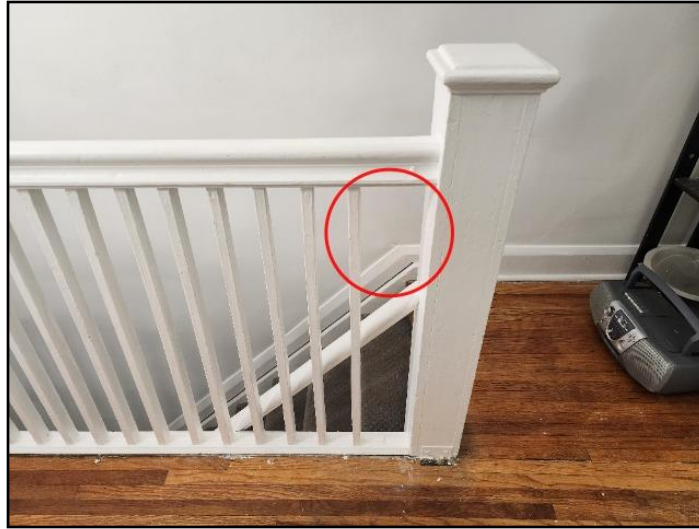
14. Condition: • [Too far apart](#)

28. Too far apart

Safety recommendation

Task: Repair/ adjust
