YOUR INSPECTION REPORT

FOR THE PROPERTY AT:
387 Kennedy Avenue
Toronto, ON M6P 3C5

INSPECTION DATE:
Thursday, February 26, 2026

RE: Report No. 9098, v.4
387 Kennedy Avenue
Toronto, ON
M6P 3C5

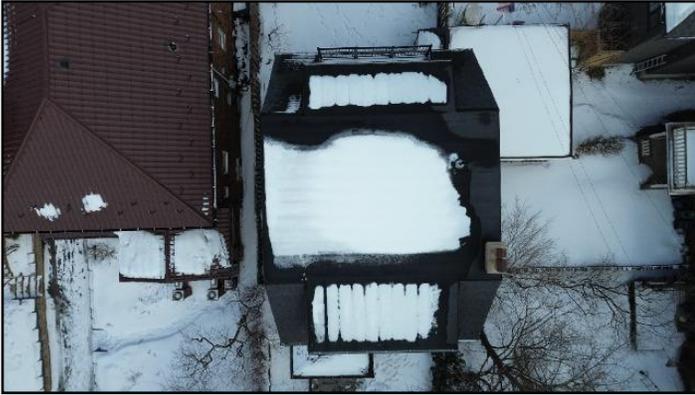
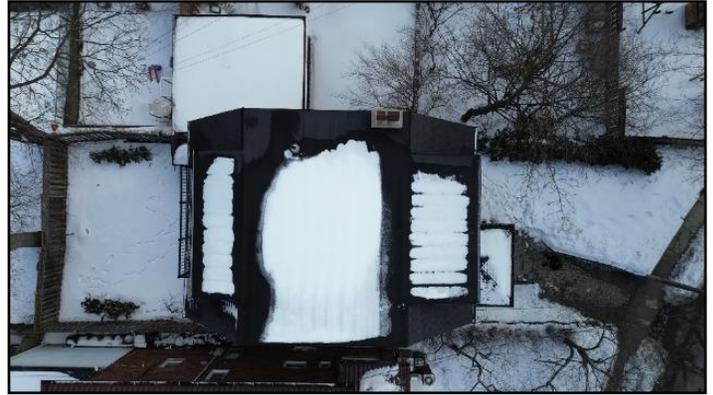
Inspection limited/prevented by: • Snow/ice/frost • Due to significant snow accumulation at the time of inspection, roof-related components could not be evaluated.

1. Roof view

2. Roof view

Once snow conditions permit, these areas should be re-evaluated to confirm overall condition.

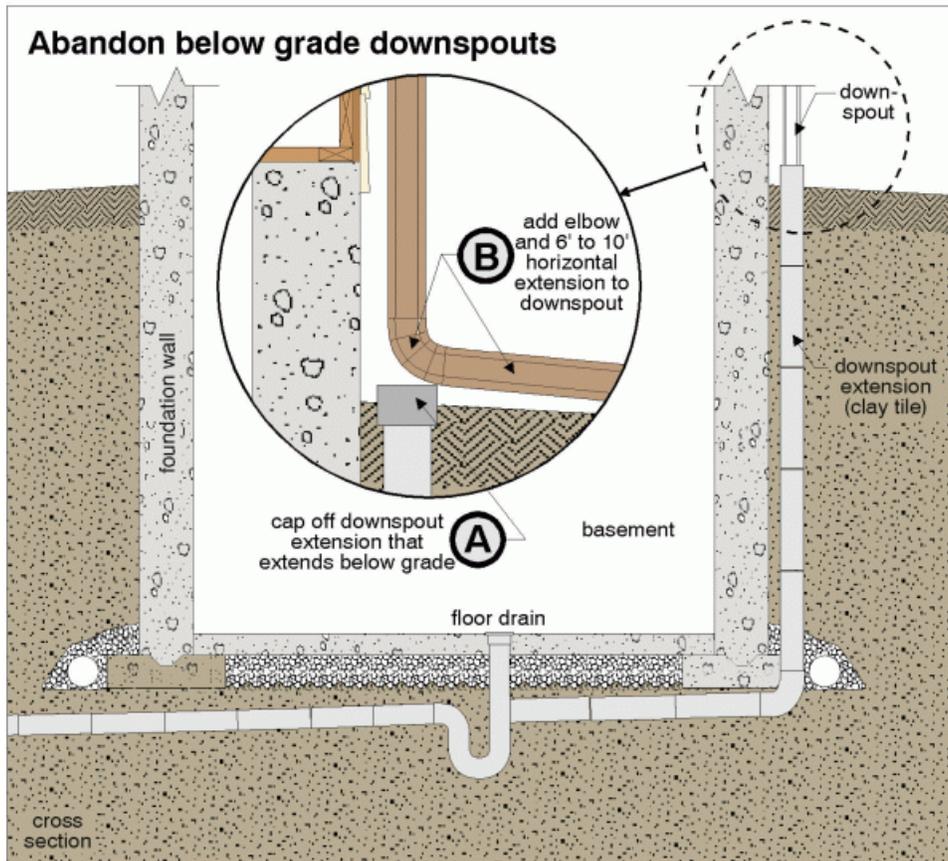
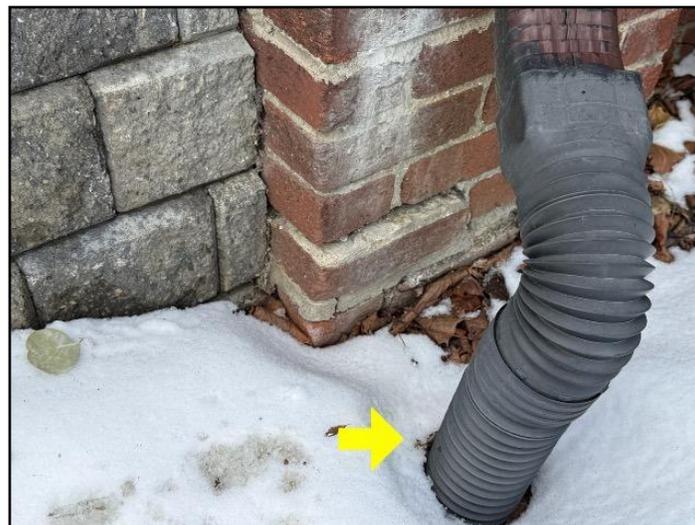
Condition: • Discharge below grade

3. Discharge below grade

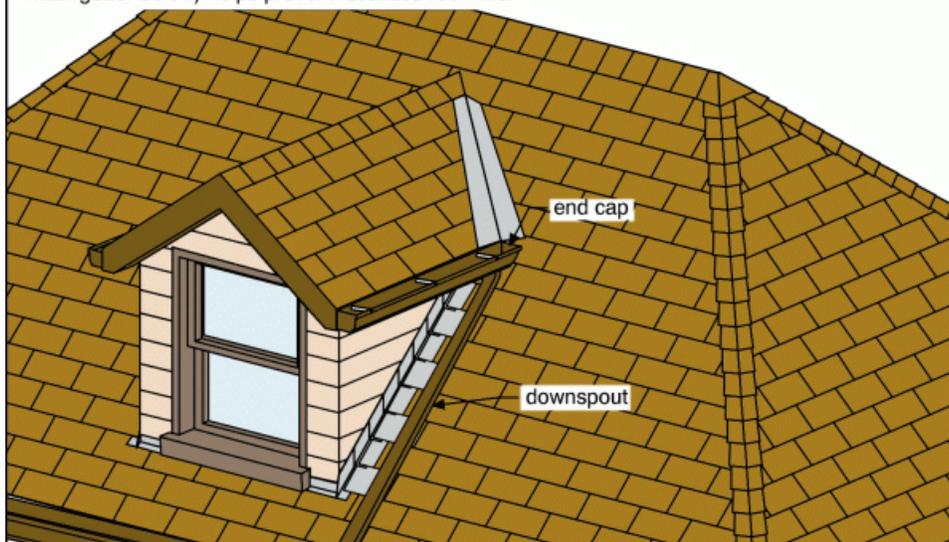
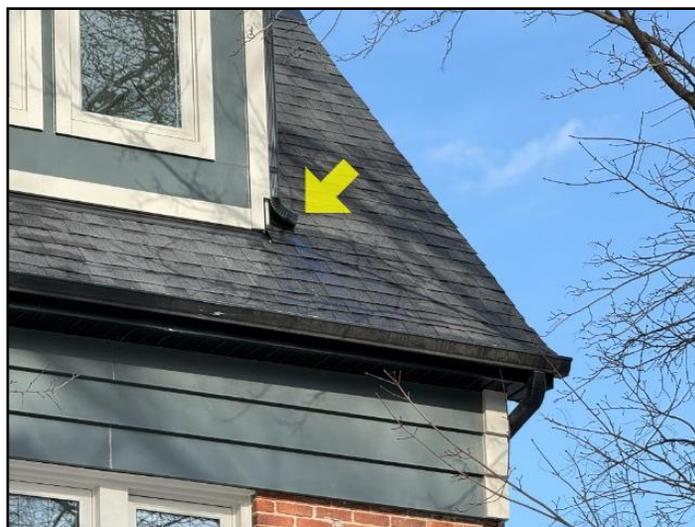
Condition: • [Discharge onto roofs](#)

Downspout running across roof

4. Discharge onto roofs

Improvement recommendation - Extend Downspout to lower gutter to protect roof covering from premature wear.

installing a downspout (from the secondary roof to the main gutter below) helps prevent localized roof wear

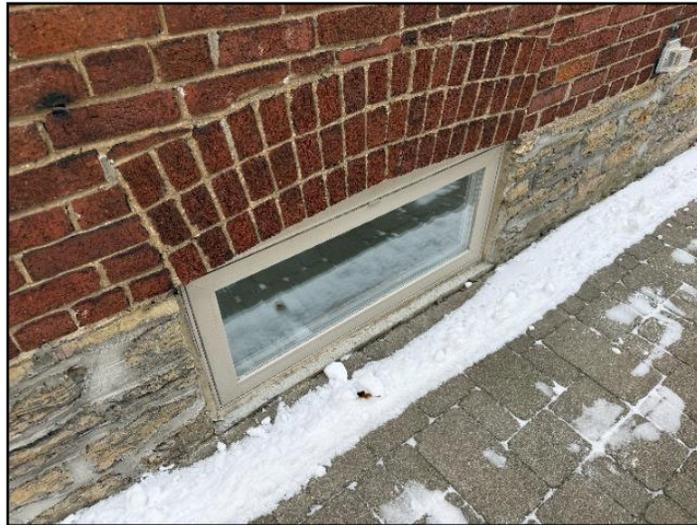
Basement window at or near grade level. Modern standards recommend that the bottom of the window be at least 6 inches above grade or have a window well installed. Consider adding window well if regrading or when necessary. In the meantime, ensure windows remain well-sealed to prevent water intrusion.

5. Sill - Near or at Grade Level

Task: Monitor for moisture intrusion / Improve

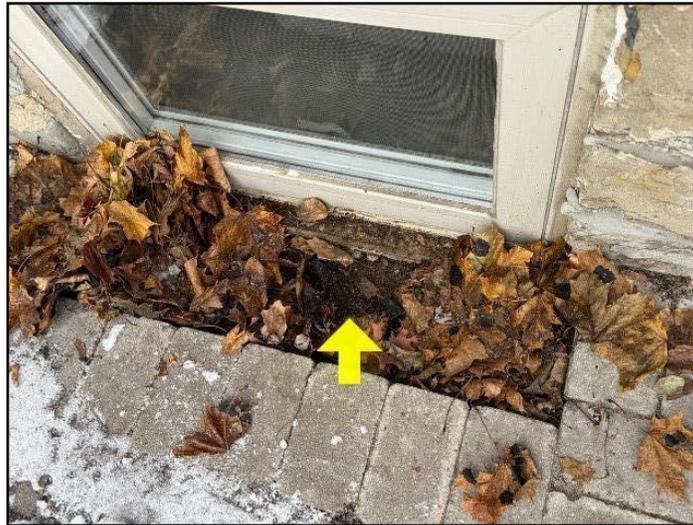
6. Rear window well

Condition: • [Missing](#)

Window well was filled with debris and organic material at the time of inspection. Less than approximately 6 inches of clearance was observed below the window frame. No gravel base or drain was visible after limited clearing of debris; presence of a drain could not be confirmed.

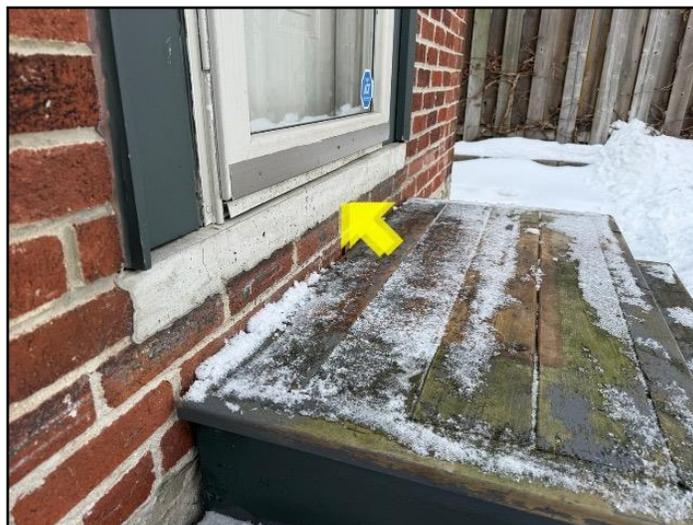
Condition: • [Inadequate sill projection](#)

7. Missing

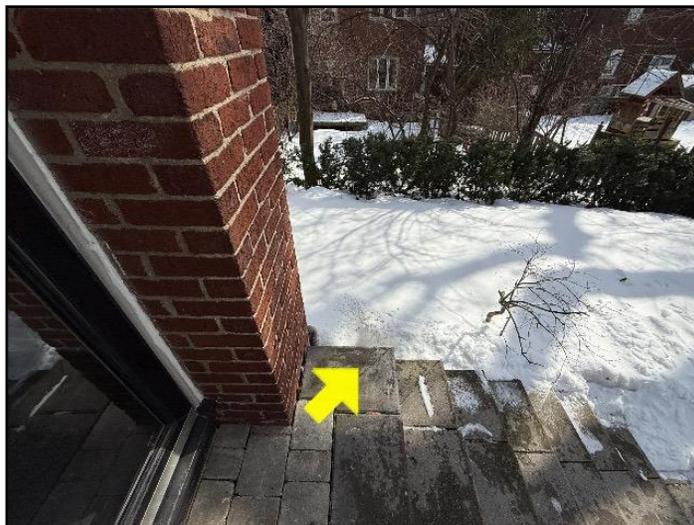
Condition: • [Missing](#)

Implication(s): Fall hazard

8. Missing

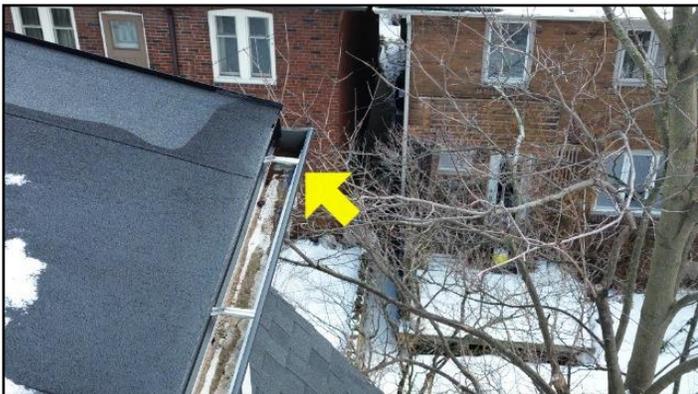
9. Loose fastener

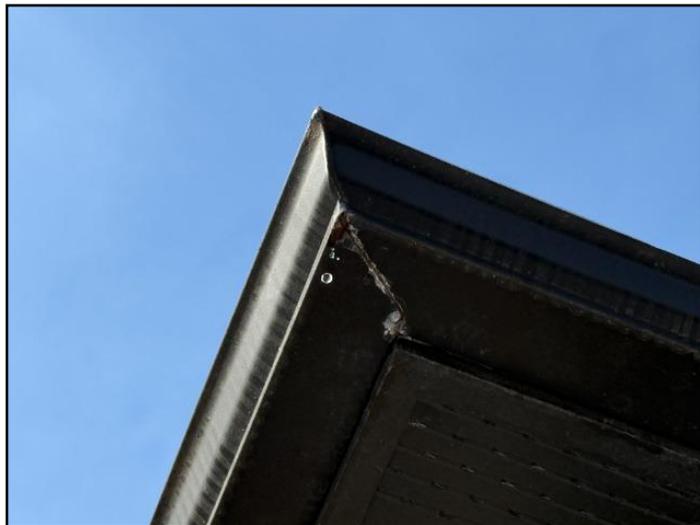
10. Gutter joint

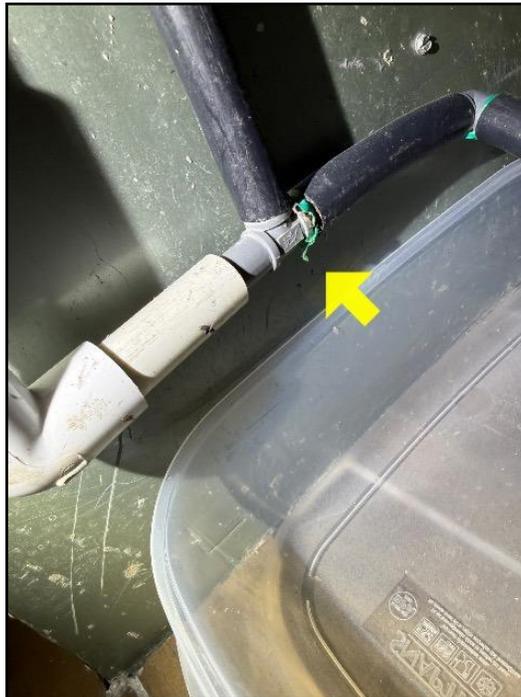
Condition: • Condensate drain line problems

Minor leak at condensate drain tube at the time of the inspection.

12. Condensate leak

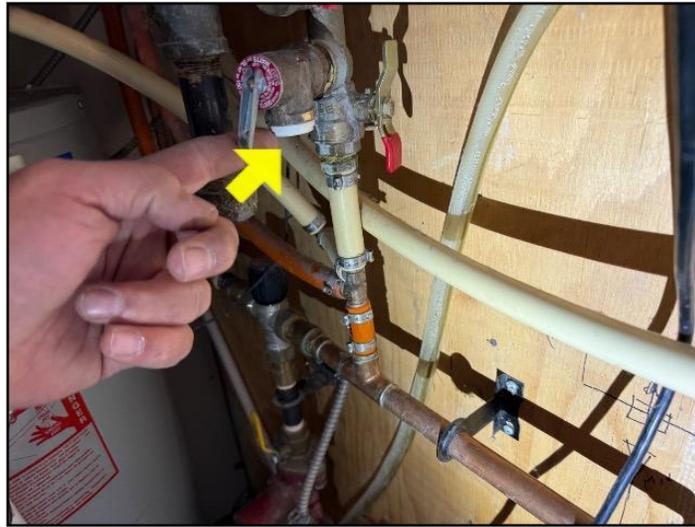
Condition: • [No pipe extension](#)

13. No pipe extension

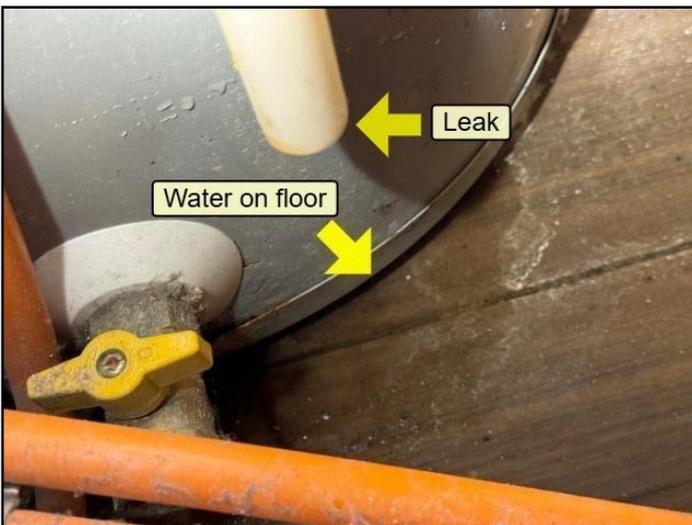
Condition: • [Leaking](#)

Implication(s): Chance of damage to finishes

15. Leaking

Task: Service

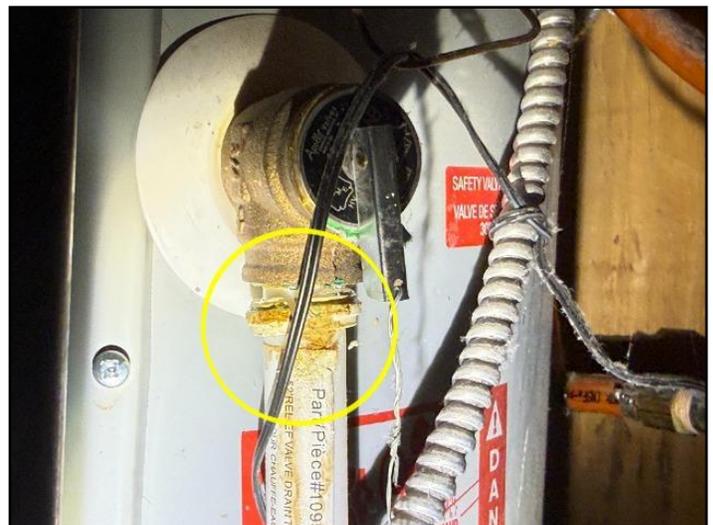
16. Leaking

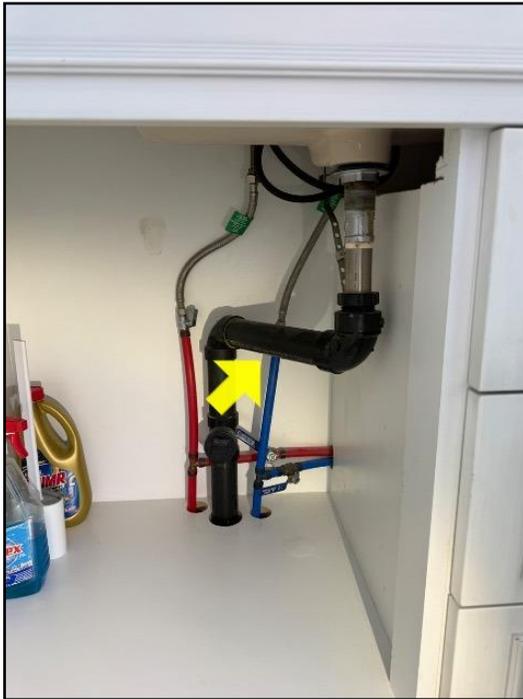
17.

Condition: • [Tailpiece \(fixture outlet pipe\) too long](#)

Task: Monitor for siphoning / Improve
