# YOUR INSPECTION REPORT

FOR THE PROPERTY AT:  
61 Skylark Road  
Toronto, ON M6S 4M5

INSPECTION DATE:  
Friday, September 19, 2025

RE: Report No. 8553, v.3  
61 Skylark Road  
Toronto, ON  
M6S 4M5

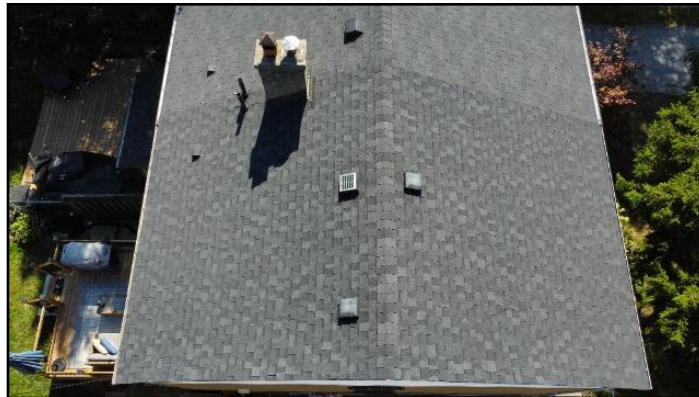
1. Asphalt shingles -- Good condition

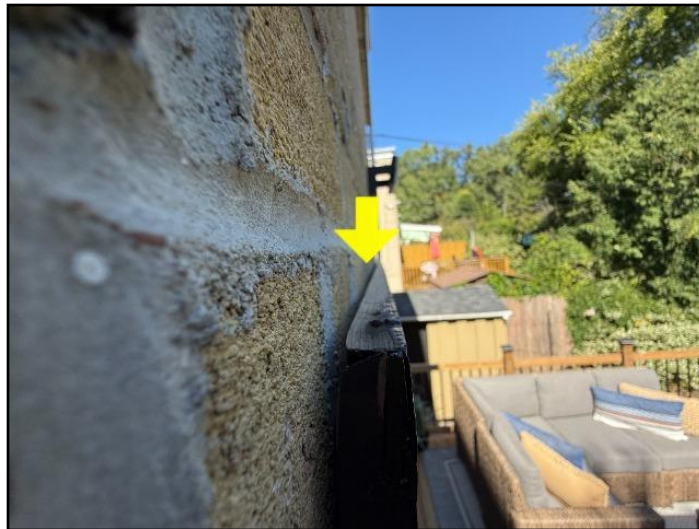
**Condition:** • [Caulking missing, loose or deteriorated](#)

2. Caulking missing

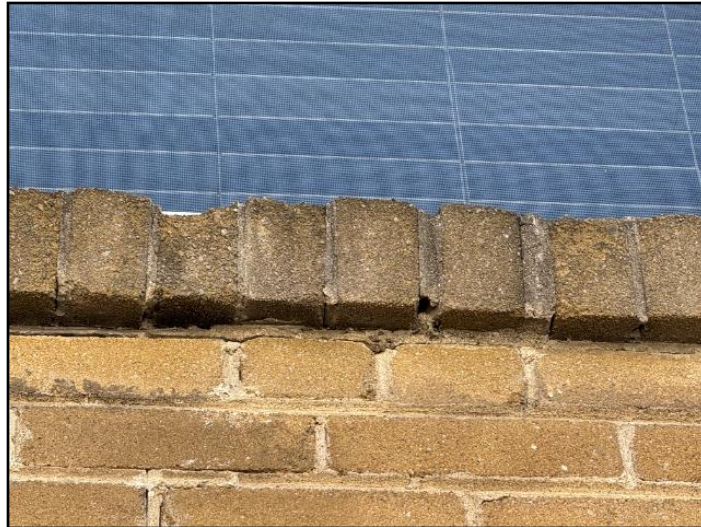
3. example

**Condition:** • [Sill deteriorated](#)

Masonry deterioration is commonly observed on exterior window brick sills. Brick sills typically deteriorate over time. Consider replacing them with limestone or concrete sills to reduce long-term maintenance requirements.

**Task:** Repair or Replace

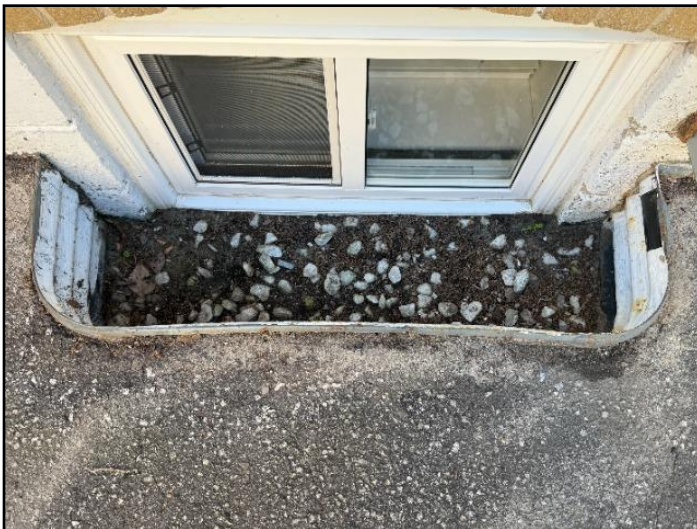
**Condition:** • [Less than 6 inches below window](#)

4. Less than 6 inches below window

Additionally plastic well covers recommended

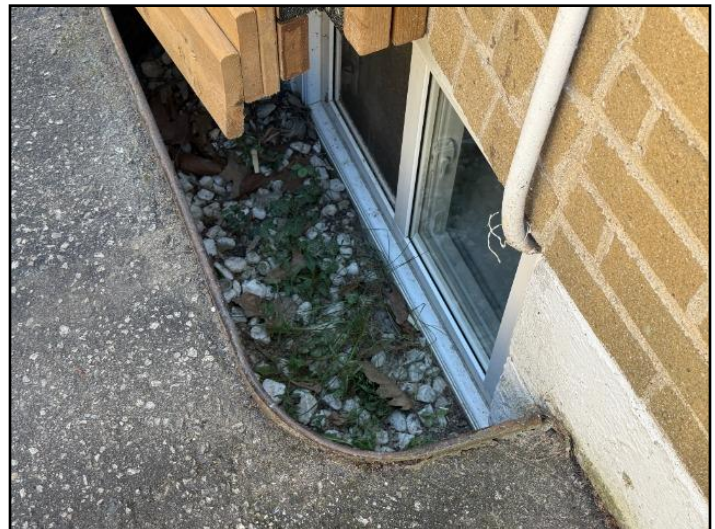
5. Less than 6 inches below window

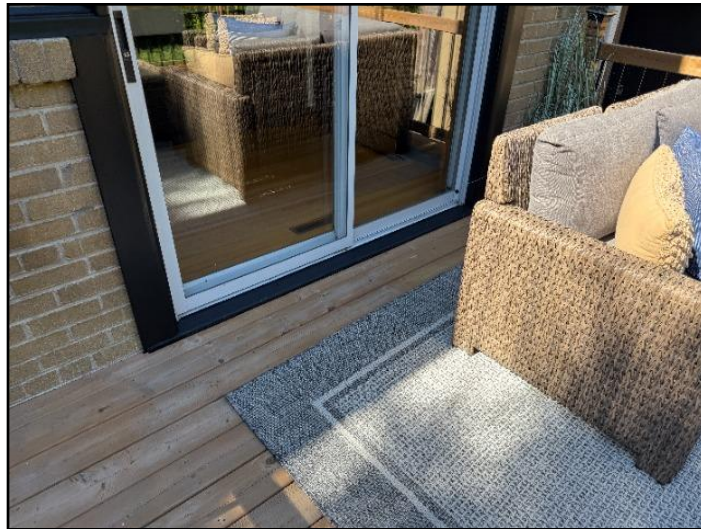
**Condition:** • Threshold too low

Having a minimal step makes the inside/outside transition easier. On the other hand, it also makes it more prone to snow buildup/leakage.

6. Threshold too low

While it is probably not practical to improve the current situation, it will be important to keep any weatherstripping/caulking in good condition.

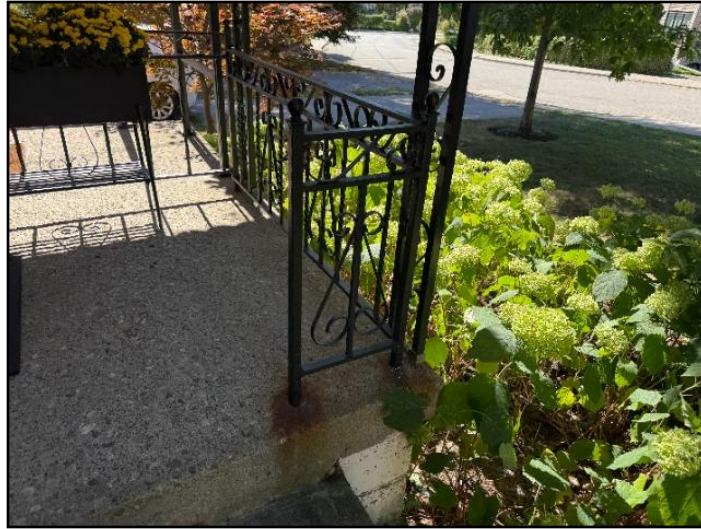
**Condition:** • [Too low](#)

**Implication(s):** Fall hazard

7. Too low

**Task:** Upgrade

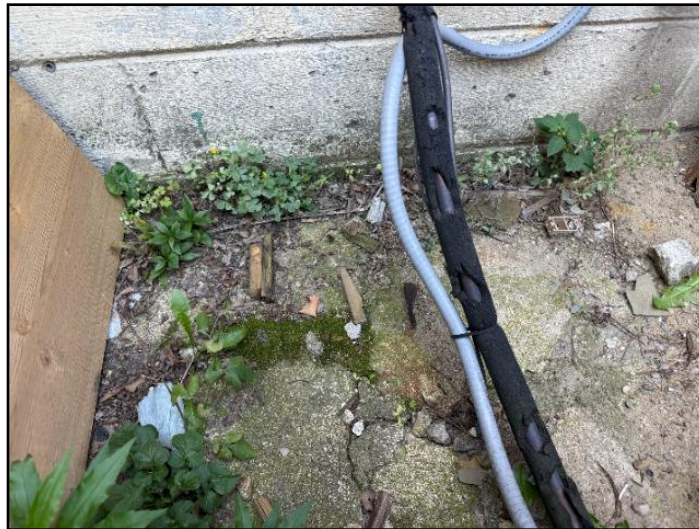
**Condition:** • Low Areas.

8. example of low area

Fill in low areas and ensure the ground slopes away from the home for at least 6 feet to promote proper drainage. This is a standard maintenance practice for all homes to prevent water accumulation near the foundation

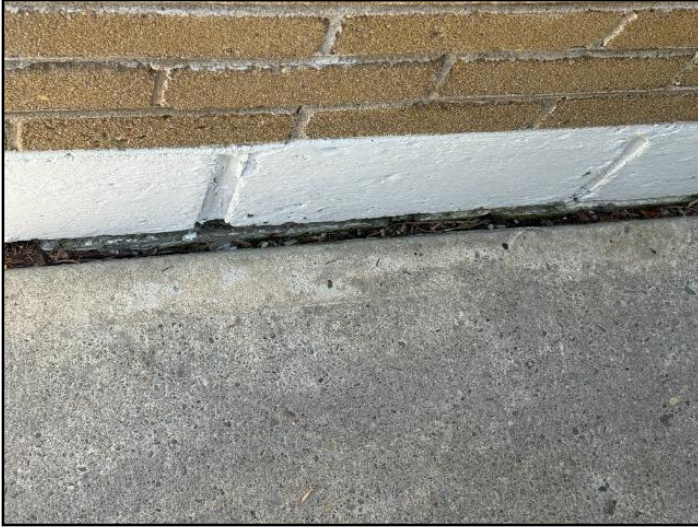
**Condition:** • [Unsealed gap at building](#)

9. Unsealed gap at front

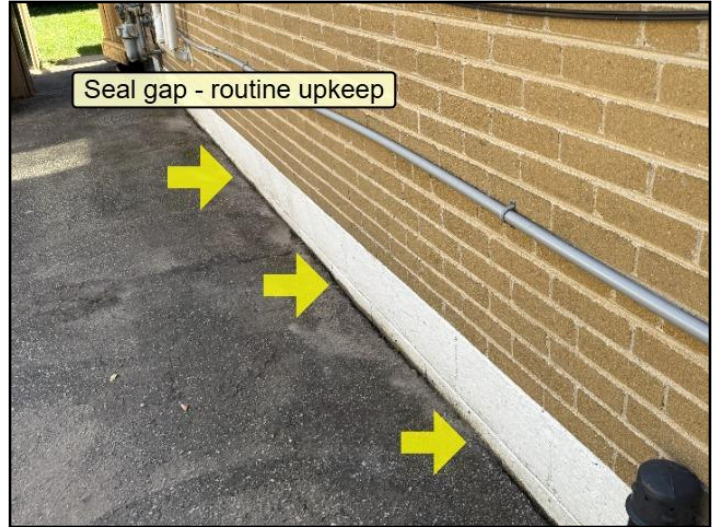
10. Unsealed gap at building

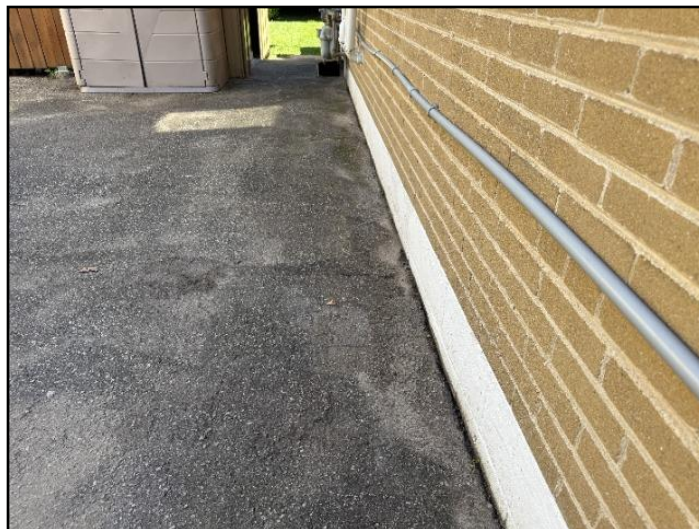
**Condition:** • Driveway settlement / low areas near home.

11. Driveway settlement near garage

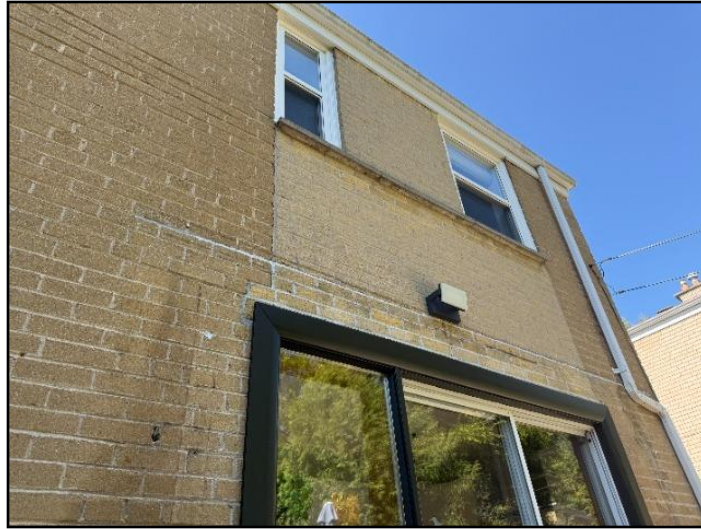
12. example

**Condition:** • [Prior repairs](#)

It is common to find a multitude of wall repairs on homes of this age (including prior window removals or new door/window installations)

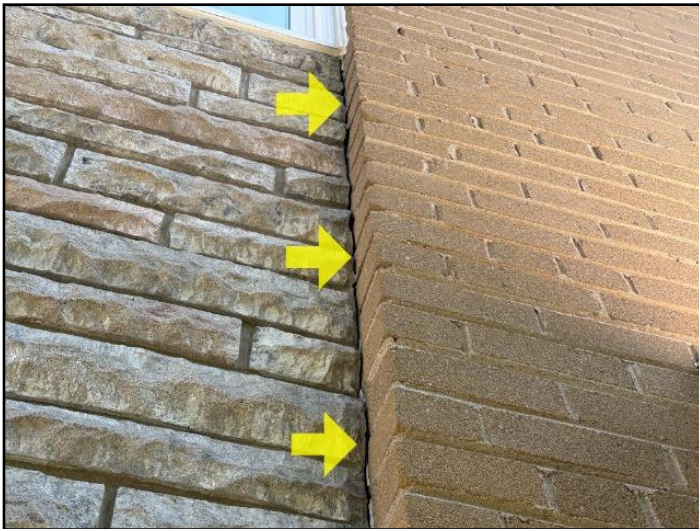
**Condition:** • [Mortar missing](#)

13. Mortar missing

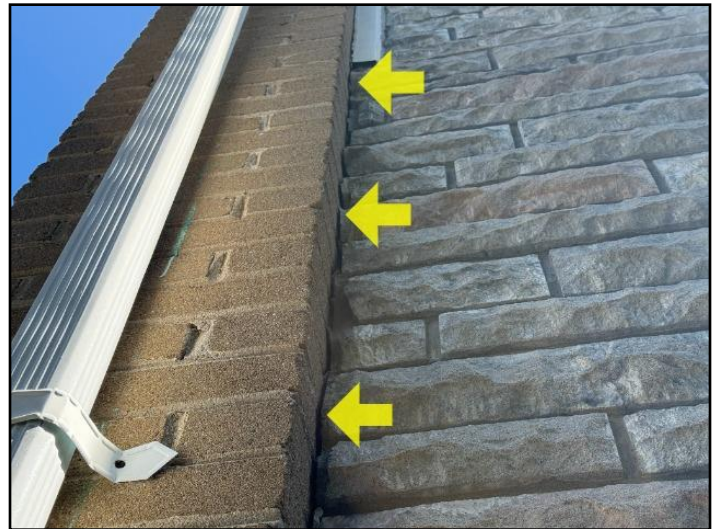
14. Mortar missing

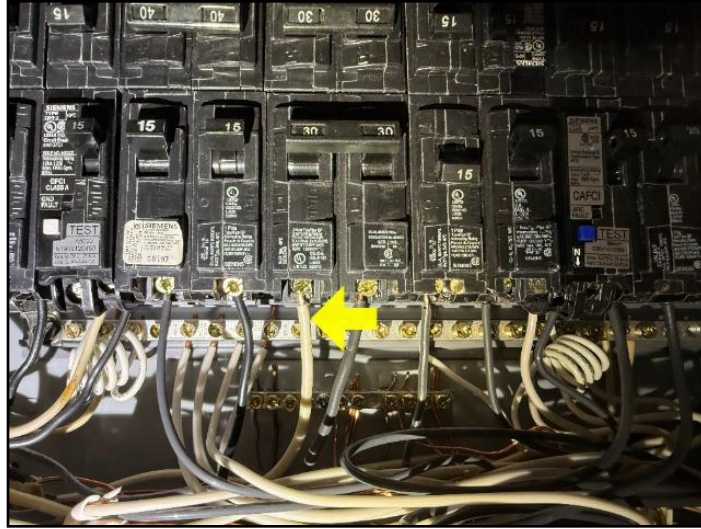
**Condition:** • White wires connected to breakers not identified as hot/live/ungrounded

16. White wires connected to breakers not...

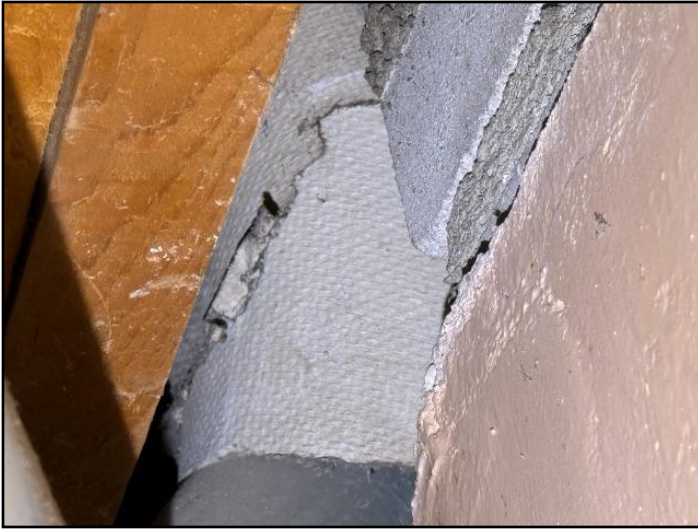
**Condition:** • Insulation on ductwork may contain asbestos

**Implication(s):** Potential health hazard if disturbed

17. Insulation on ductwork may contain asbestos

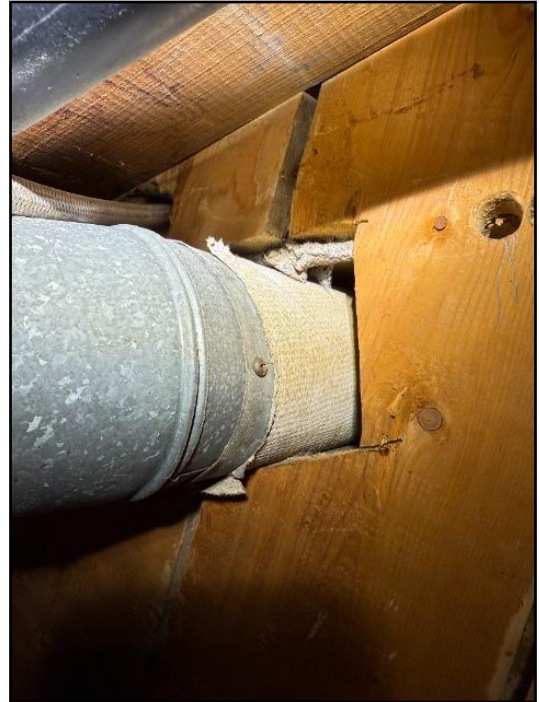
18. Insulation on ductwork may contain asbestos

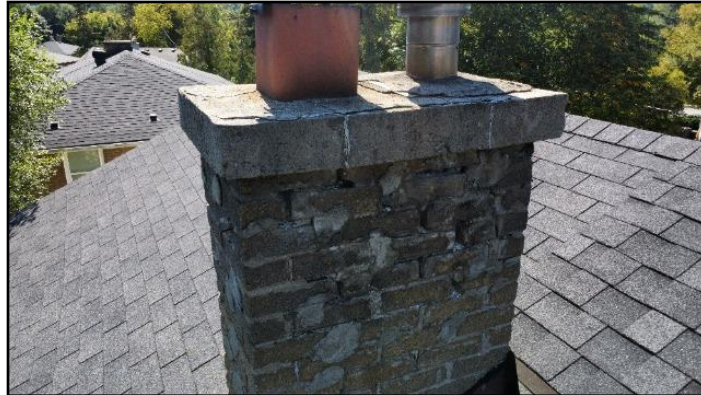
**Condition:** • Loose, missing or deteriorated masonry and/or mortar

Additionally, chimney cap (crown) exhibits cracks. Appears to be a shared chimney - typically repair costs are shared.

19. Loose, missing or deteriorated masonry...

**Task:** Repair

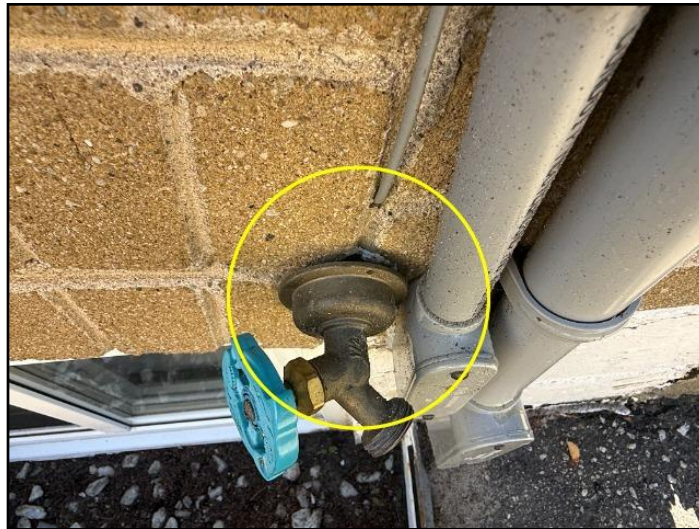
**Condition:** • Handle loose OR damaged

22. Handle loose OR damaged

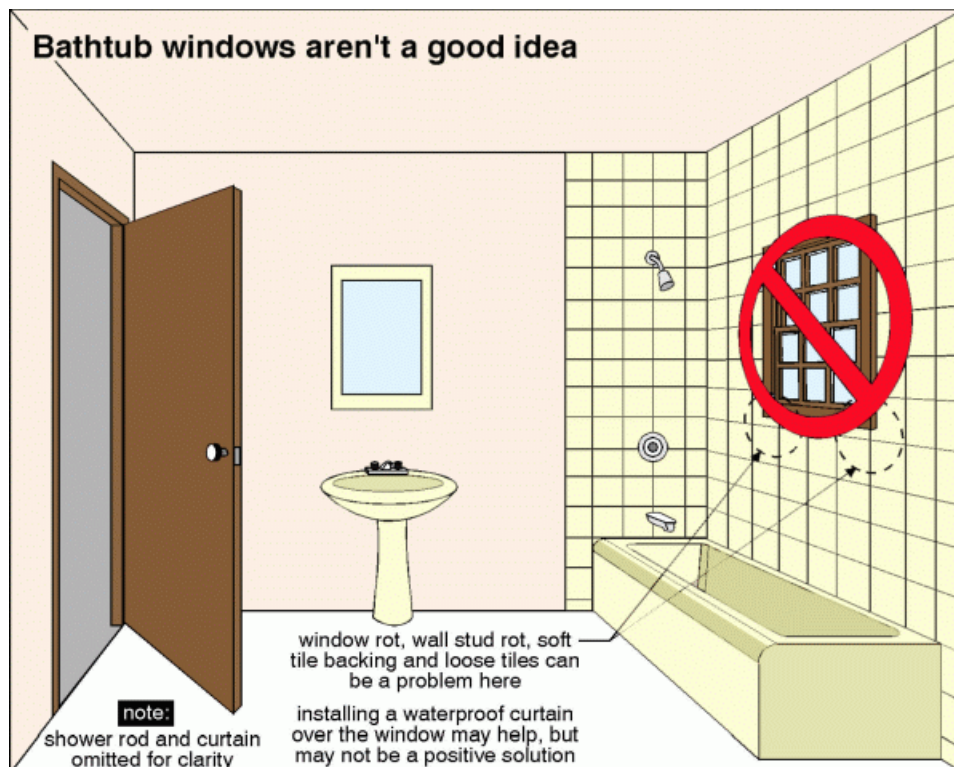
**Condition:** • [Unprotected window](#)

Windows in bathtub area were common when this house was originally built. These windows are vulnerable to water damage. Shower Curtain can provide temporary protection. Ensure grout and caulking are maintained regularly

**Task:** Protect

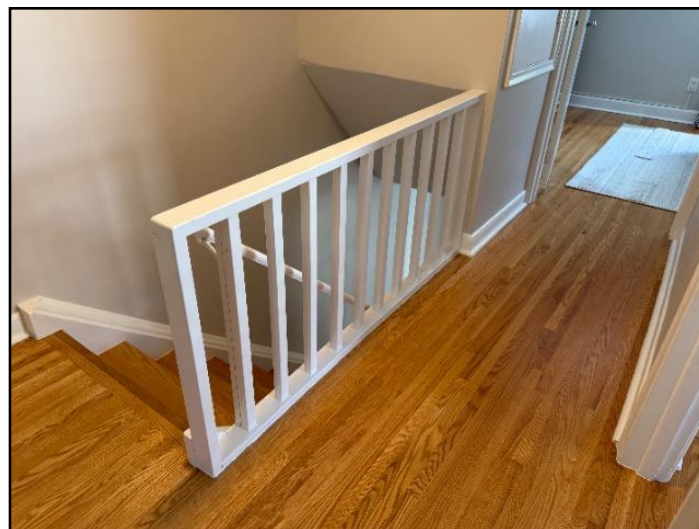
**Condition:** • [Too low](#)

**Implication(s):** Fall hazard

23. Too low

**Task:** Upgrade

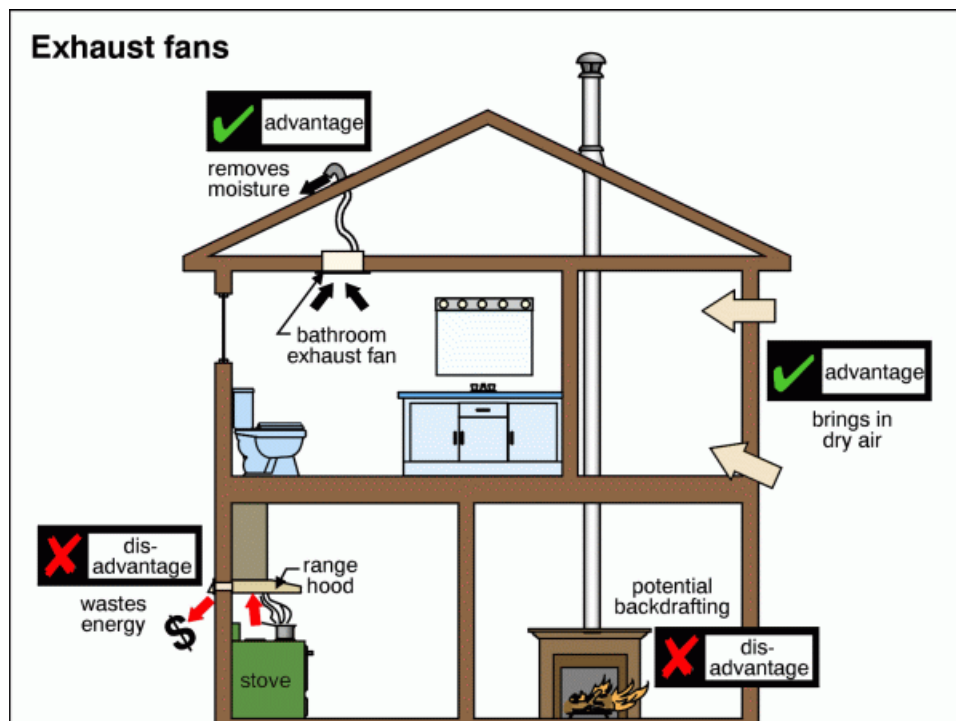
**Condition:** • [Missing](#)

Exhaust fans in bathrooms are recommended upgrades. While not standard when the house was originally built, when only windows were required, exhaust fans help to remove moisture, which could otherwise contribute to mildew and mold growth.
