Your Inspection Report

90 Brown St
Port Hope, ON L1A 3E3

INSPECTION DATE:
Wednesday, December 10, 2025

RE: Report No. 5915
90 Brown St
Port Hope, ON
L1A 3E3

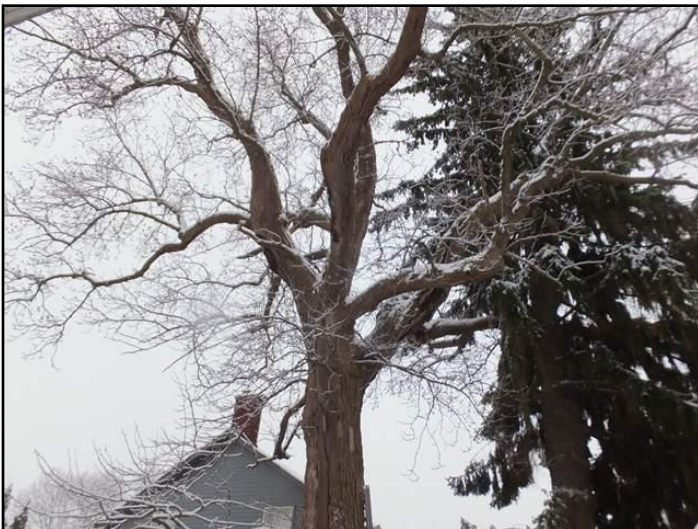
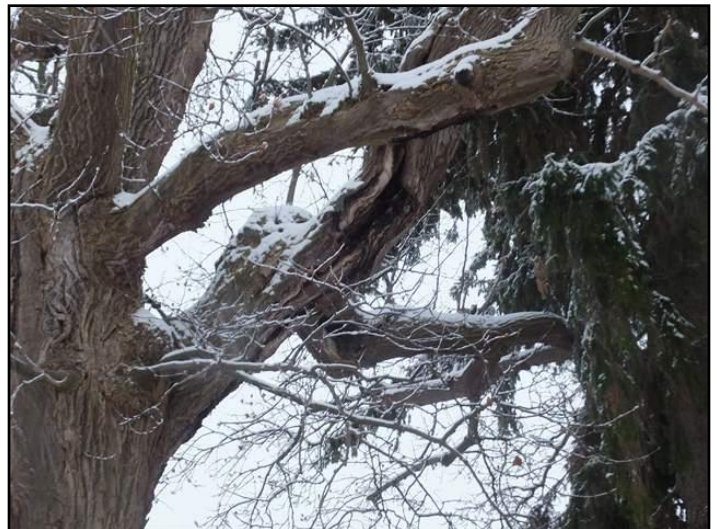
Condition: • Older tree at the rear may require some pruning. Consult with an arborist or tree maintenance company.

Implication(s): Dead branches can fall and cause damage to fences or structures.

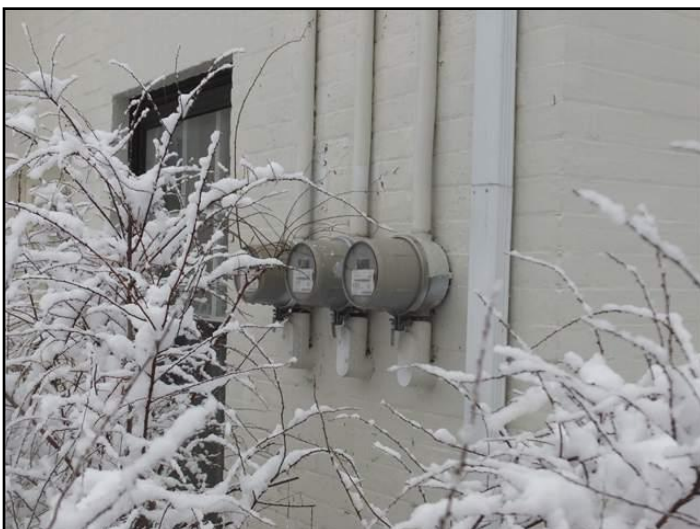
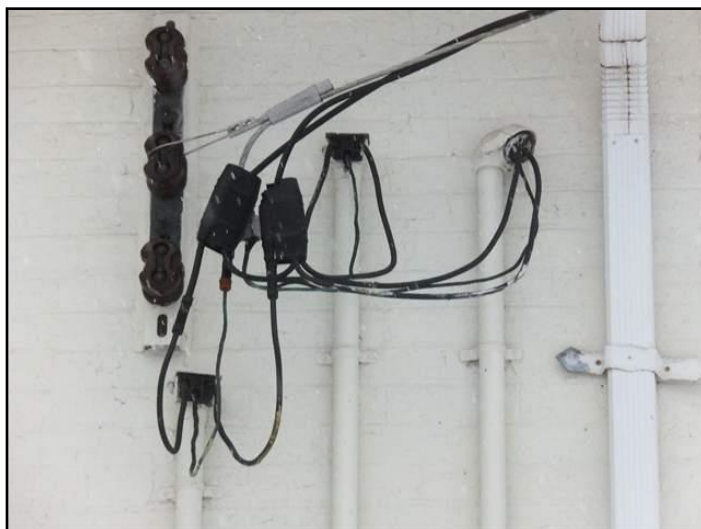
Three 100 amp services, separately metered

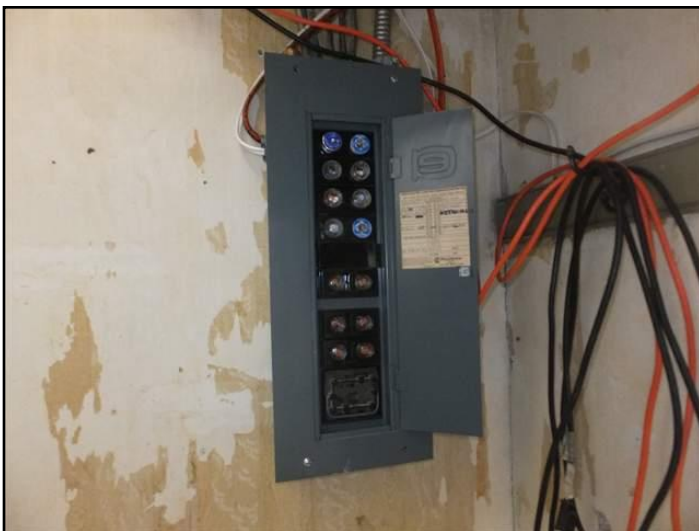
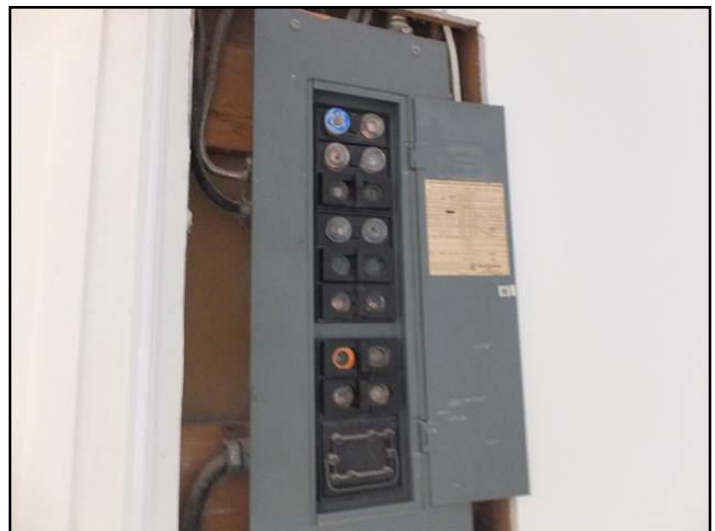
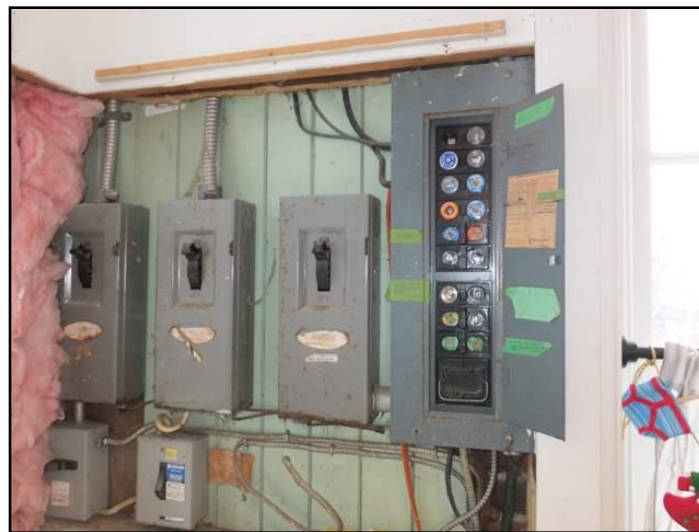
Condition: • [Obsolete](#)

The presence of fused electrical panels may be an issue with some insurers.

Implication(s): Electric shock | Fire hazard

Budget for eventual replacement of the older fused shut-offs and distribution panels.

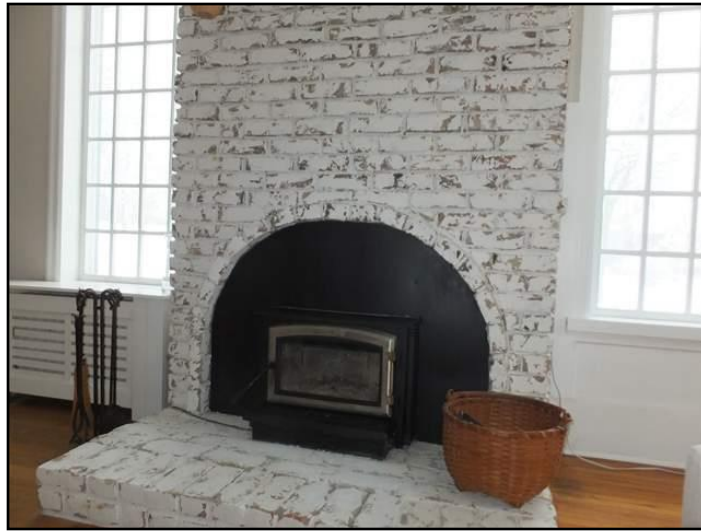
8.

Condition: • Do NOT use either of the solid fuel fireplaces unless inspected and approved for use by a WETT certified professional.

Implication(s): Safety and insurance requirements

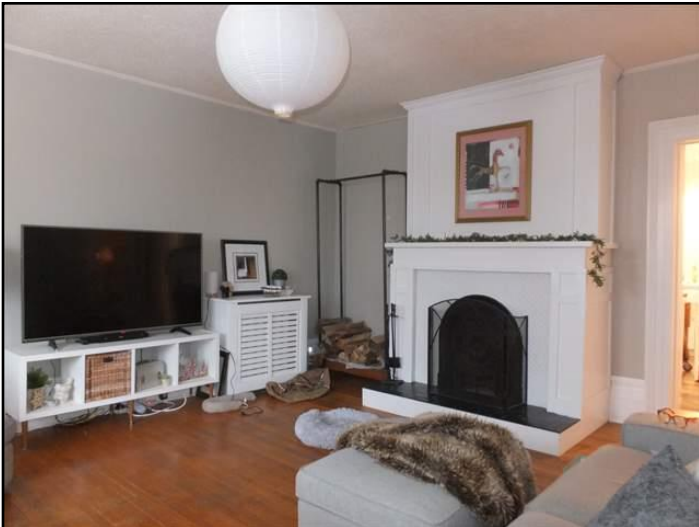
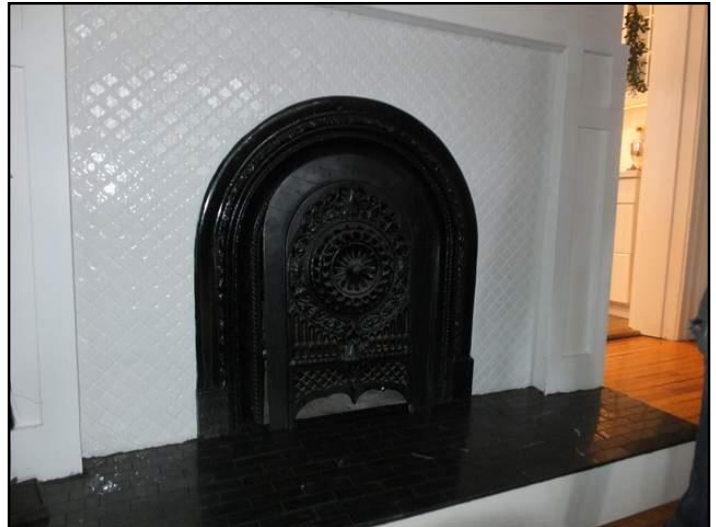
Condition: • [Designed for coal. Consult a specialist before using.](#)

Implication(s): Hazardous combustion products entering home | Fire hazard

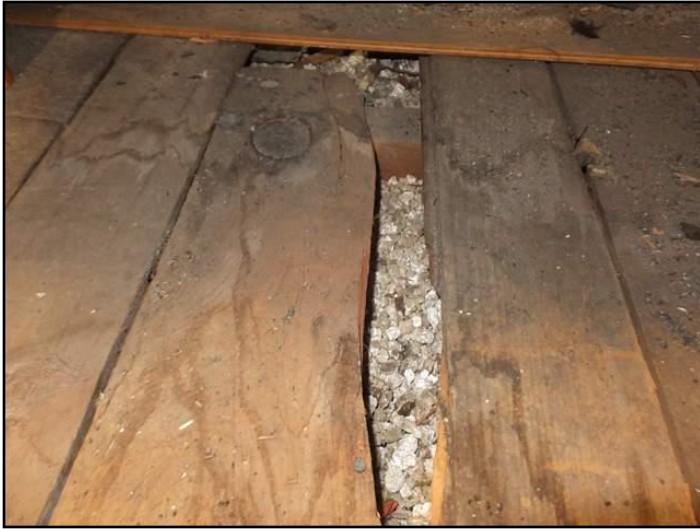
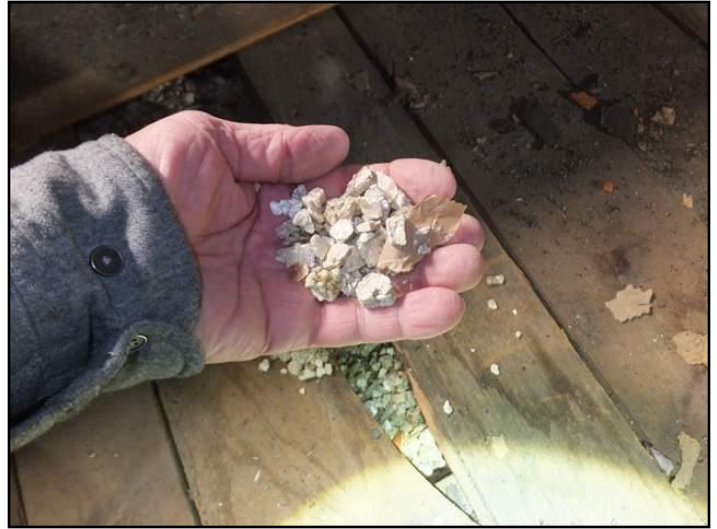
Condition: • [Possible Zonolite \(vermiculite\)](#)

Some forms of vermiculite (eg: Zonolite) are known to potentially contain asbestos, which is a known carcinogen.

Presence or absence of asbestos in vermiculite cannot be determined by visual inspection. * The Seller is reportedly in possession of a report from an environmental laboratory stating that no asbestos was found in the insulation samples provided.

Task: Provide environmental laboratory report

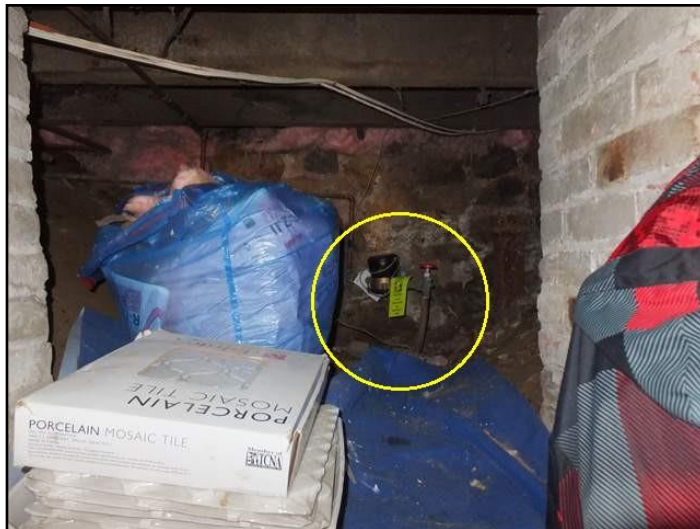
13. North side of basement area
