YOUR Inspection Report

123 Hometown Street
Anywhere, PE

Friday, April 2, 2010

RE: Report No. 1179, v.3
123 Hometown Street
Anywhere, PE

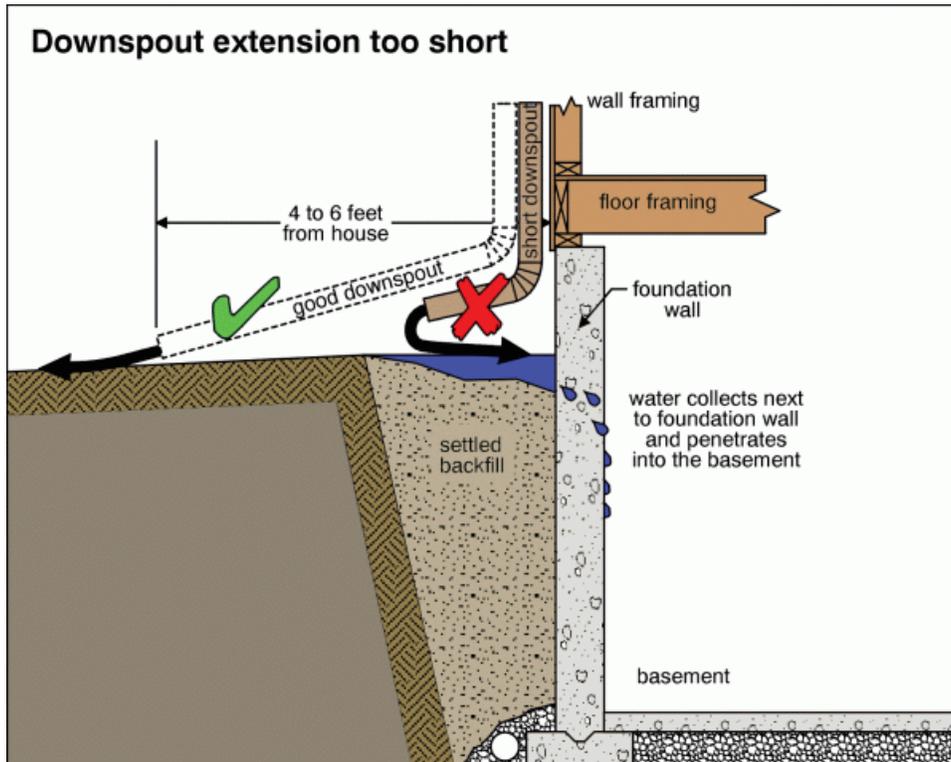
3. Condition: • Should discharge 6 feet from building

Implications: Chance of water damage to structure, finishes and contents.

3. Missing downspout kick out

Task: Provide

Time: Immediate

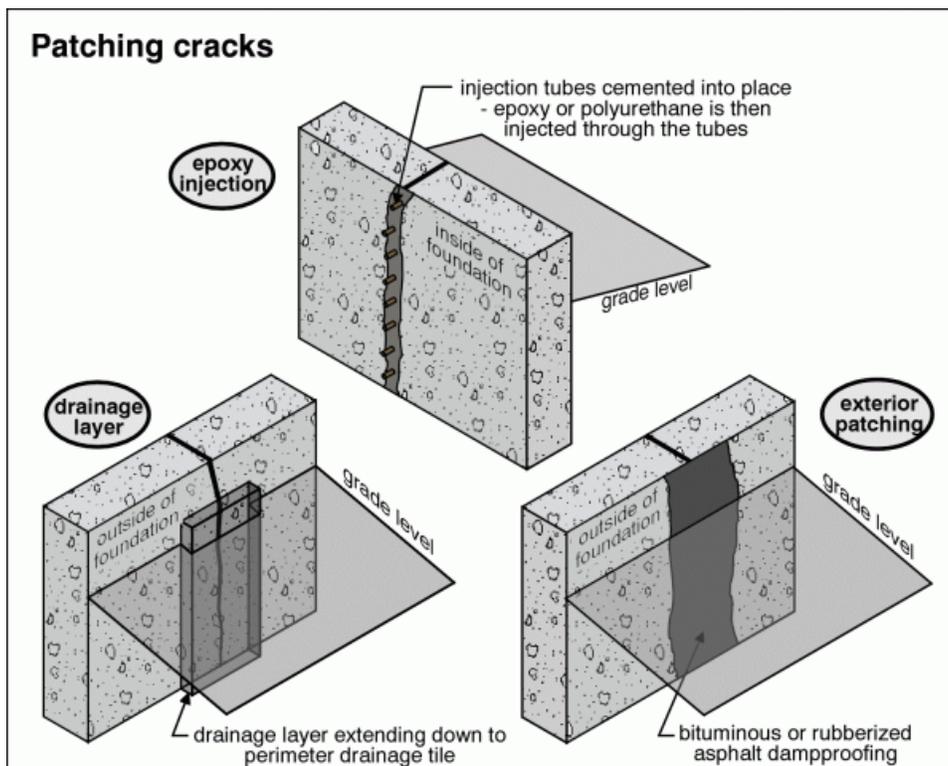
6. Condition: • Typical minor cracks

Implications: Chance of water entering building through crack.

Task: Monitor for leaks

Time: Discretionary

Crack repair - epoxy and polyurethane injection

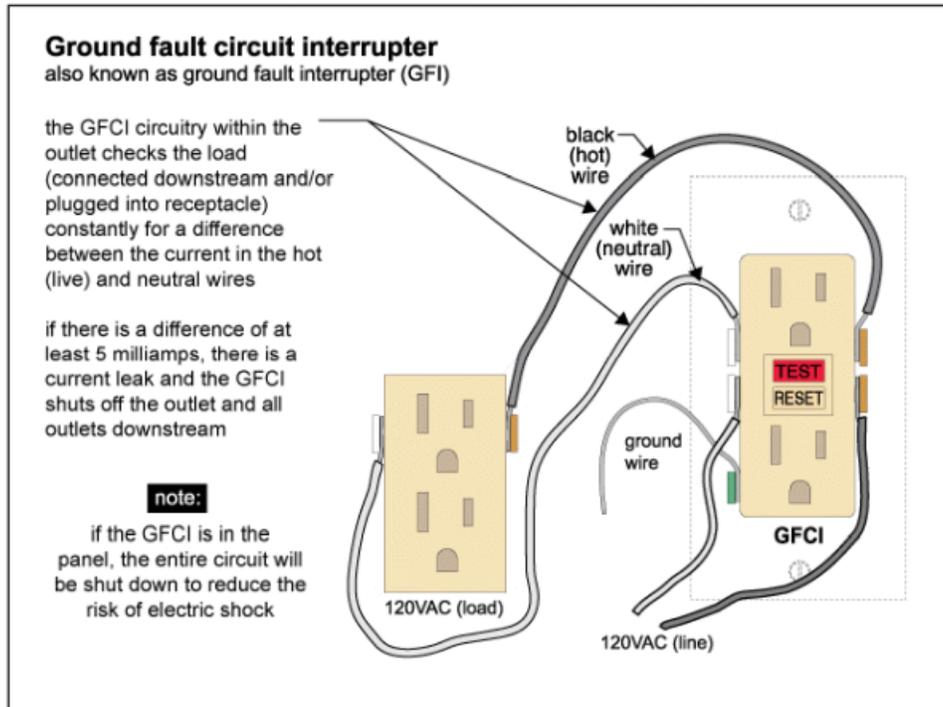
9. Condition: • No GFCI/GFI (Ground Fault Circuit Interrupter)

Task: Provide GFI outlet for safety

Time: ASAP

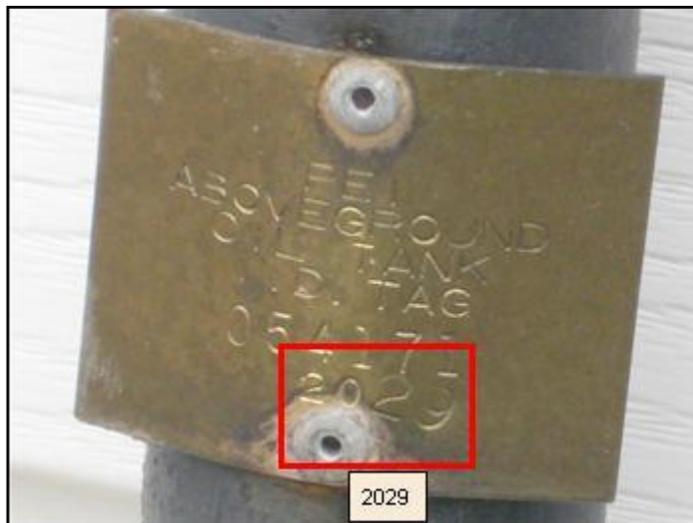
12.

• Replacement date of the steel oil tank. The steel oil tank expires on June 30 of the stamped year on the brass tag. This brass tag can be found fastened to the oil tank vent pipe located at the exterior of the home. This is a requirement by the PEI Government oil tank regulations.

The expiry date on the tag is not a guarantee of the steel oil tank's integrity. Property owners are responsible for their tank's quality and condition. Regular Inspections for rust are recommended.

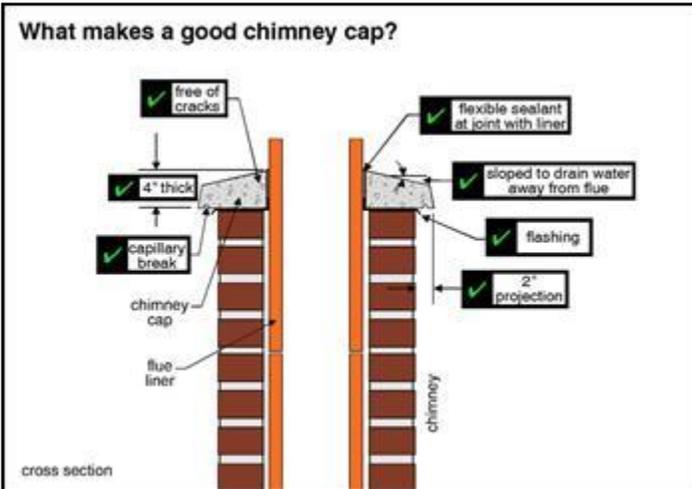
13. Condition: • This brick chimney appears to have no liner and lacks a proper chimney cap. It is recommend when burning wood that flu liner be installed inside the brick chimney. This flu liner, installed properly is a second layer of protection from fumes entering the home and flu fires. Flu fires can lead to structural fires. Your Insurance company may require a liner in the chimney. Implications: Carbon monoxide poisonous fumes entering the home, illness, Fire Hazard.

Task: Provide a chimney liner

Time: ASAP

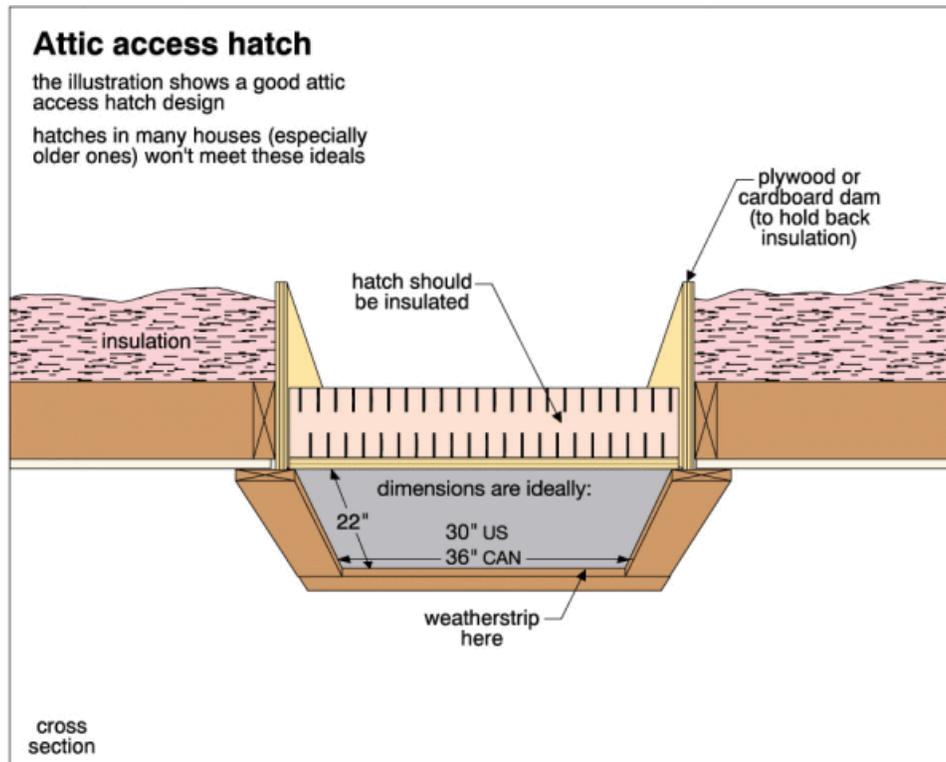
14. Condition: • Not insulated and not weatherstripped

Attic hatch Not insulated, weather stripped. Implications: Chance of condensation damage to finishes and/or structure, Increased heating and cooling costs, Reduced comfort.

Task: Provide insulation and weather stripping

Time: Less than 1 year
