Your Inspection Report

7 Innisfree Crt
Toronto, ON M6S 3N7

PREPARED BY:
Scott Lutz, RHI

RE: Report No. 97297
7 Innisfree Crt
Toronto, ON
M6S 3N7

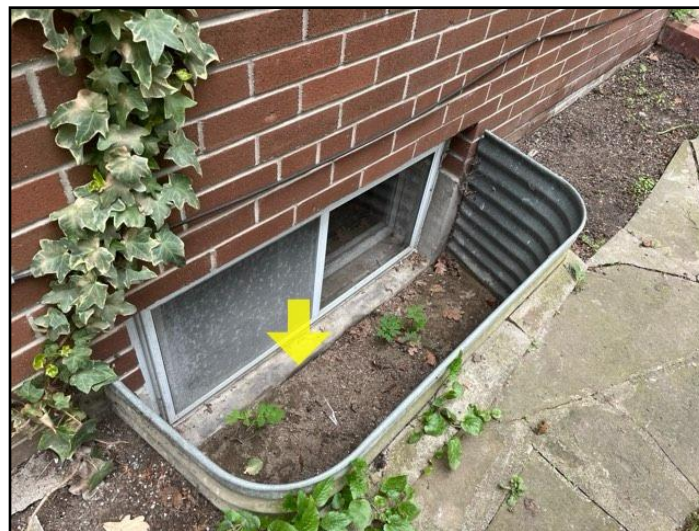
Condition: • Window close to grade in well

Window close to grade in well

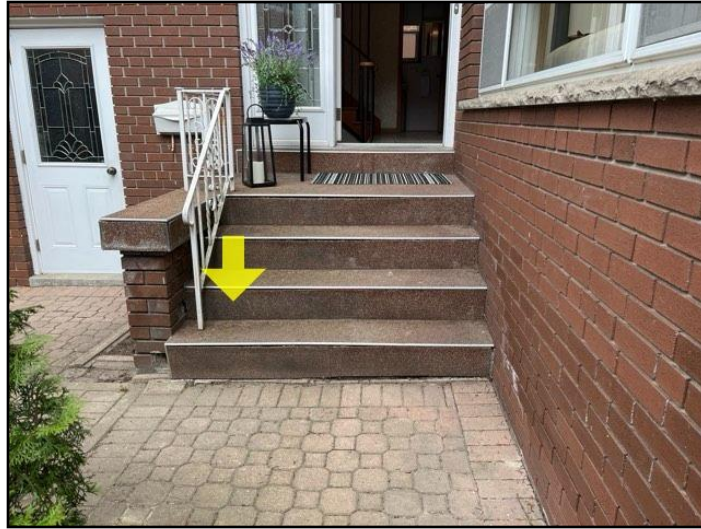
Condition: • [Steps or landings settling or heaving](#)

Steps or landings settling or heaving

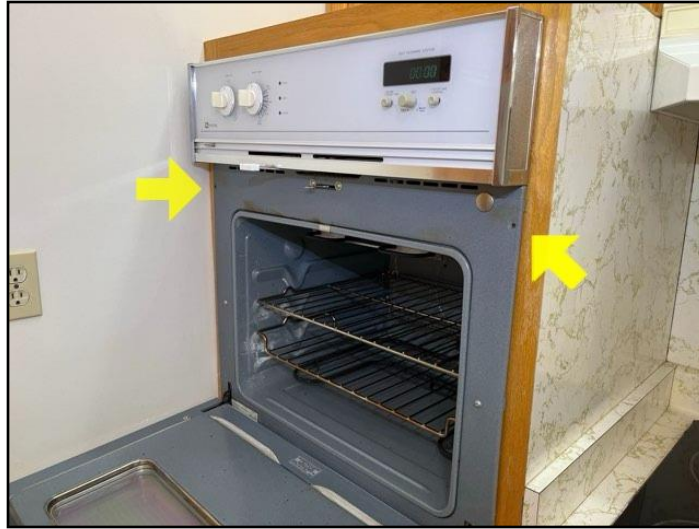
Condition: • Not well secured

Not well secured
