Your Inspection Report

179 Glendonwyne Rd
Toronto, ON M6P 3E8

INSPECTION DATE:
Thursday, March 26, 2026

RE: Report No. 96456, v.2
179 Glendonwyne Rd
Toronto, ON
M6P 3E8

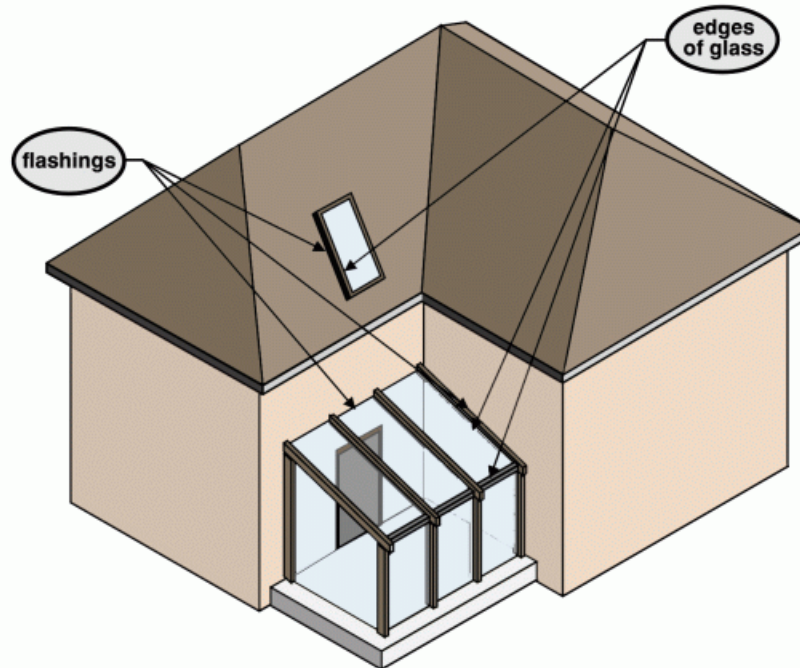
Skylight and solarium leaks

skylights and solariums are very prone to leakage
leakage typically occurs through the flashings or at
the edges of the glass

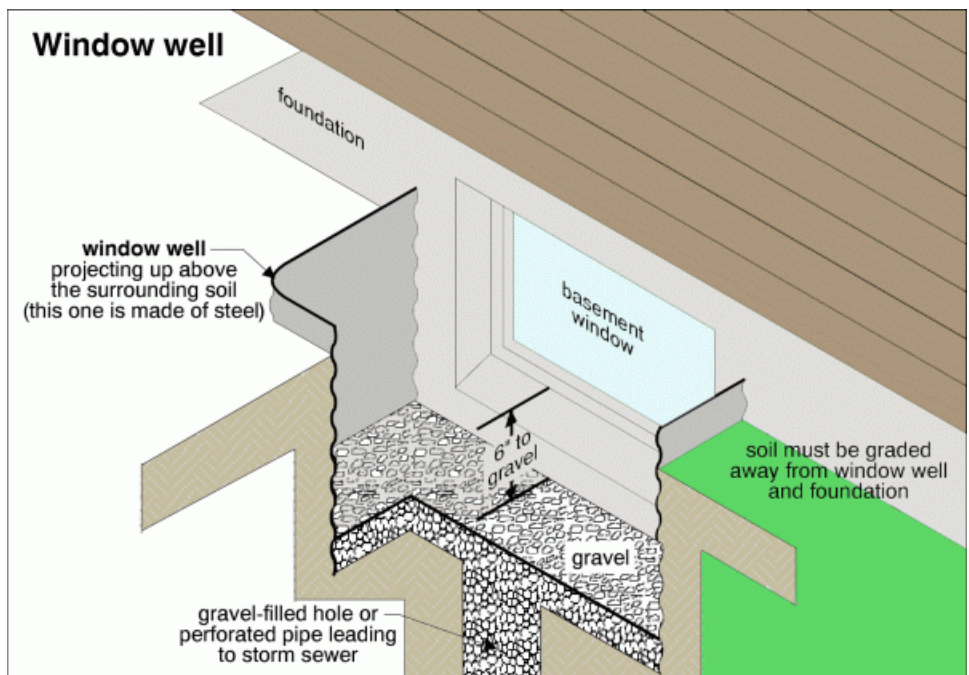
Condition: • Rotted wood

Rotted/damaged wood at the top of one window well will eventually need to be replaced.

Task: Repair

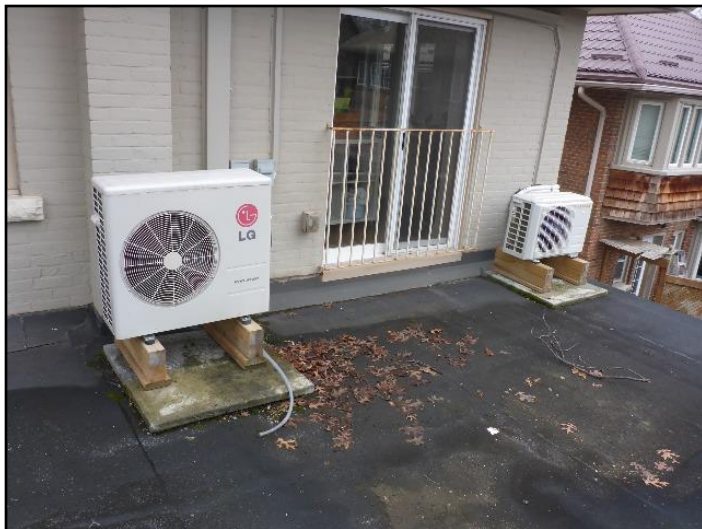
Ductless (Mini split) system- outdoor units

There are two ductless units on the roof that work with four indoor units (heads) inside the home to provide cooling and auxiliary heating.

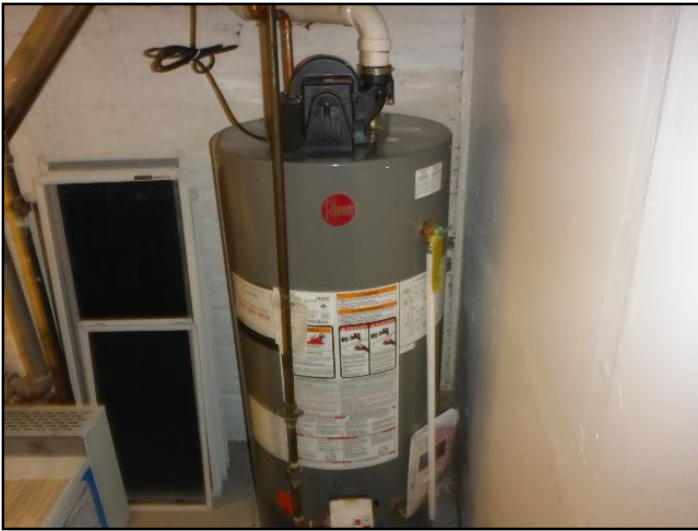
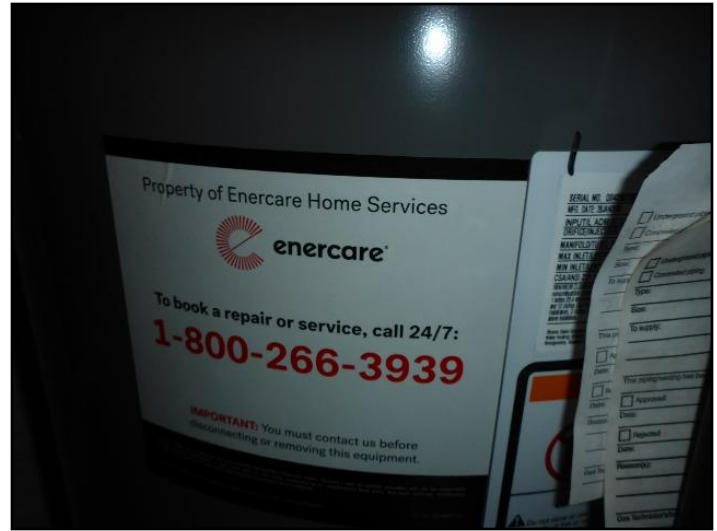
Rental sticker noted- ask seller details regarding ownership of the water heater.

Rental sticker noted

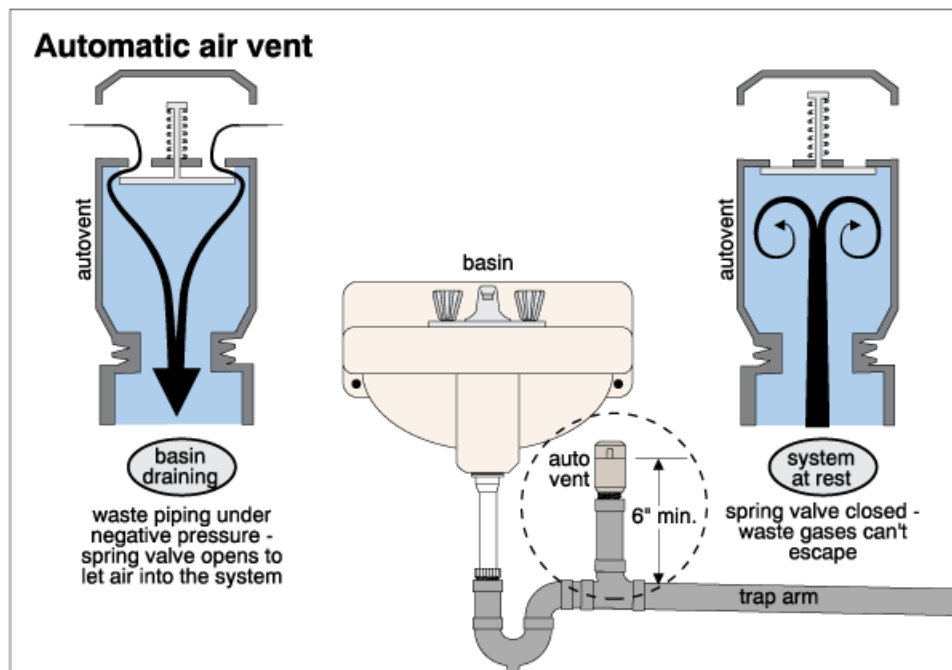
Automatic air vent

Auto vent noted beside the sink at this location. A failed auto vent can allow sewer gases into the home.
