Your Inspection Report

1152 Concession Road 1
Brechin, ON L0K 1B0

Monday, August 18, 2025

RE: Report No. 3117
1152 Concession Road 1
Brechin, ON
L0K 1B0

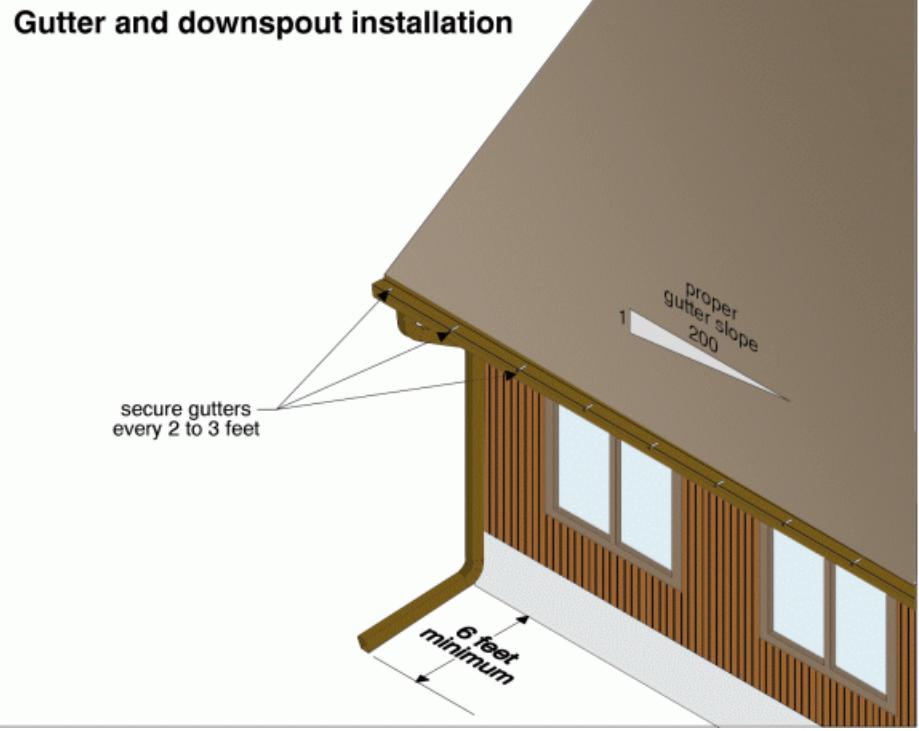
Downspout extension too short

proper gutter slope
1/200

secure gutters every 2 to 3 feet

6 feet minimum

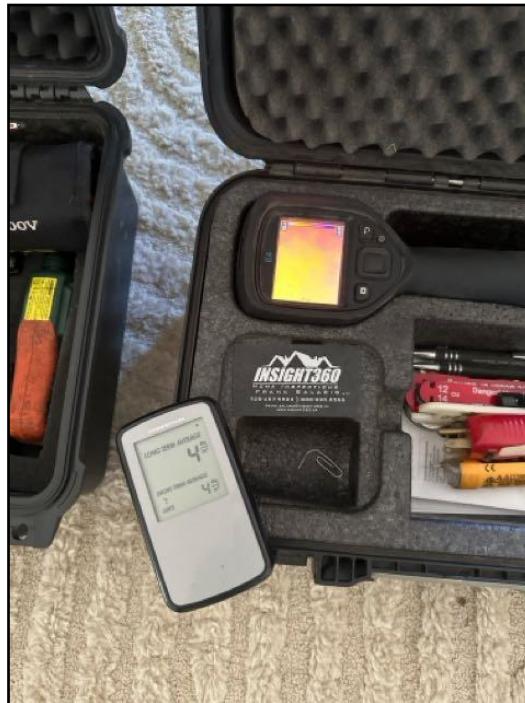
47. Radon

Radon levels measured 4 Bq/m³ during the time of inspection, safe levels in Canada are below 200 Bq/m³.

For a more accurate assessment a long term average is recommended of at least 3 months or more.

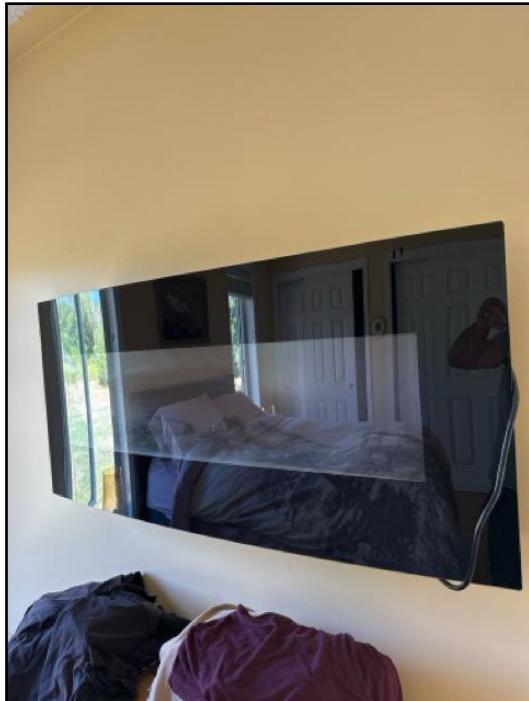
58. Missing or too few heaters

Electric fireplace space heaters

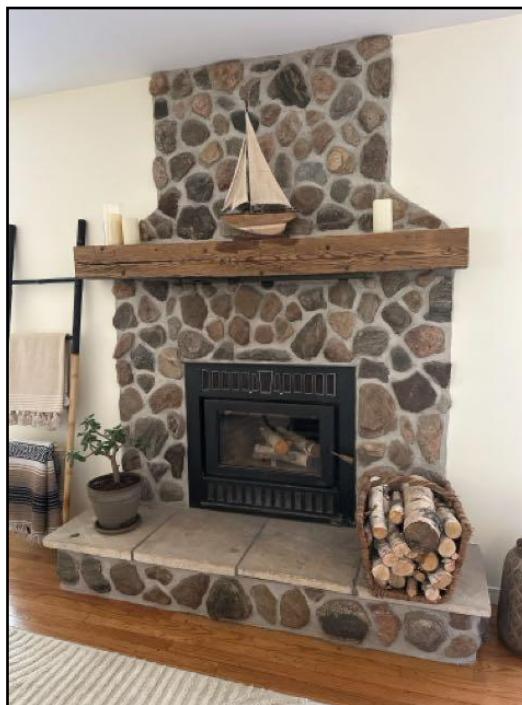
60. Fireplace

Factory fireplaces are install and inspected during house construction and can not be moved.

FYI- Prior to lighting wood fireplace during the heating season, prepare wood in chamber open damper valve to full, crack open a window and prior to lighting, heat chamber opening with a hairdryer to ensure draft is going up the chimney and then proceed to light to ensure no smoke enters the home. When the fire is roaring hot after several minutes the damper can be closed fully or to the desired setting, closing fully will have logs in the wood stove last longer. And chimney should be cleaned before and after each heating season.

Also, provide an ash pail with a lid for the safe removal of ashes.

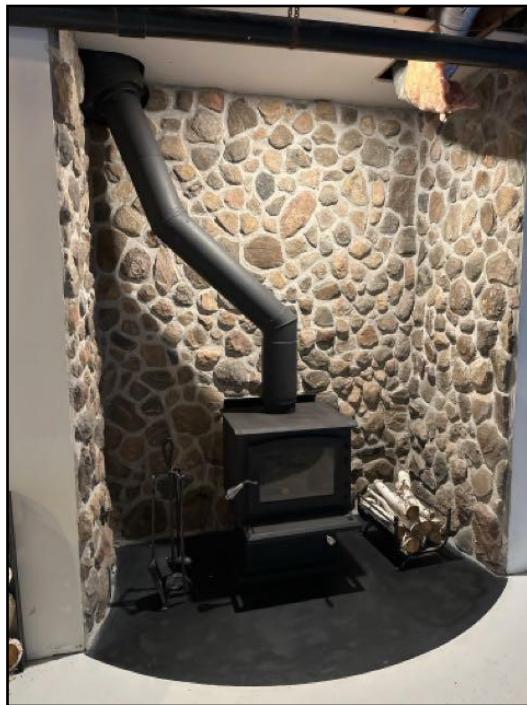
61. Wood stove

Woodstove appears to meet combustible clearances.

FYI- Prior to lighting wood stove during the heating season, prepare wood in chamber open damper valve to full, crack open a window and prior to lighting, heat chamber opening with a hair dryer to ensure draft is going up the chimney and then proceed to light to ensure no smoke enters the home. When the fire is roaring hot after several minutes the damper can be closed fully or to the desired setting, closing fully will have logs in the wood stove last longer. And chimney should be cleaned before and after each heating season.

Also, provide an ash pail with a lid for the safe removal of ashes.

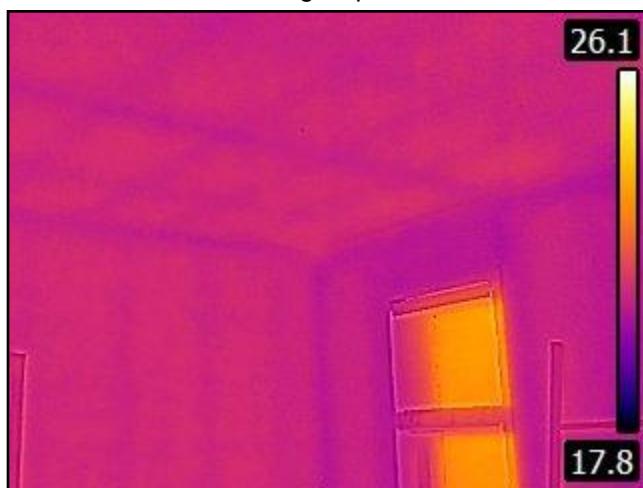
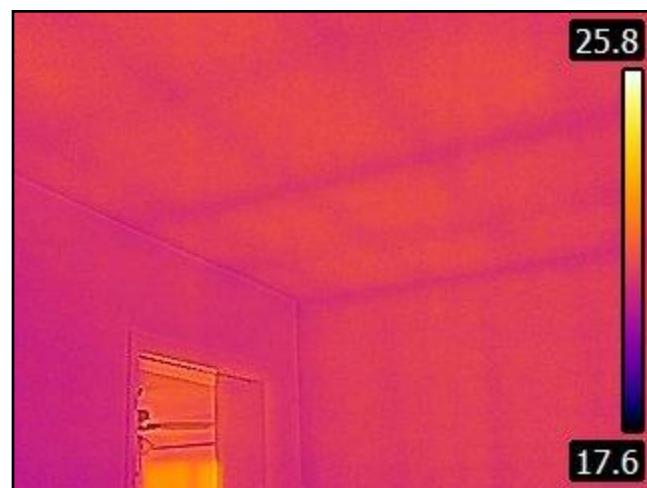
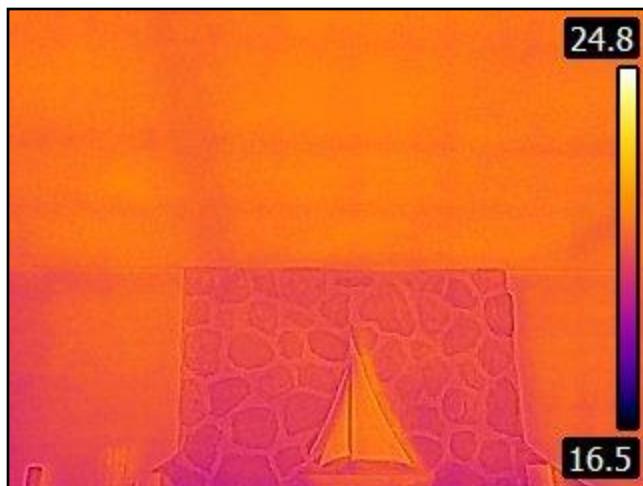
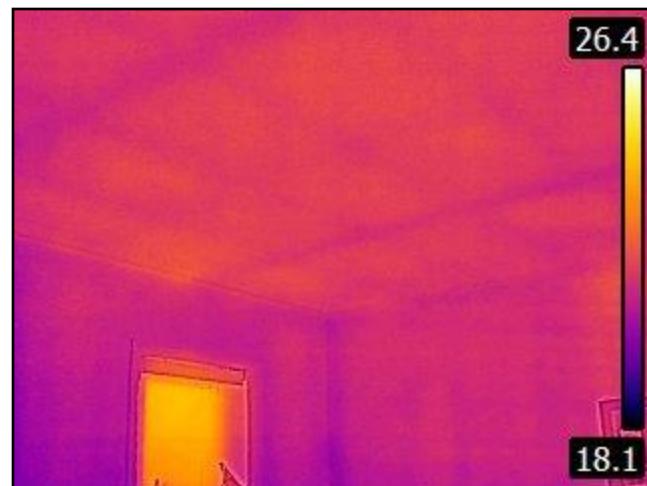
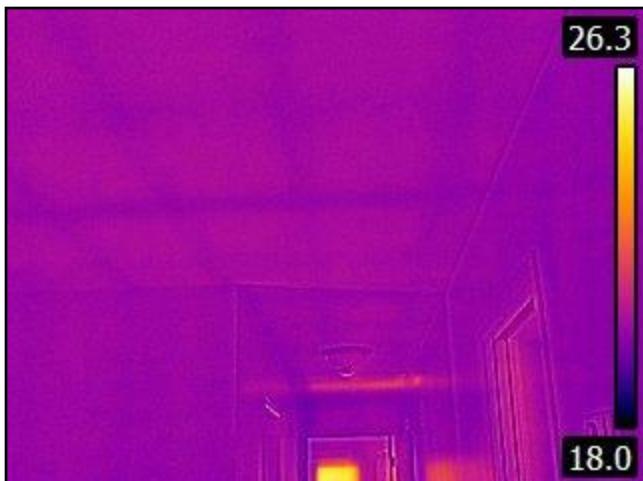
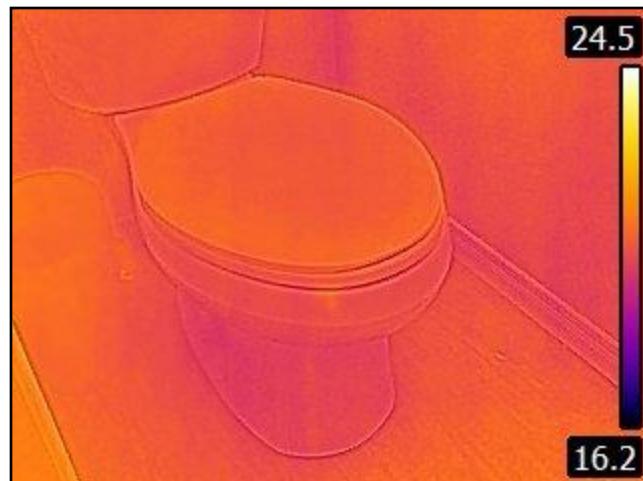
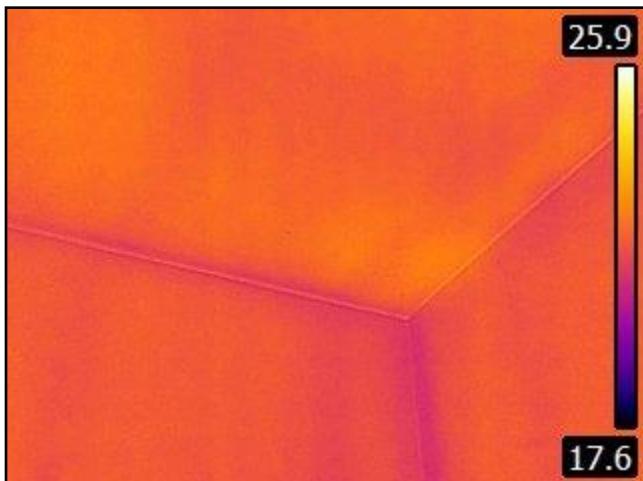
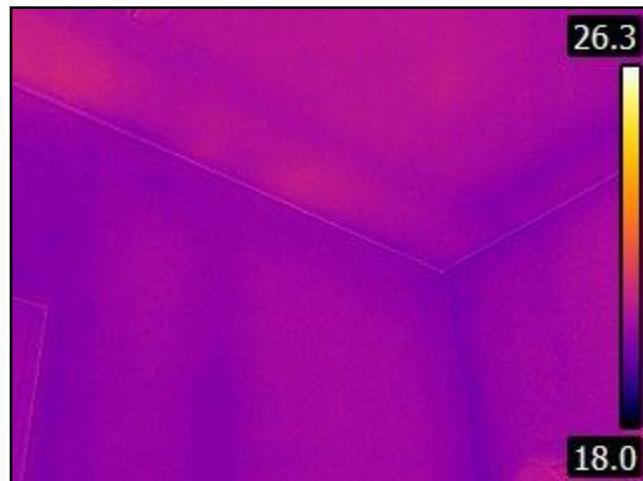
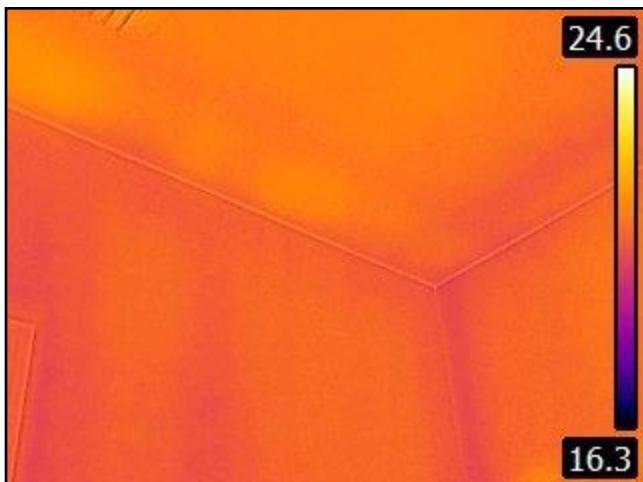
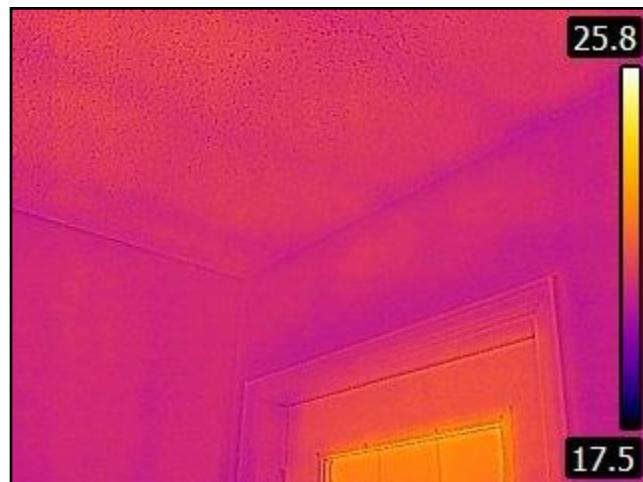
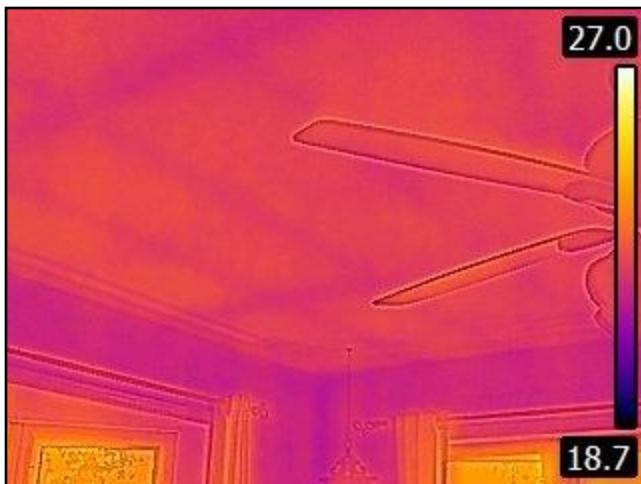
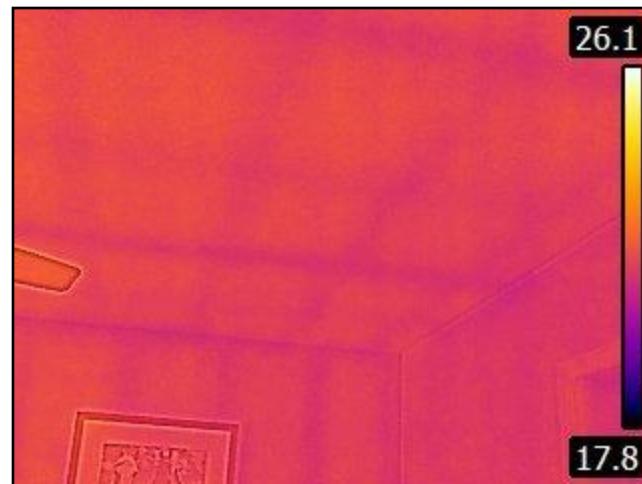
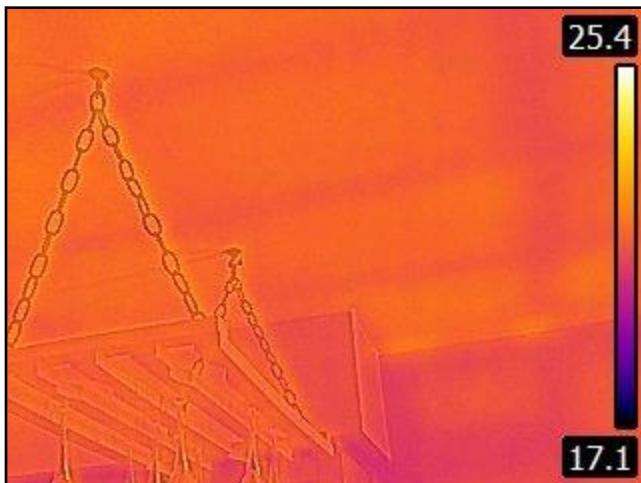
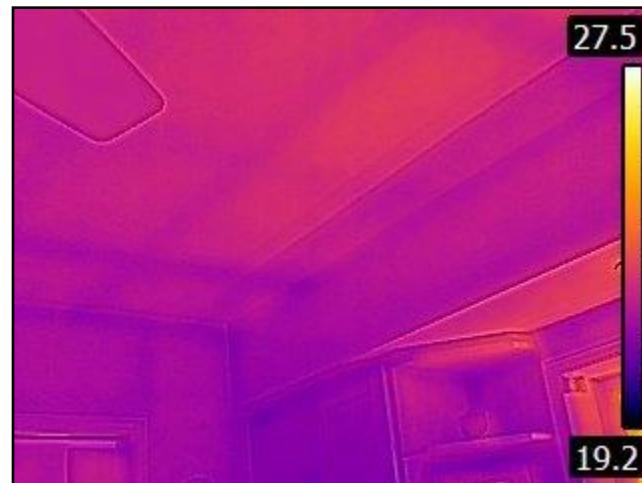
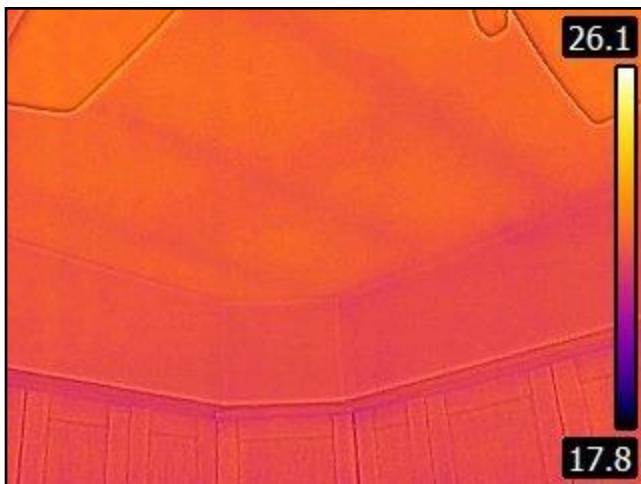
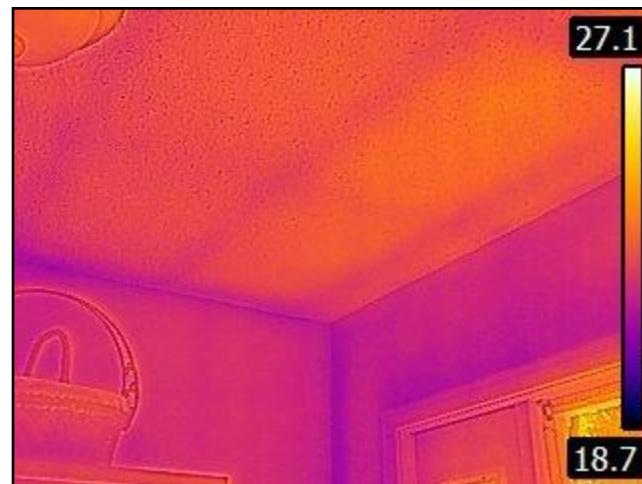
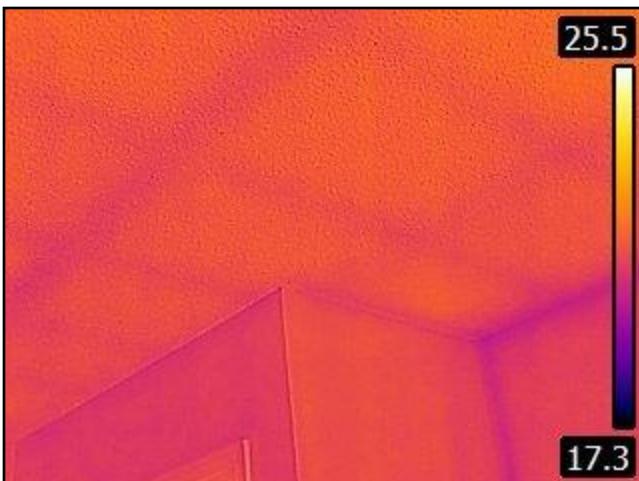
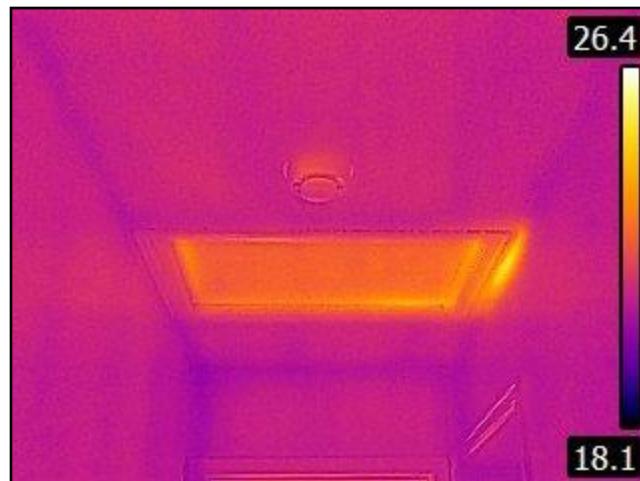
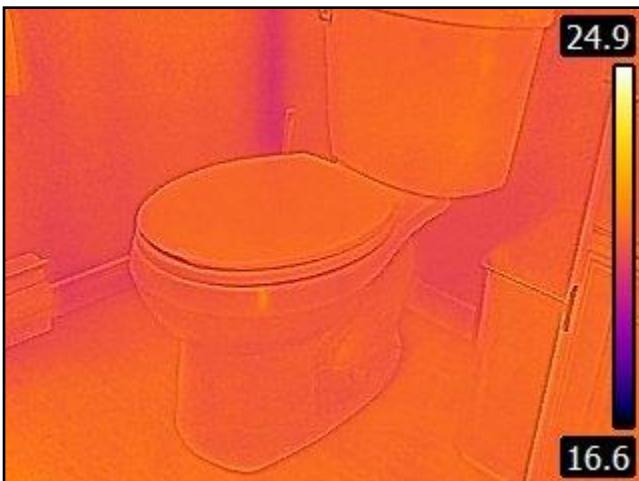
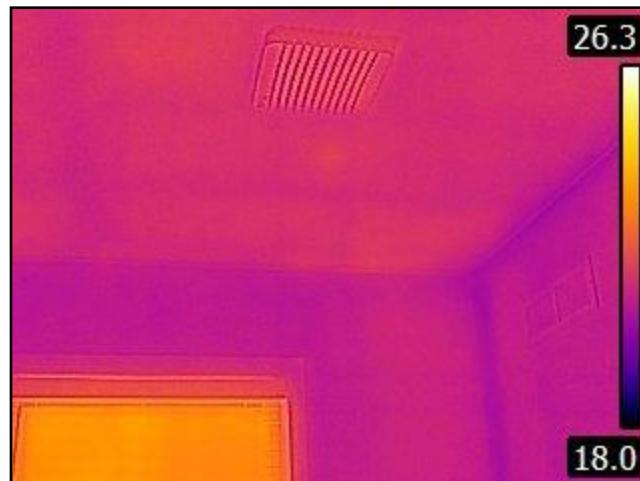
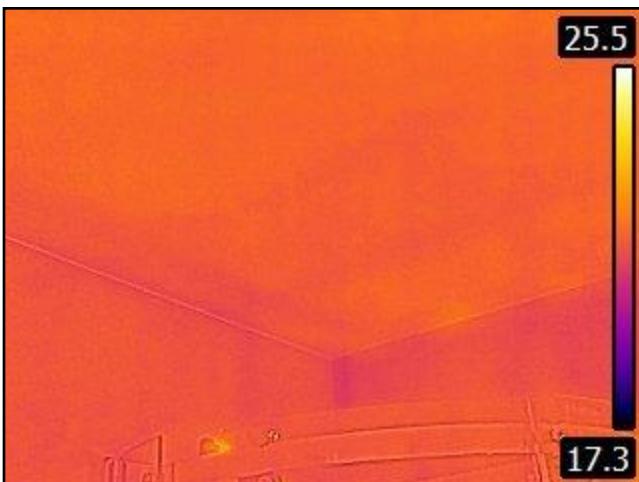
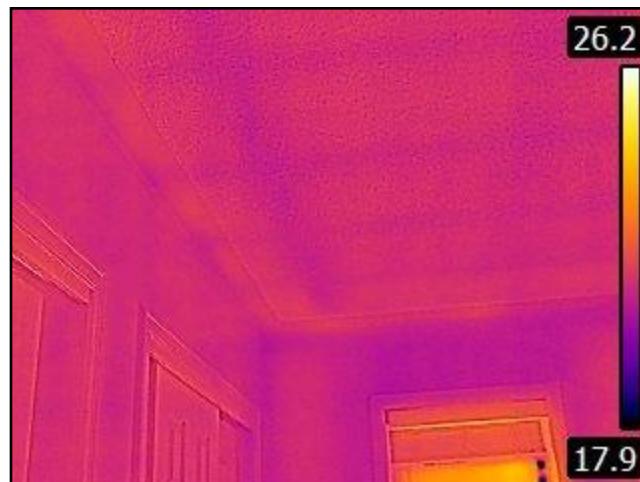
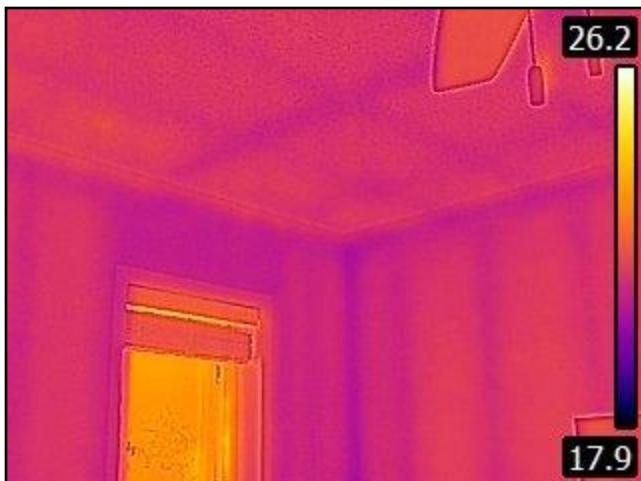
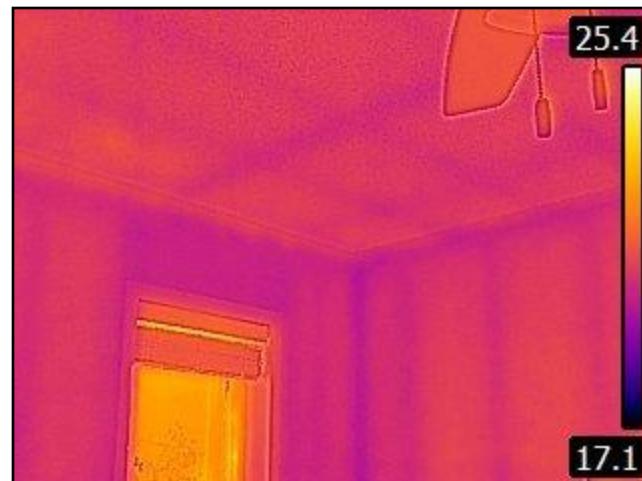
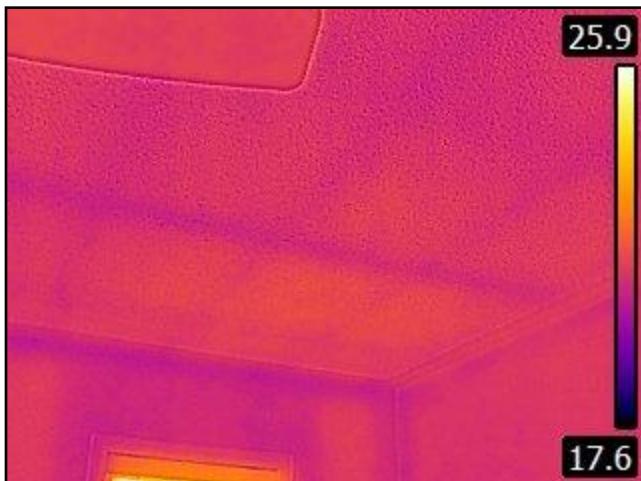
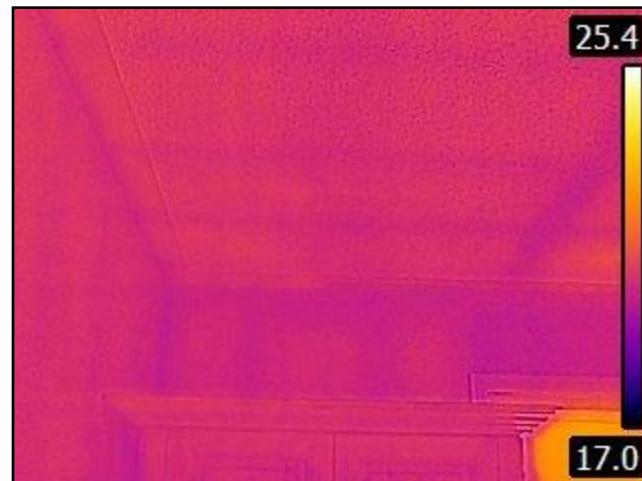
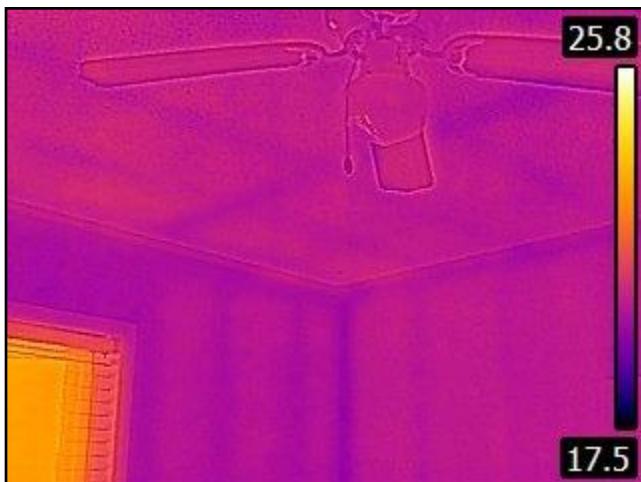
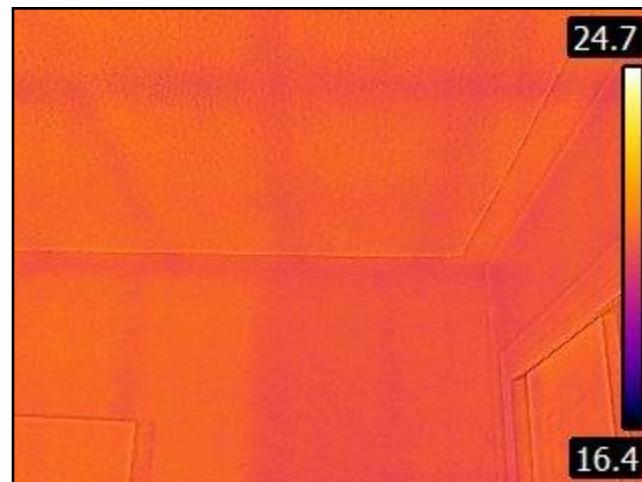
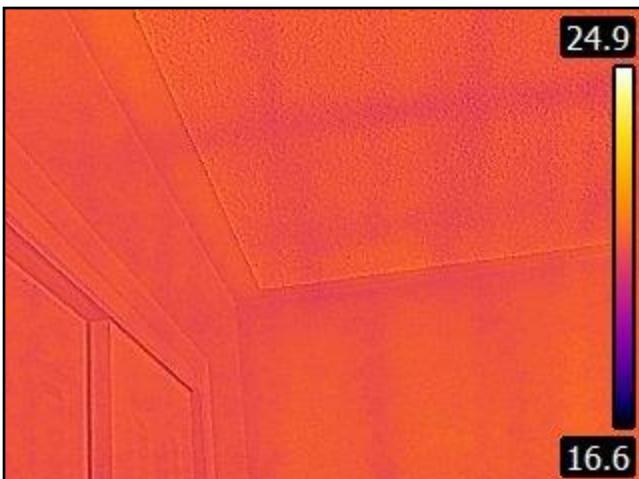
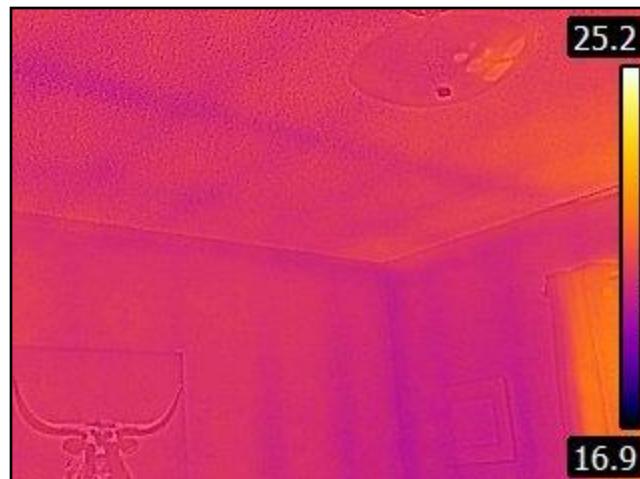
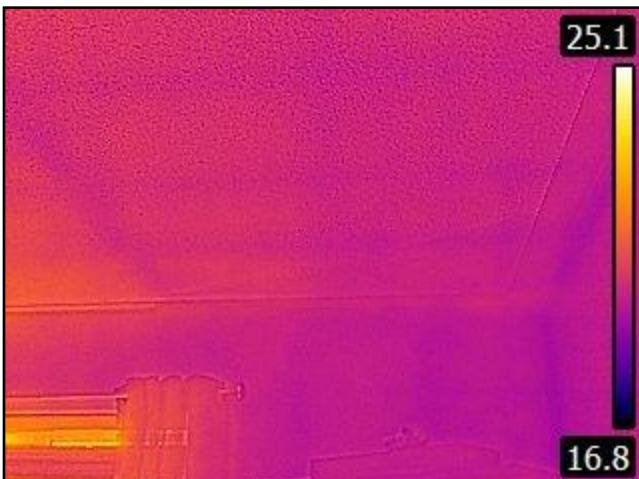
- Perimeter walls and ceiling inspected with a thermal imaging camera and no defects noted.

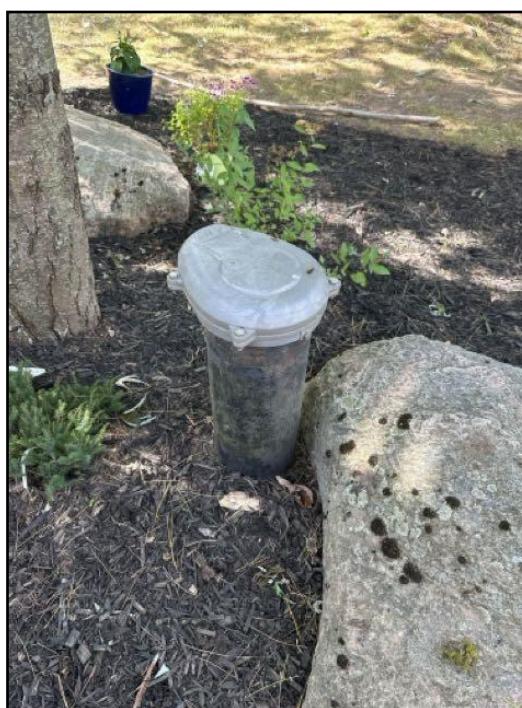
119. Private

Drilled well located near the driveway.

Recommend testing water quality 2 to 3 times yearly to ensure conditions have not changed. testing is free through the township office. They will provide bottles for sampling, ensure to run cold water for 10 minutes before taking samples. (some faucet will contain bacteria at the tip of faucet usually found in kitchens and give you false readings.

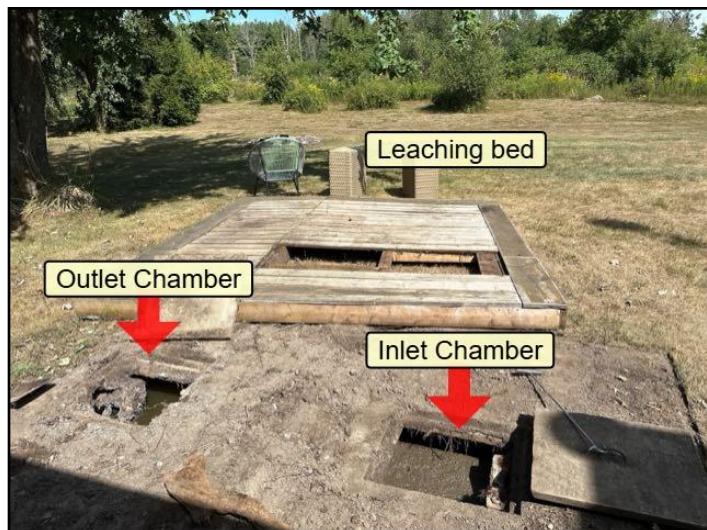
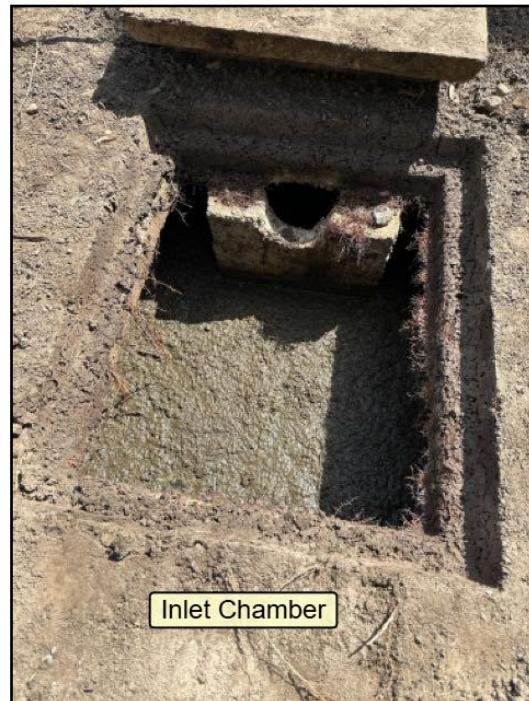
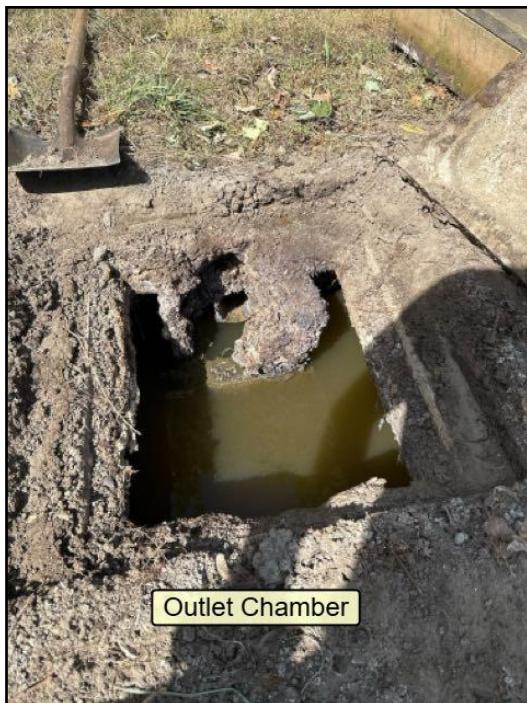
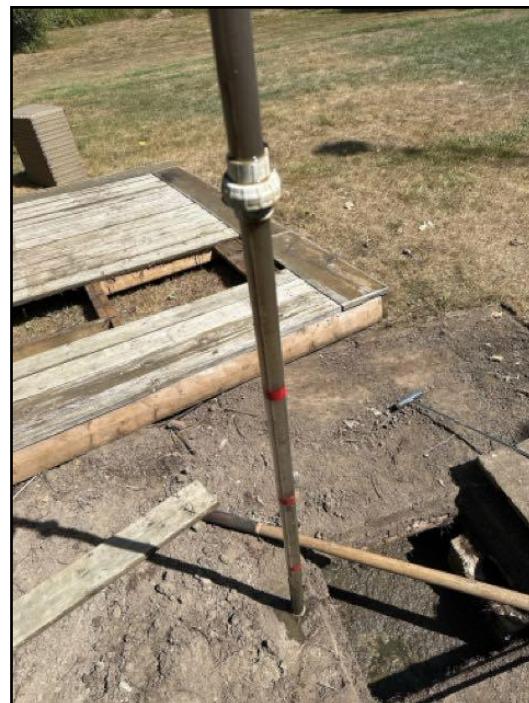
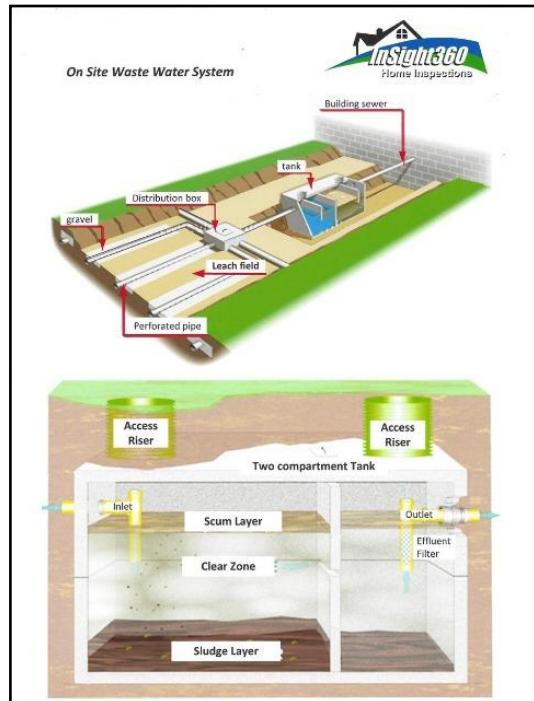
123. *Septic system*

Onsite sewage system is good condition and functioning fine. Flow test conducted for 15 minutes and leaching bed tested fine. Recommend pumping in summer of 2027 and then pumped every 3- 5 years afterwards, avoid pumping in the fall or winter whenever possible, chance of freezing and cracking tank. (Sewage generates heat and does not allow tank to freeze) Recommend dumping yogurt once a month or every few visits to promote good bacteria and avoid using harsh chemicals that could kill the bacteria.

3600L concrete septic tank is sized for 3 bedrooms up to 20 fixture units and up 2200 sqft of living space, 6 people every day all year.

Avoid driving heavy vehicles over septic tank and leaching bed and keep leaching bed clear of trees and shrubs(roots can clog pipes).

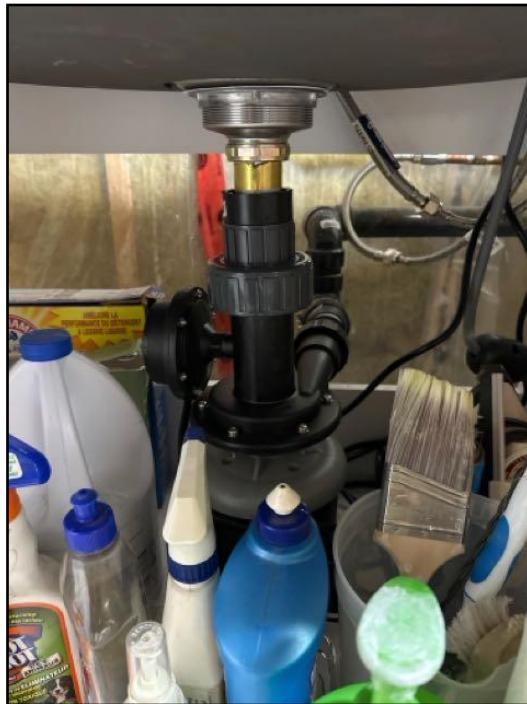
129. Laundry tub pump

Laundry tub pump tested fine

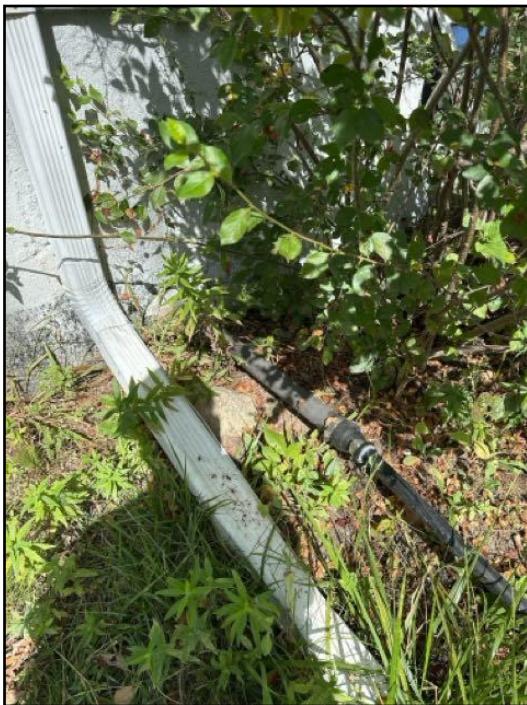
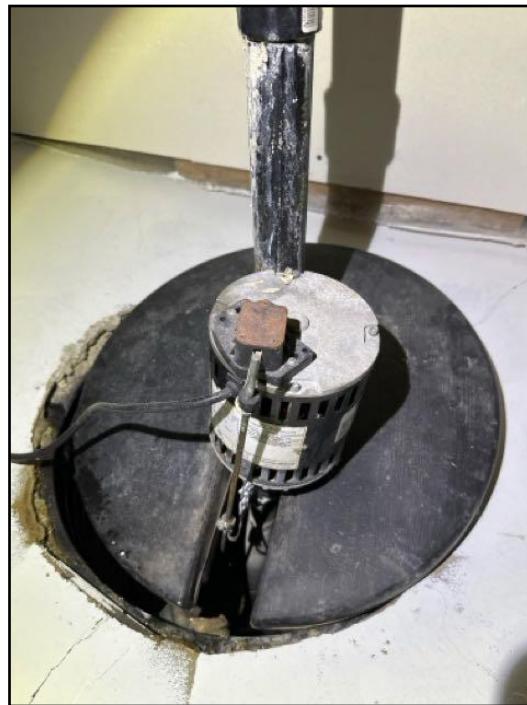
130. Sump pump

Sump pump tested fine. Recommend installing a battery backup sump pump in the event of a power failure. And monitor exterior discharge pipe for freezing during the winter months especially in the spring. Consider improving the exterior discharge pipe to have an air gap or installing a heat line to prevent it from freezing.

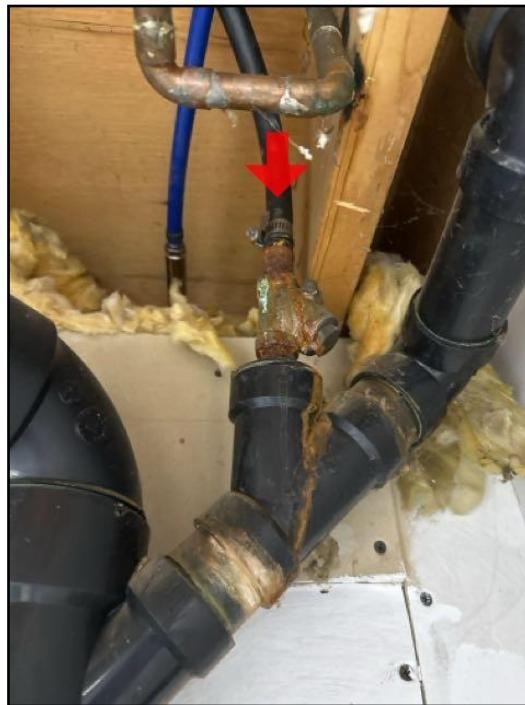
137.

13. Condition: • Iron filter backwash has a small leak, recommend repairs and replacing metal connector with a plastic type.

Task: Repair

Time: Less than 1 year

Cost: Minor

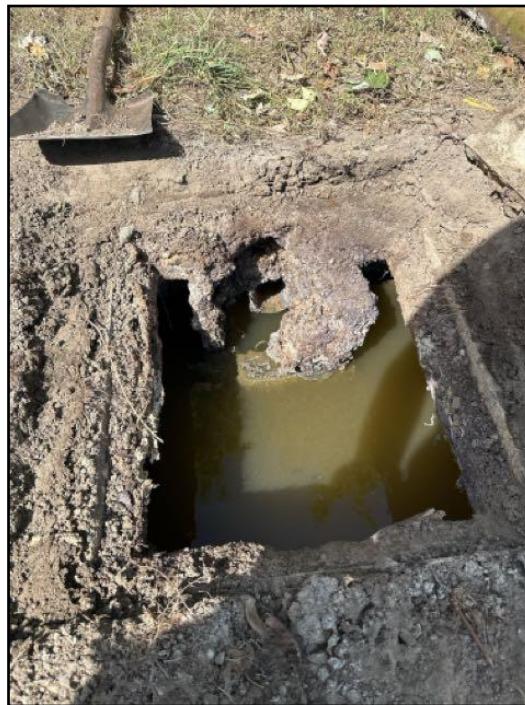
139. Septic system

16. Condition: • Outlet baffle is deteriorating, recommend replacing with the plastic baffle.

Task: Replace

Time: Immediate

Cost: Minor
