# INSPECTION REPORT

For the Property at:  
**41 HERTLE AVENUE**  
TORONTO, ON M4M 2L3

Prepared for: CHRIS OLSEN FORD THURSTON  
Inspection Date: Saturday, May 3, 2025  
Prepared by: Joe Marino

RE: Report No. 4039, v.2  
41 Hertle Avenue  
Toronto, ON  
M4M 2L3

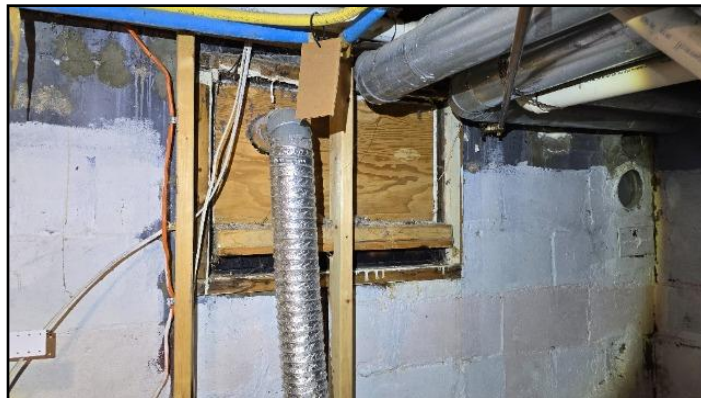
9. Original window removed

4. Condition: • Original window removed

Location: Rear Basement

Task: Request disclosure

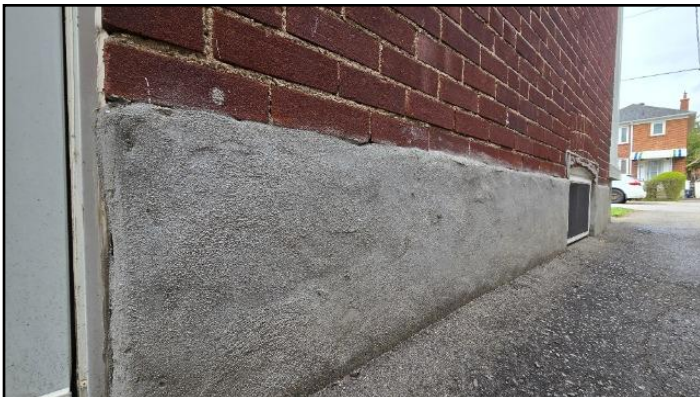
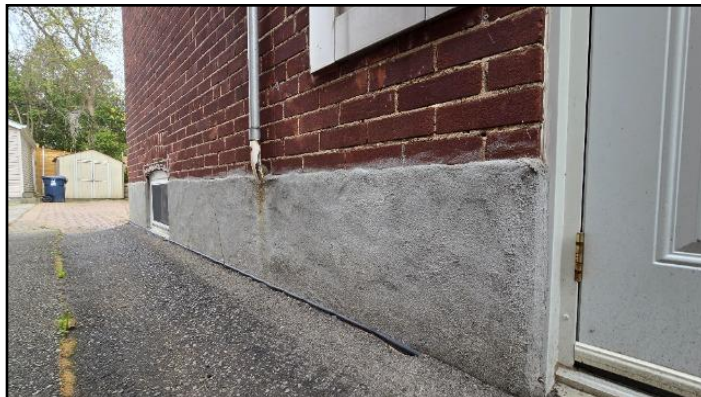
- Parging noted at foundation walls

28. Parging noted at foundation walls

29. Parging noted at foundation walls

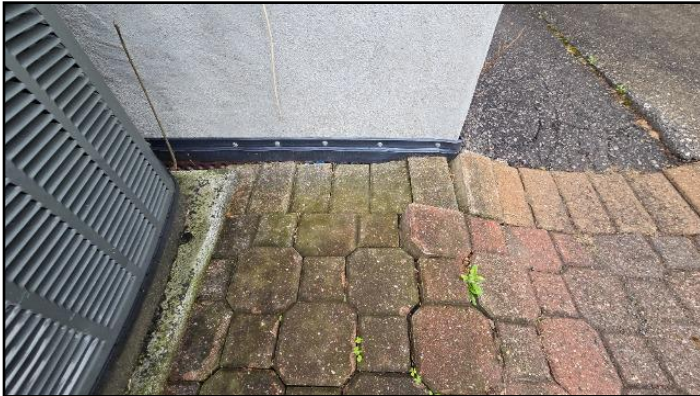
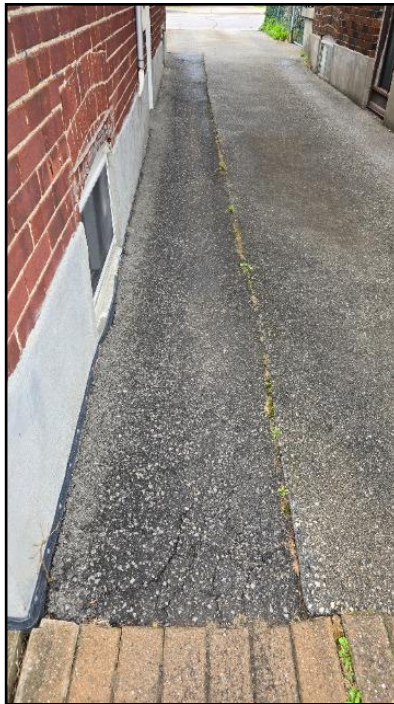
**9. Condition:** • Water proofing was added to the homes foundation. Follow up with listing agent

**Location:** Various Basement

31. Water proofing was added to the homes...

33. Water proofing was added to the homes...

**Task:** Further evaluation Request disclosure

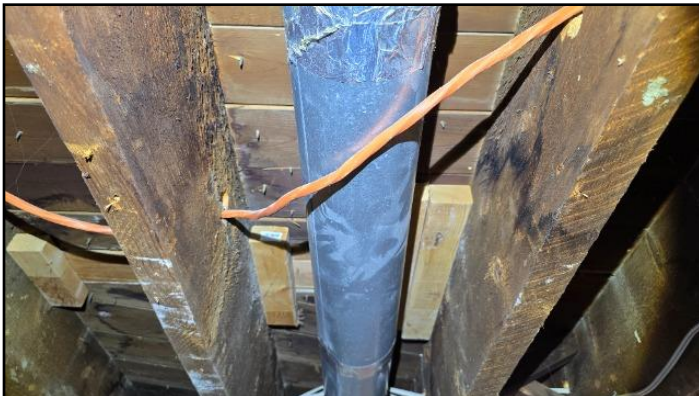
**10. Condition:** • [Too close to/touching ducts, pipe, chimneys, etc.](#)

**Location:** Various Basement

41. Too close to/touching ducts, pipe, chimneys...

43. Too close to/touching ducts, pipe, chimneys...

**Task:** Improve Remove

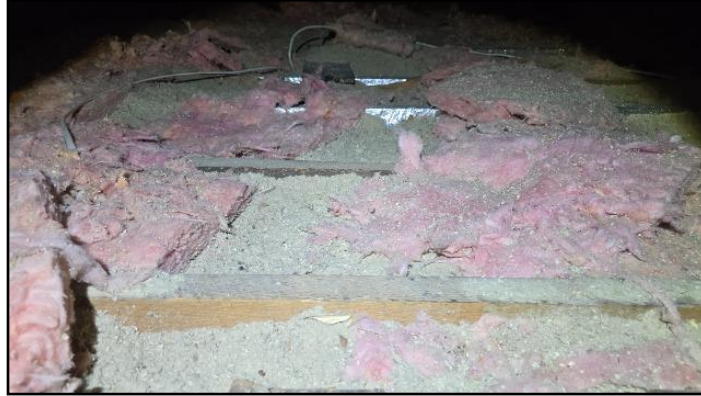
**17. Condition:** • [Amount less than current standards](#)

84. Amount less than current standards

**Task:** Improve Upgrade

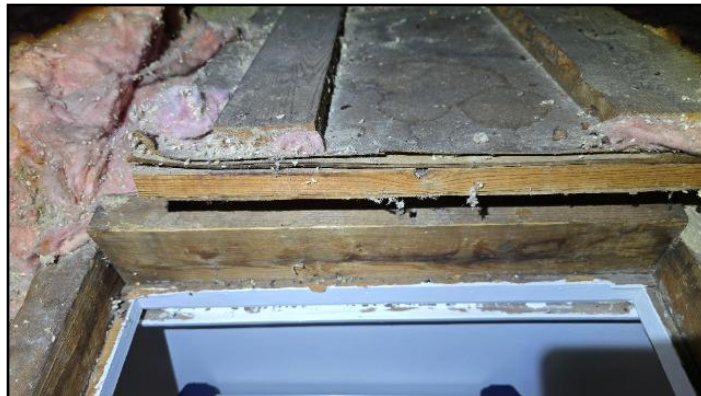
**Location:** Attic

**18. Condition:** • [Not insulated and not weatherstripped](#)

85. Not insulated and not weatherstripped

**Task:** Provide Improve

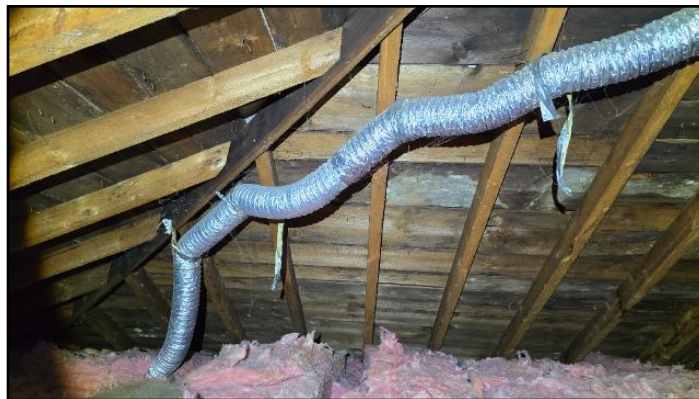
Location: Attic

25. Condition: • [Not insulated in unconditioned space](#)

106. Not insulated in unconditioned space

Task: Provide Improve Upgrade Protect

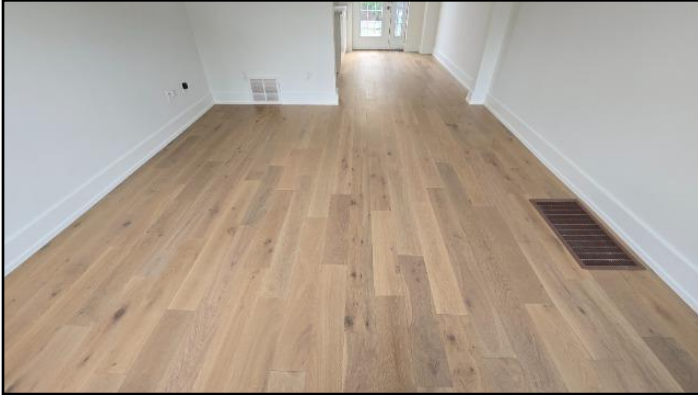
107. Various flooring noted

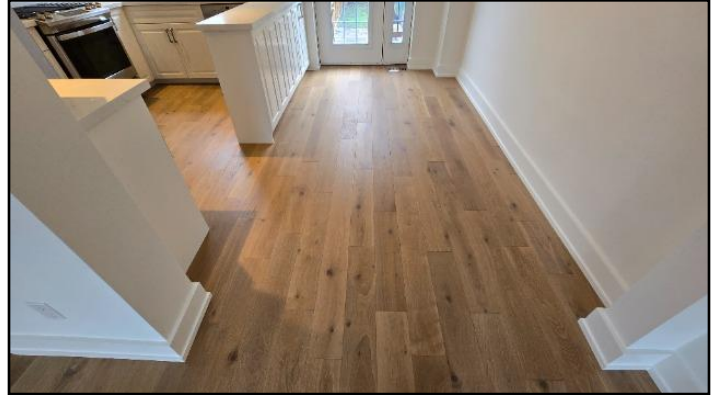
108. Various flooring noted

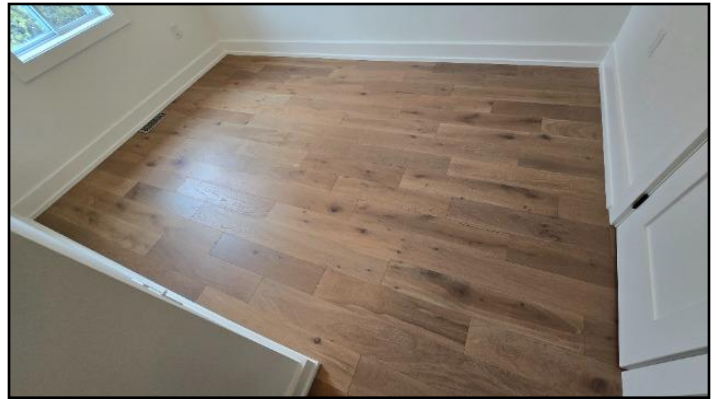
110. Various flooring noted

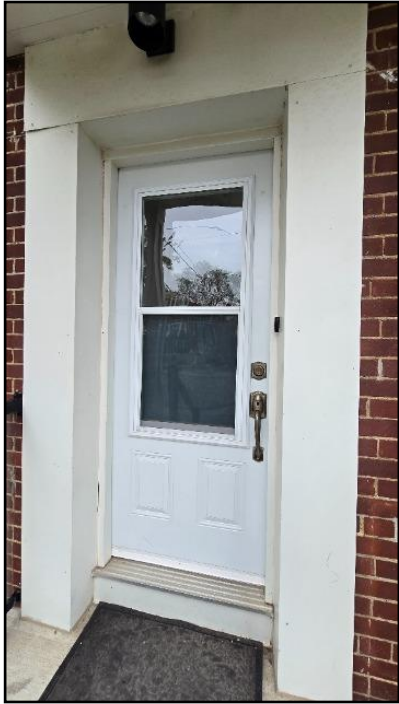
114. Various Doors Noted

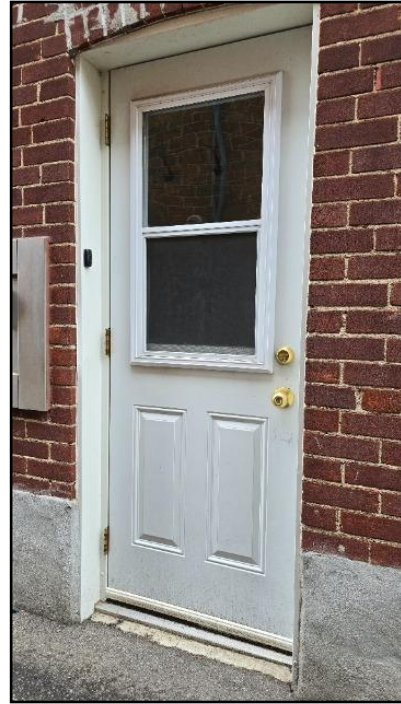
115. Various Doors Noted
