Your Inspection Report

12 Weybourne Crescent
Toronto, ON M4N 2R3

INSPECTION DATE:
Wednesday, March 18, 2026

RE: Report No. 96377
12 Weybourne Crescent
Toronto, ON
M4N 2R3

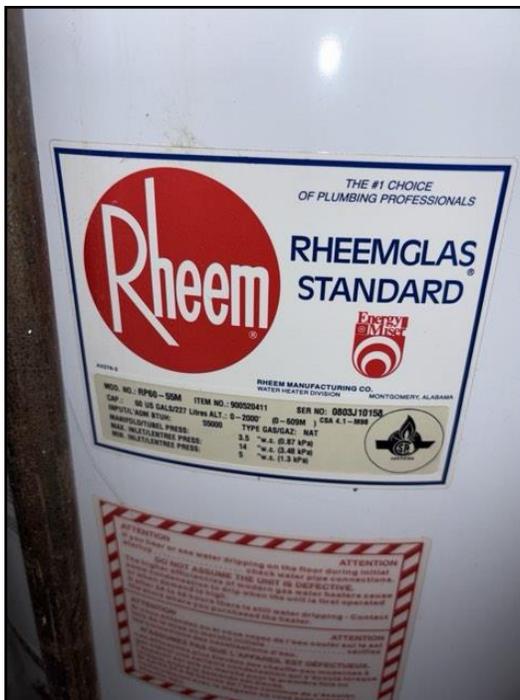
Conventional

- Water heater fuel/energy source:** • Gas
- Water heater approximate age:** • 23 years
- Water heater typical life expectancy:** • 10 to 15 years
- Waste and vent piping in building:** • Plastic • Cast iron • Not visible in some areas.
- Pumps:** • None
- Floor drain location:** • Center of basement
- Backwater valve:** • None noted
