Your Inspection Report

7 Innisfree Crt
Toronto, ON M6S 3N7

PREPARED BY:
Scott Lutz, RHI

RE: Report No. 97297
7 Innisfree Crt
Toronto, ON
M6S 3N7

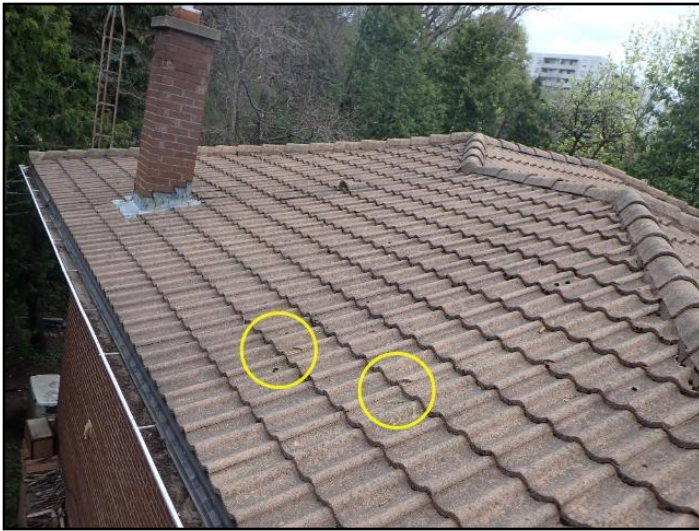
Condition: • Chipped

Chipped

Task: Repair

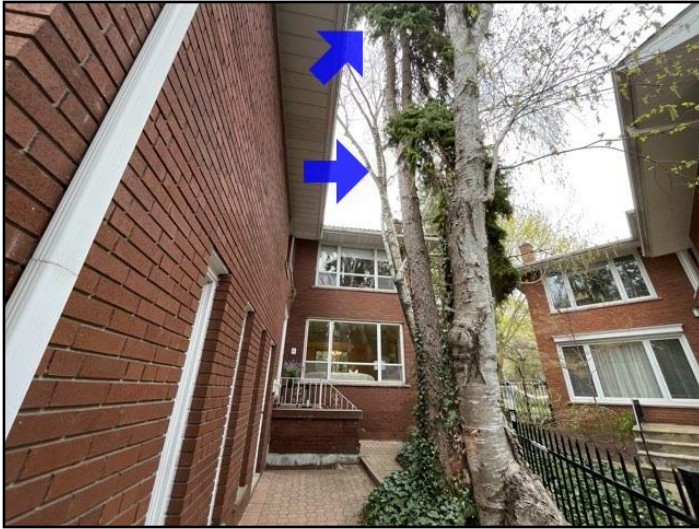
Condition: • Tree branches touching roof

Branches close / touching

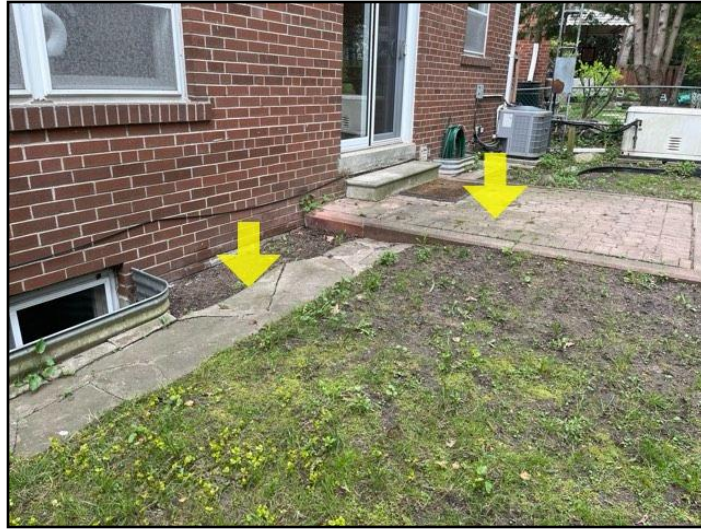
Condition: • Settlement

Settlement or other movement

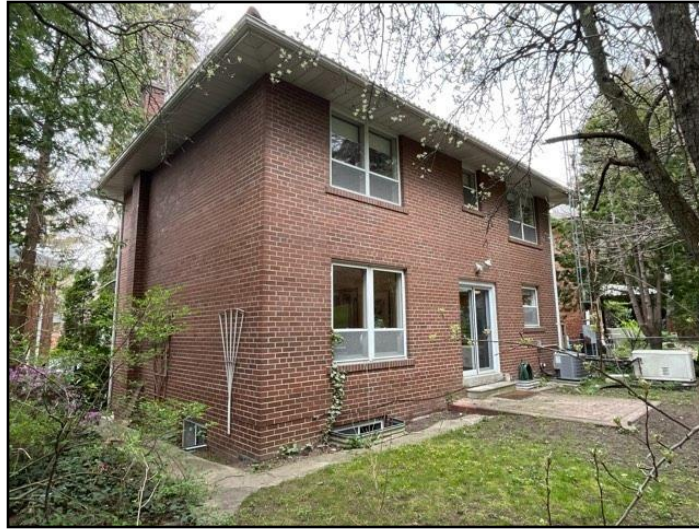
Condition: • [No swale](#)

No swale

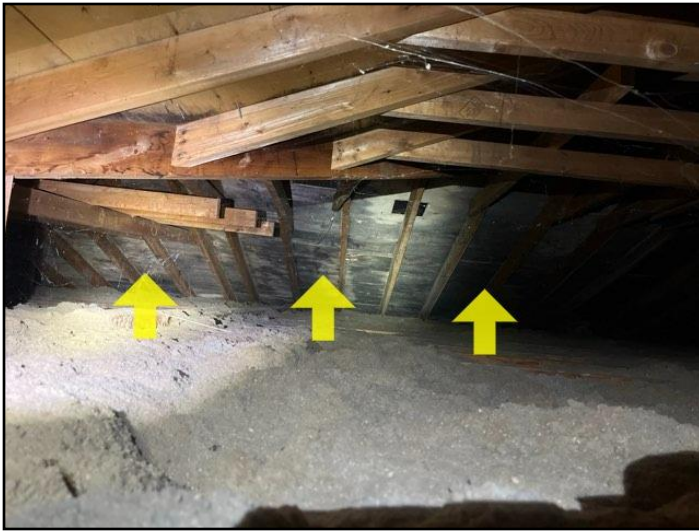
Condition: • Mould

Mould - Upper, Left side

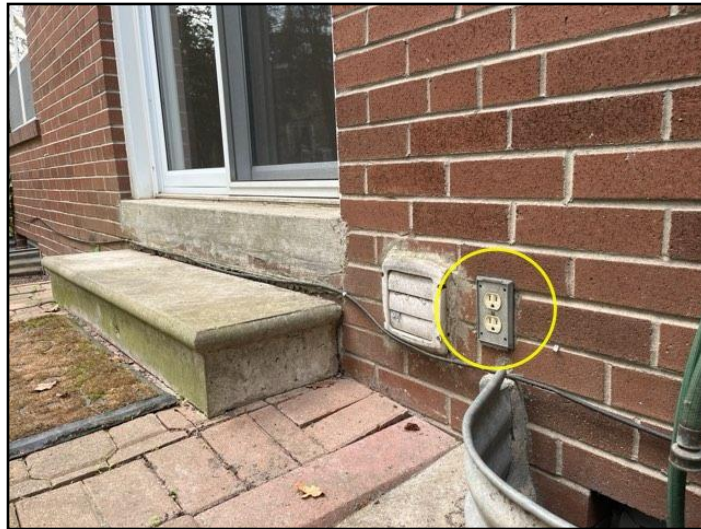
Condition: • [Wrong type](#)

Wrong type

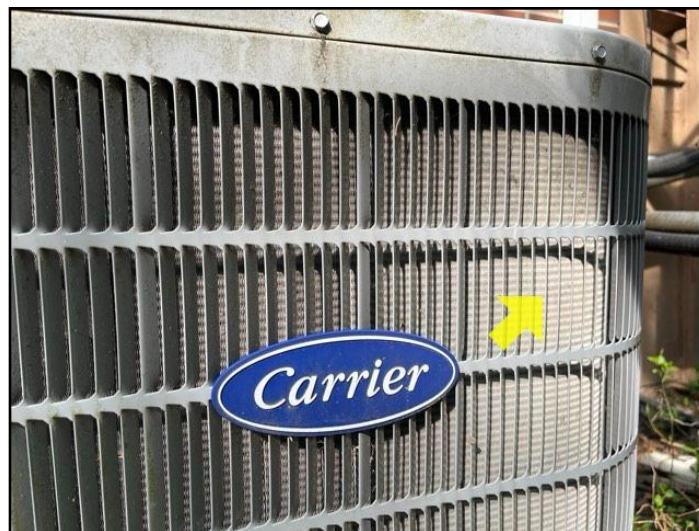
Dirty

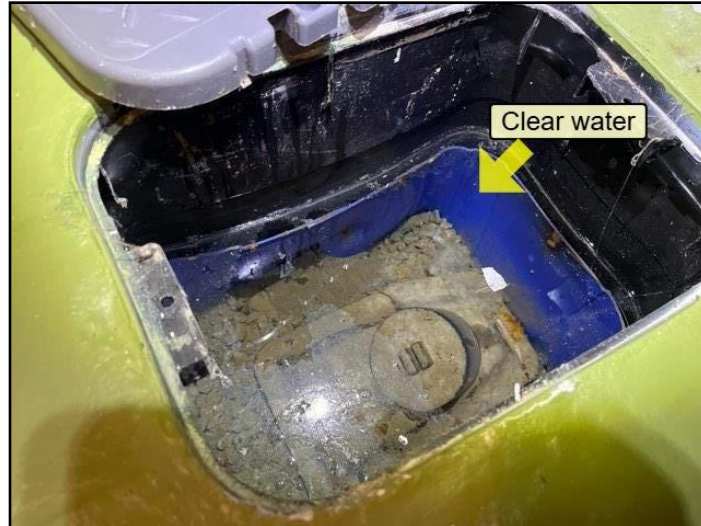
Standing water

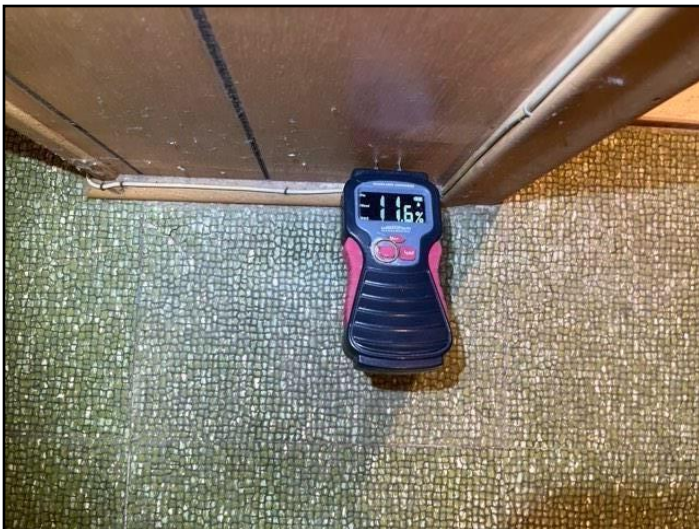
Inside Wall

Condition: • Typical reading noted with meter during inspection.

Condition: • Evidence of moisture noted
Slightly elevated moisture meter readings.

Task: Ensure gutters and downspouts are working properly and exterior grade slopes down away from the home. Monitor the area for evidence of moisture, particularly in the spring when snow melts or after heavy or persistent rains.
