# INSPECTION REPORT

For the Property at:  
**41 HERTLE AVENUE**  
TORONTO, ON M4M 2L3

Prepared for: CHRIS OLSEN FORD THURSTON  
Inspection Date: Saturday, May 3, 2025  
Prepared by: Joe Marino

RE: Report No. 4039, v.2  
41 Hertle Avenue  
Toronto, ON  
M4M 2L3

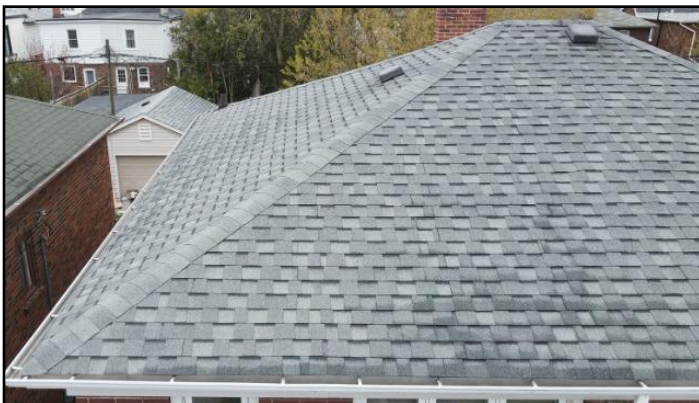
2. Asphalt shingles

These images shows roofings condition on day of inspection. Balance of roofing on drone video. Monitor for any changes.

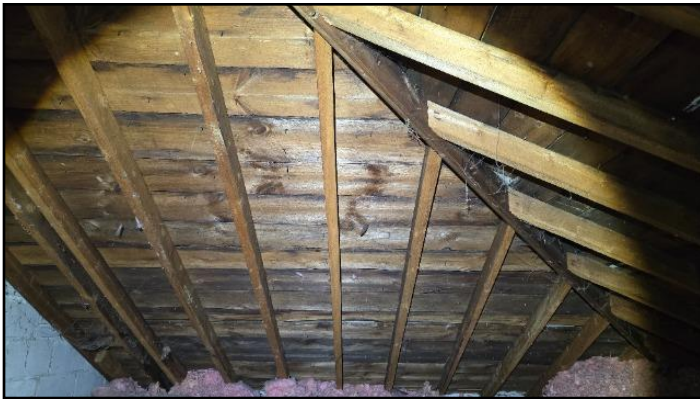
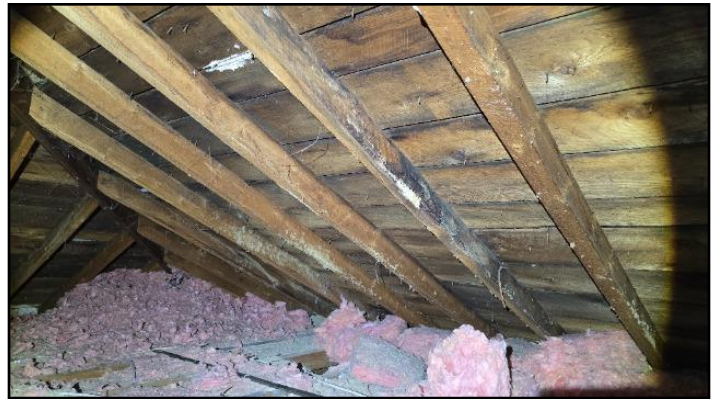
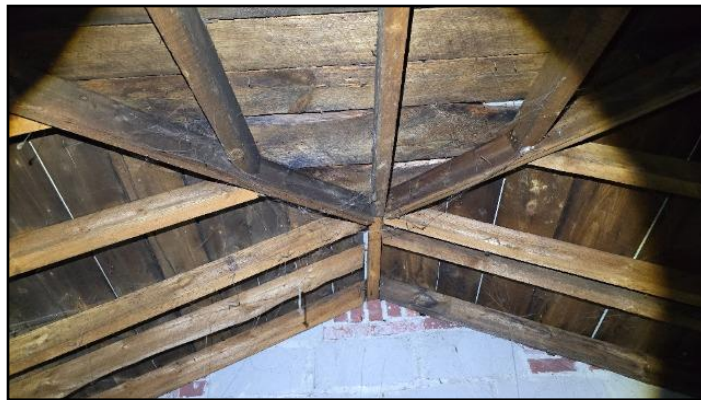
These images shows its condition on day of inspection within home. Monitor for any changes

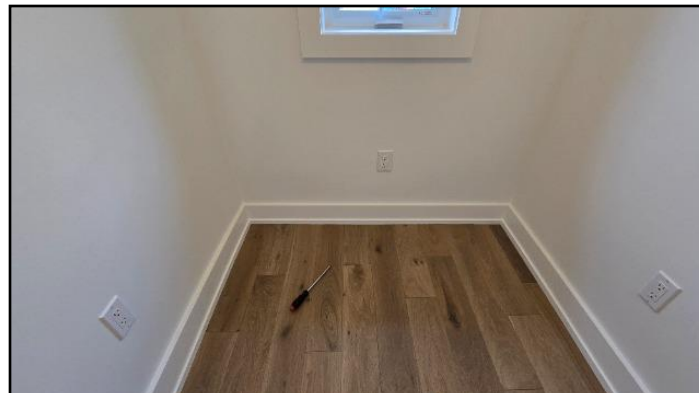
**14. Condition:** • No heat source

61. No heat source

**Task:** Improve Upgrade

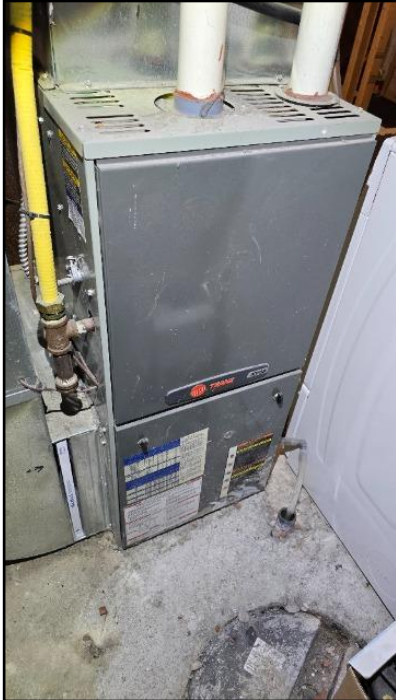
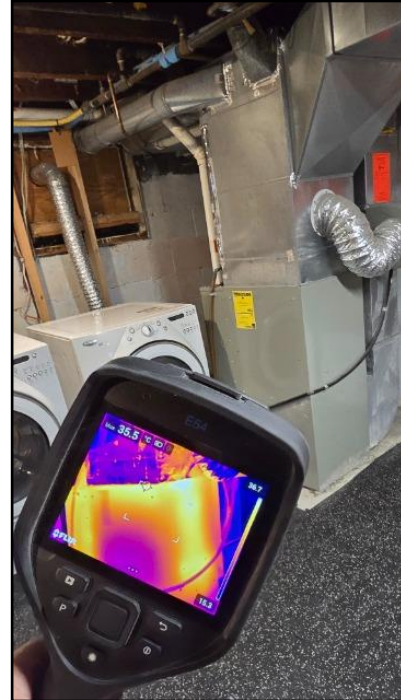
Infrared image shows unit operating on day of inspection

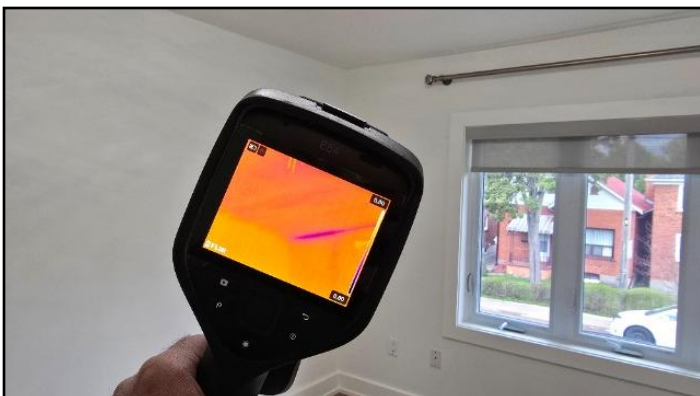
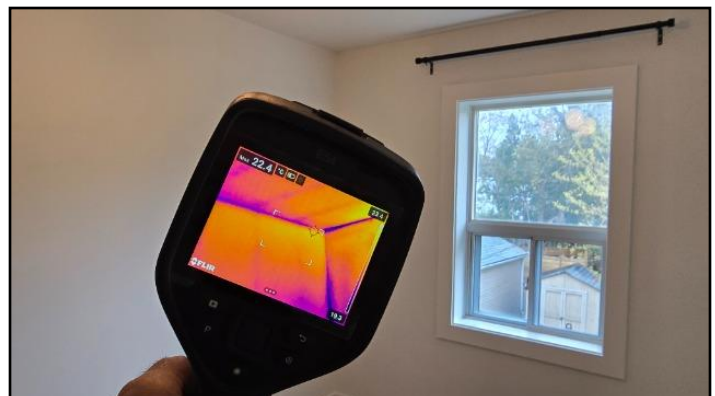
The photos below show insulation is present through infrared images but not seen physically.

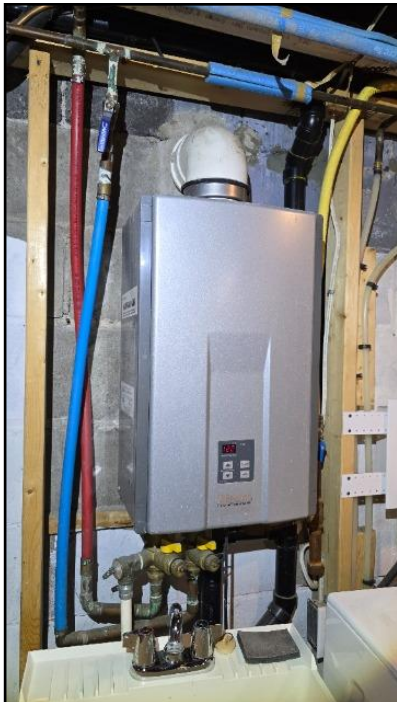
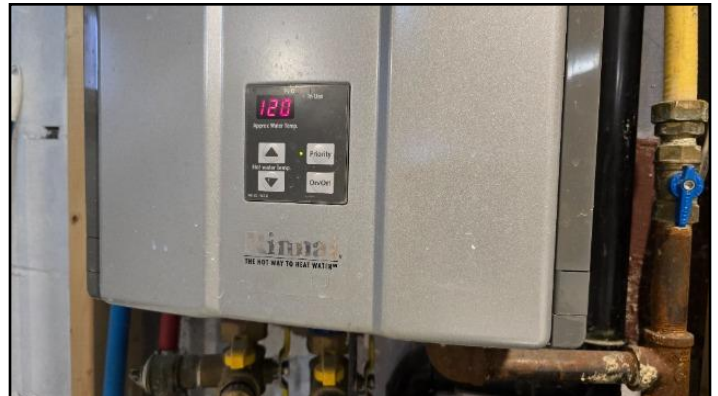
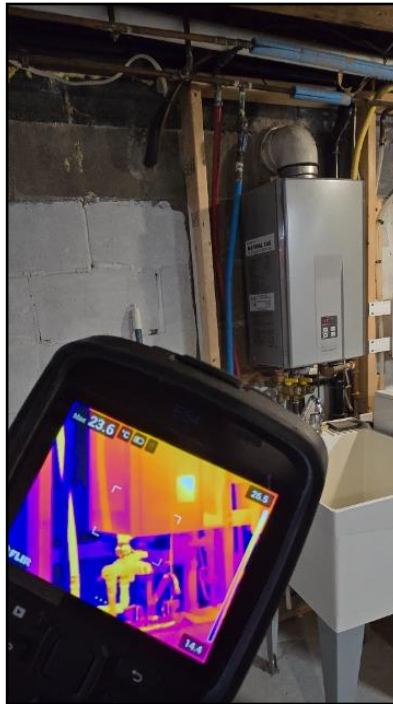
Infrared image shows unit operating and producing hot water

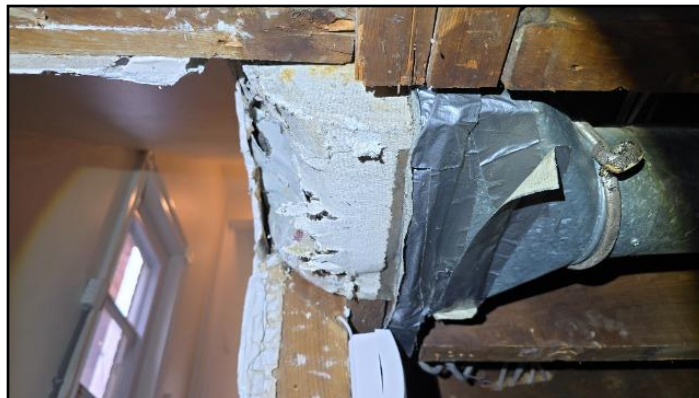
**20. Condition:** • Homes of this era may have additional environmental hazards/concerns. Example ( Lead, Asbestos, UFFI ) These items are not always visual to the home inspector. Recommend further evaluation by an appropriate contractor before any renovations of the property.

Asbestos wrap noted at heat register. Not seen if any within walls

101. Homes of this era may have additional...

**Task:** Improve Remove

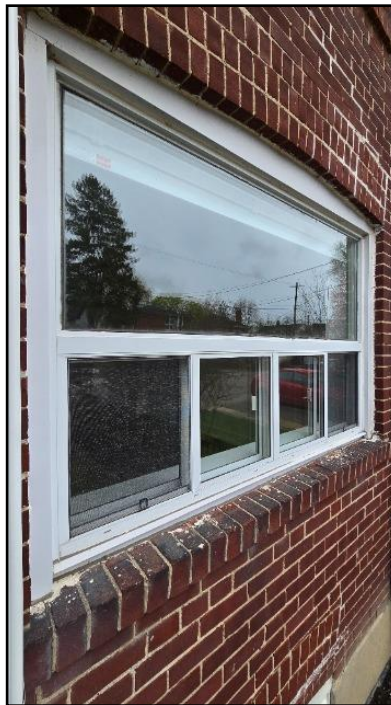
112. Sliders

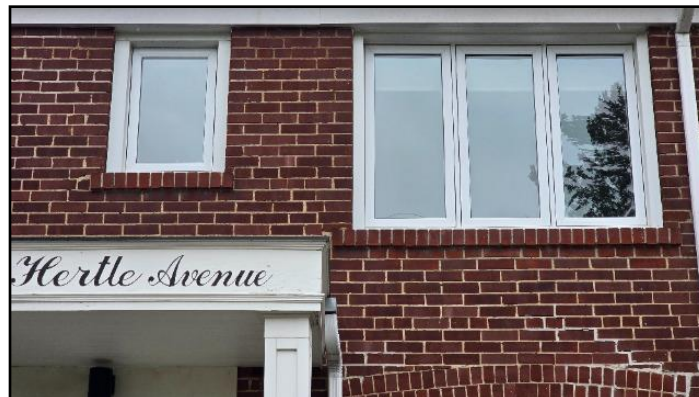
113. Casement

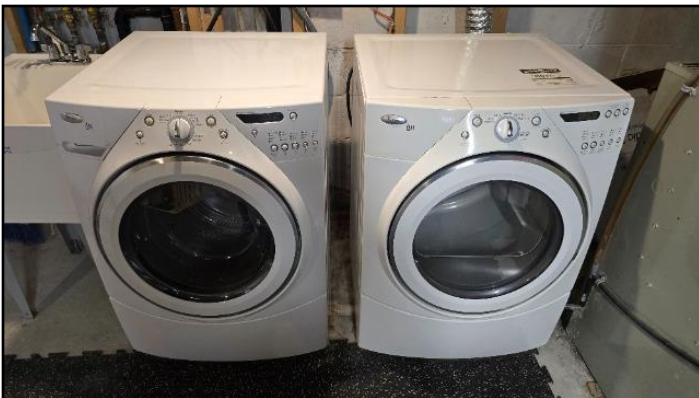
116. Appliances Present

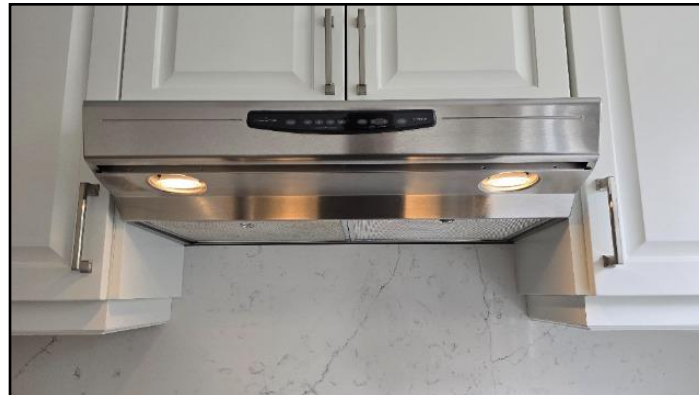
119. Exhaust fan

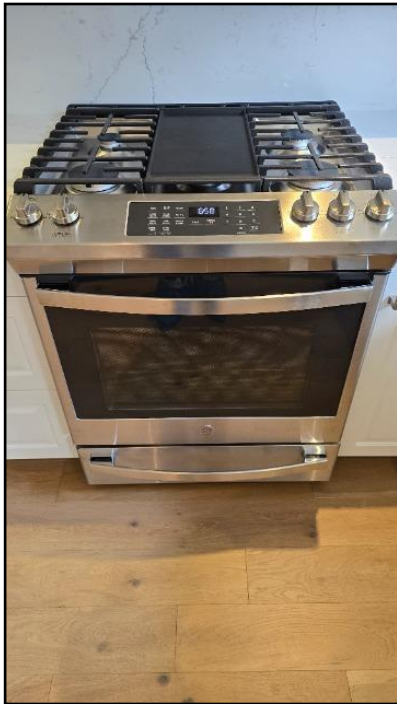
121. Present

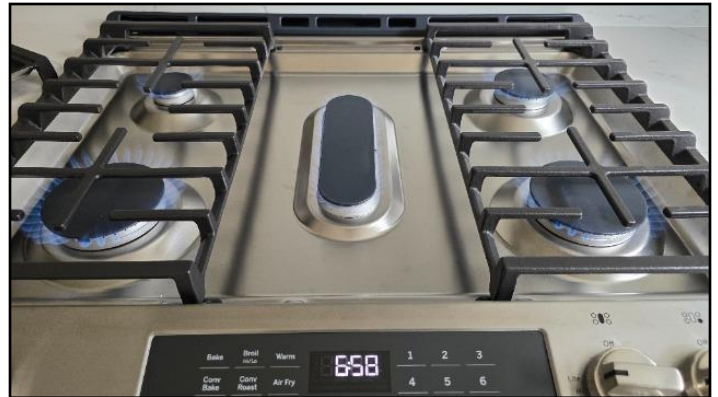
122. Present

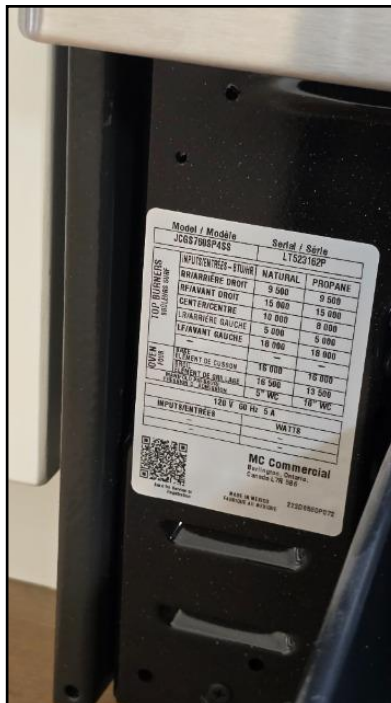
123. Present

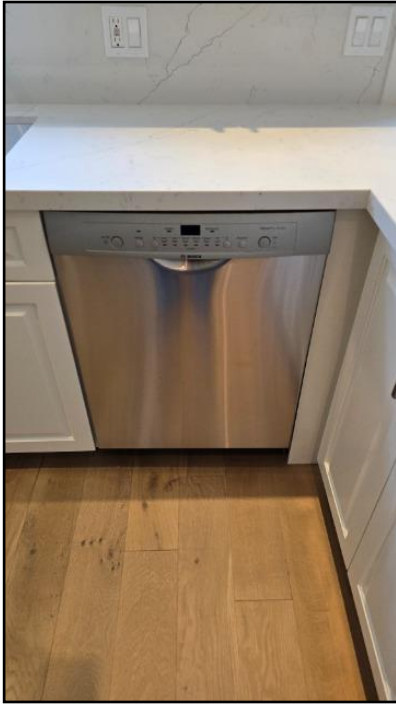
124. Present

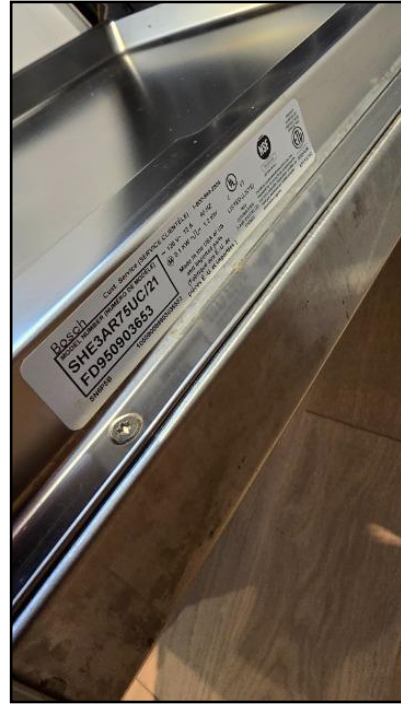
125. Present

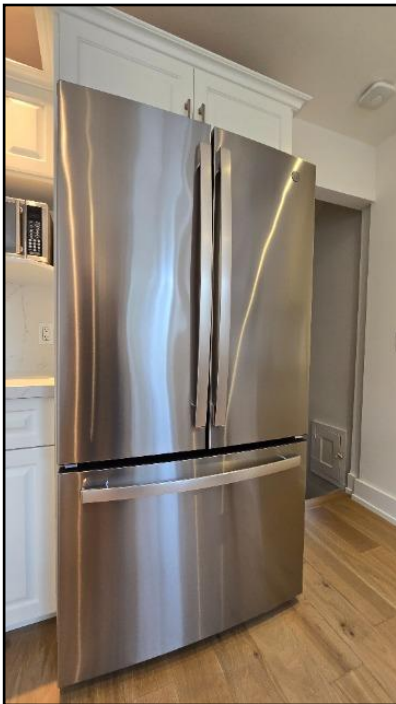
126. Present

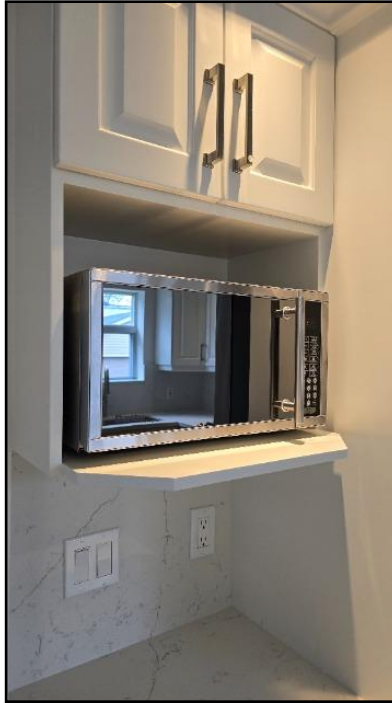
128. Present

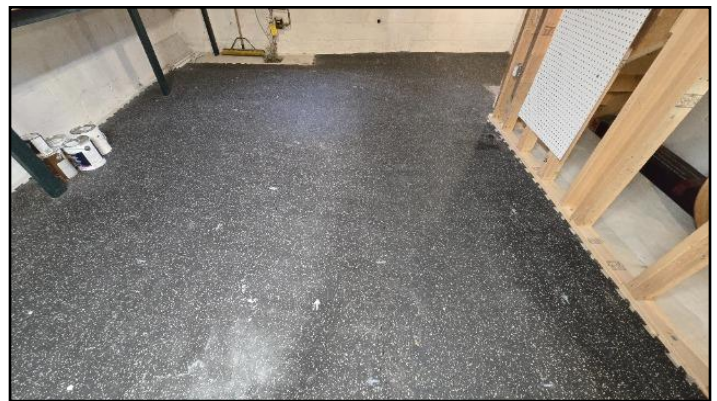
130. Rubber Matting
